DRAFT MEMORANDUM

DATE: December 1, 2022
TO: Denice Hutten, City of Half Moon Bay
FROM: Benjamin Shick, PE
SUBJECT: Pilarcitos Avenue/Kehoe Watercourse Outfall Repair Project (CIP 1005),
Project Alternatives

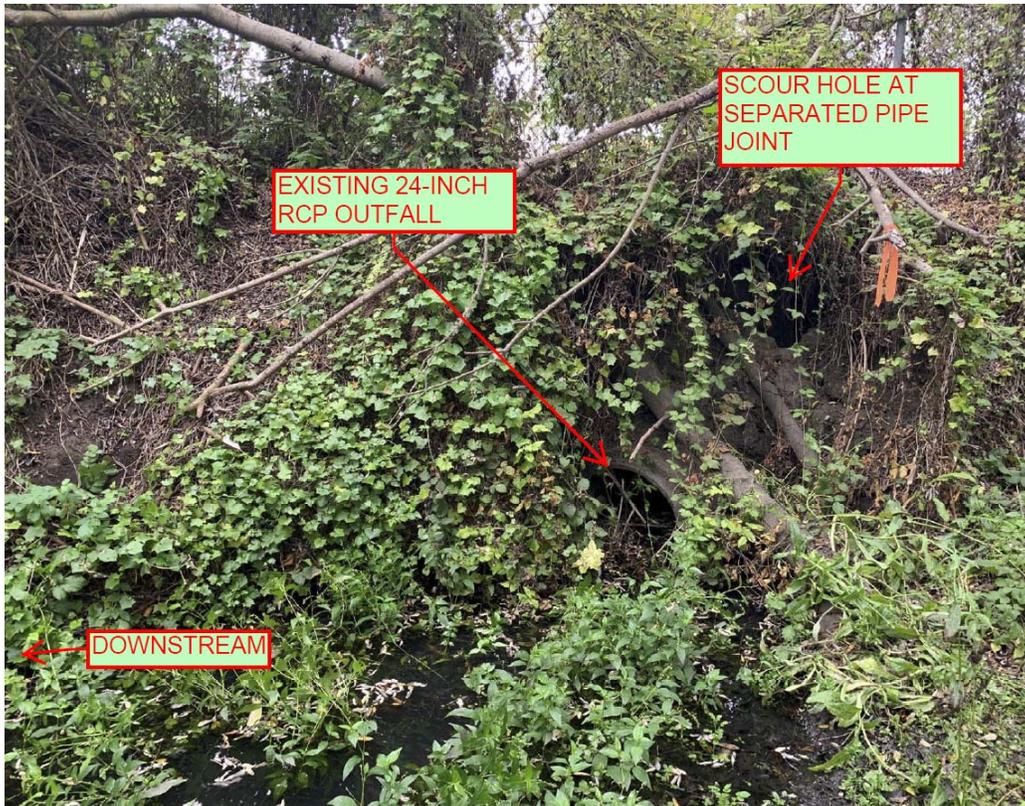
Figure 2: Photograph of Outfall, Looking North (10/5/22)

Erosion has occurred surrounding the outfall. A scour hole is present downstream of the outfall pipe. Ponding water was present in the channel and extended up the culvert to the storm drain inlet at the intersection of Pilarcitos Avenue and Kehoe Avenue. A photograph of the existing outfall and scour hole is included in Figure 2, additional photographs of the channel and outfall are included as Attachment 2 for reference.

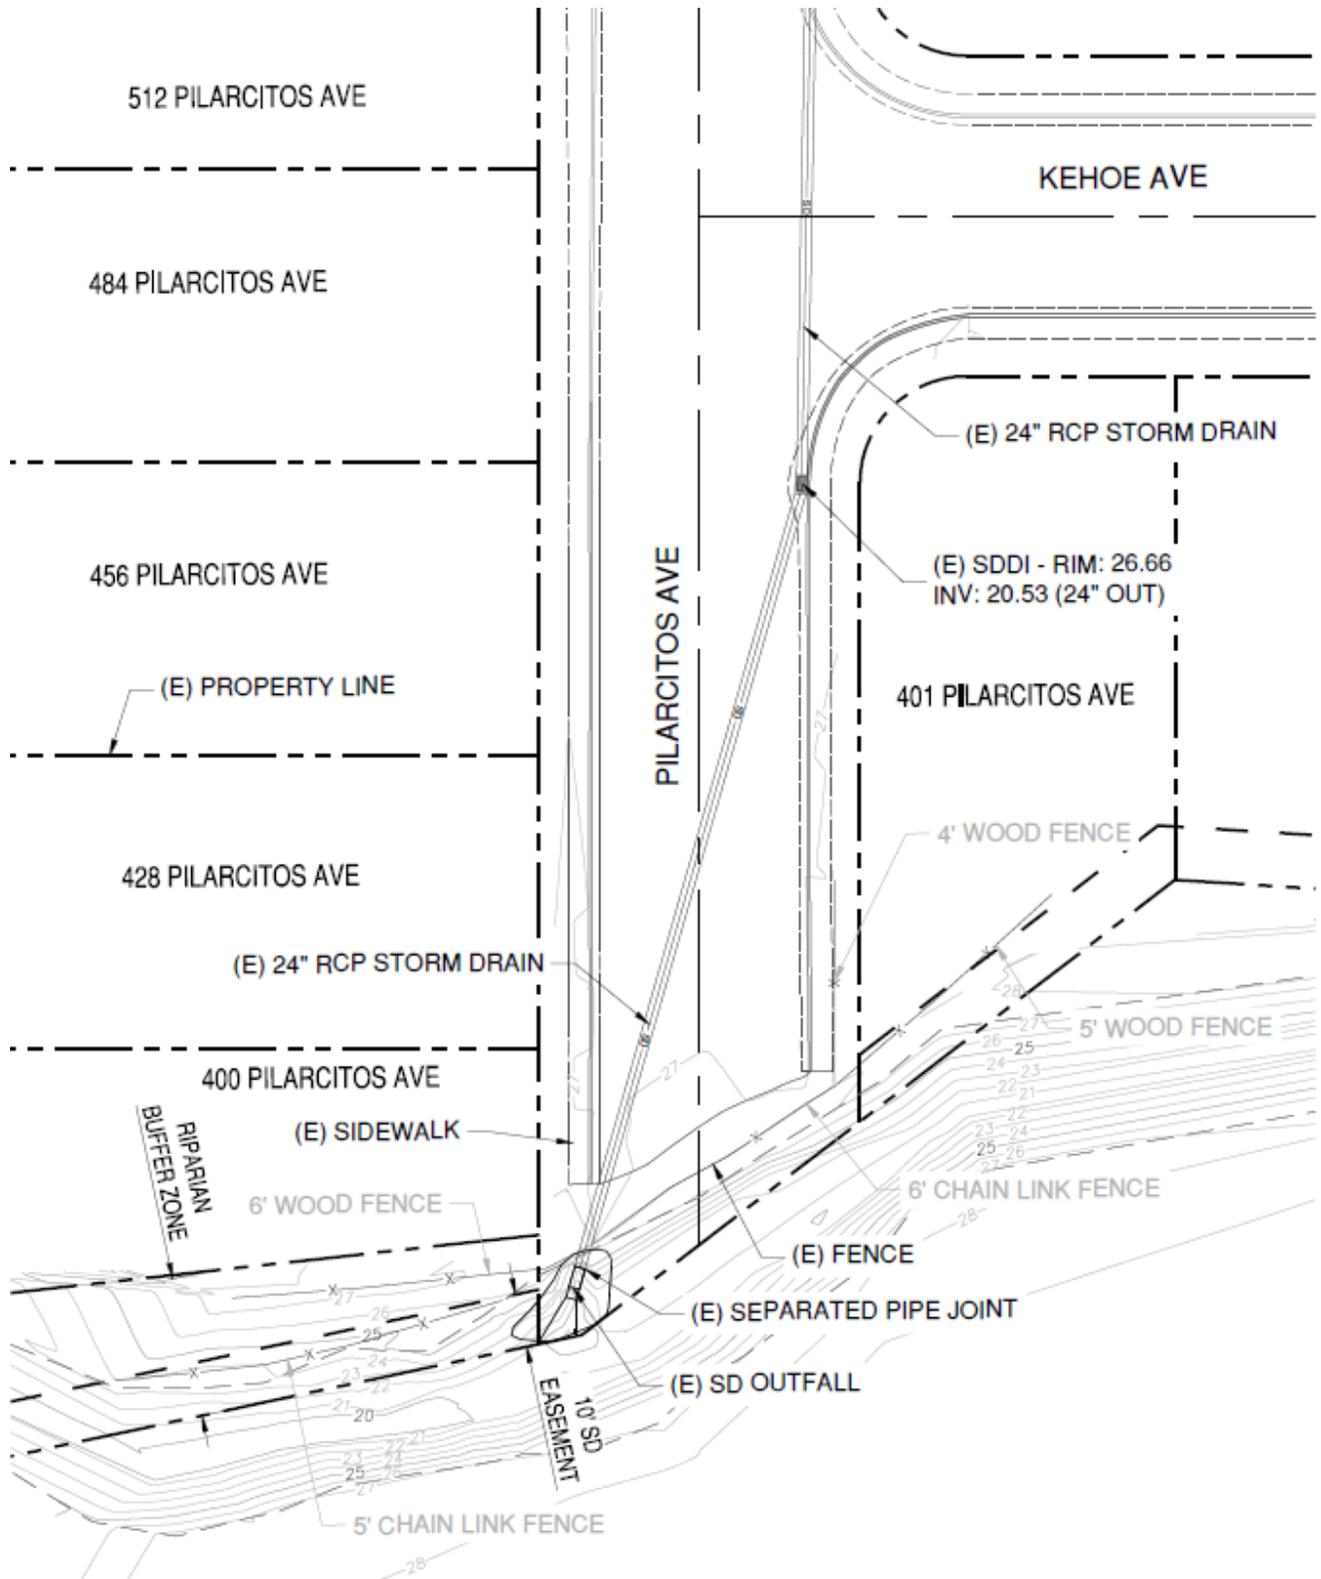
Figure 3: Existing Conditions

Topographic survey of the outfall, fencing, upstream storm drain inlet, and channel surrounding the outfall was conducted in June 2022. The outfall location, storm drain alignment, adjacent property lines and easements, and channel topography are shown in Figure 3.

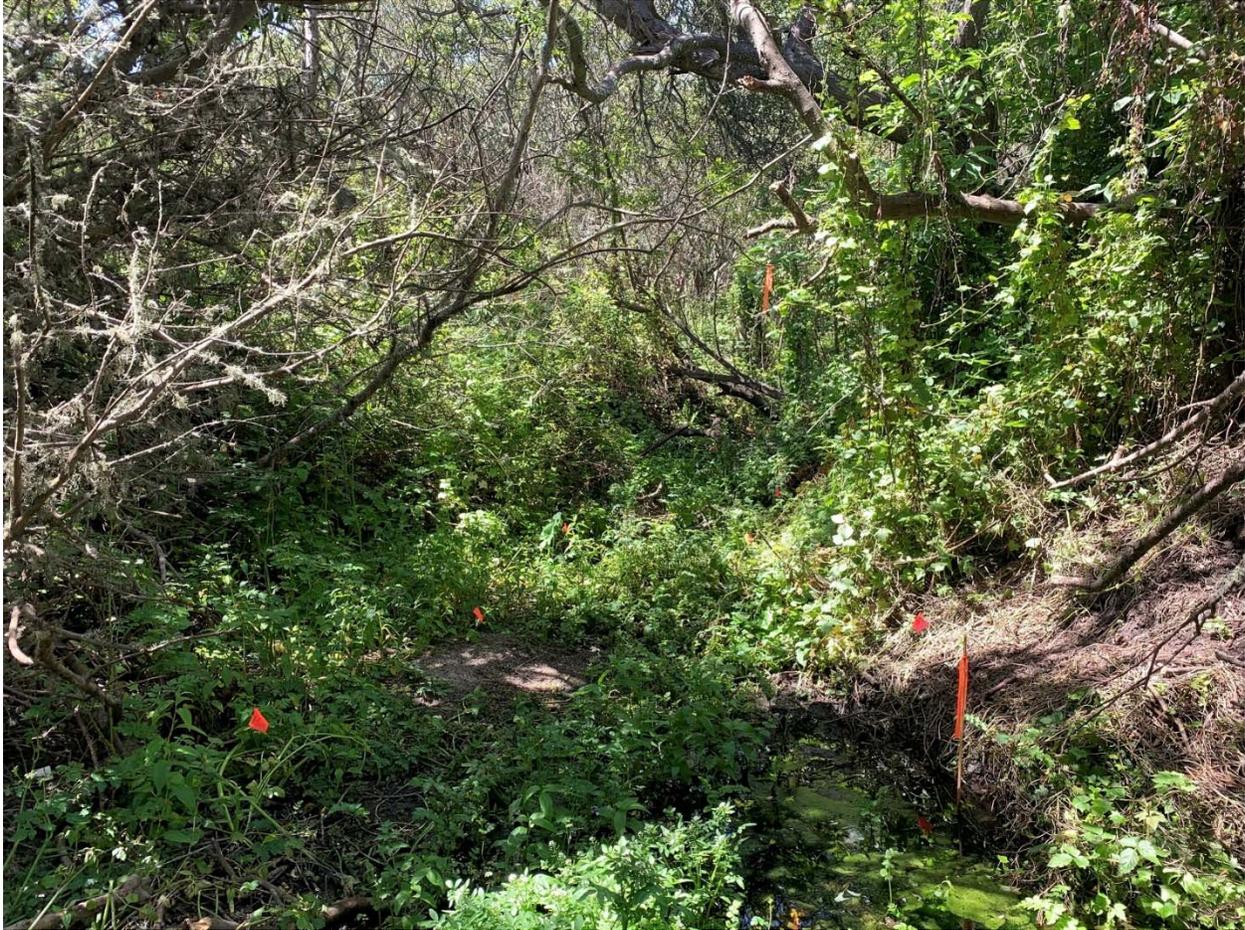
Photo 1: Looking downstream (west) from outfall location 6/9/22

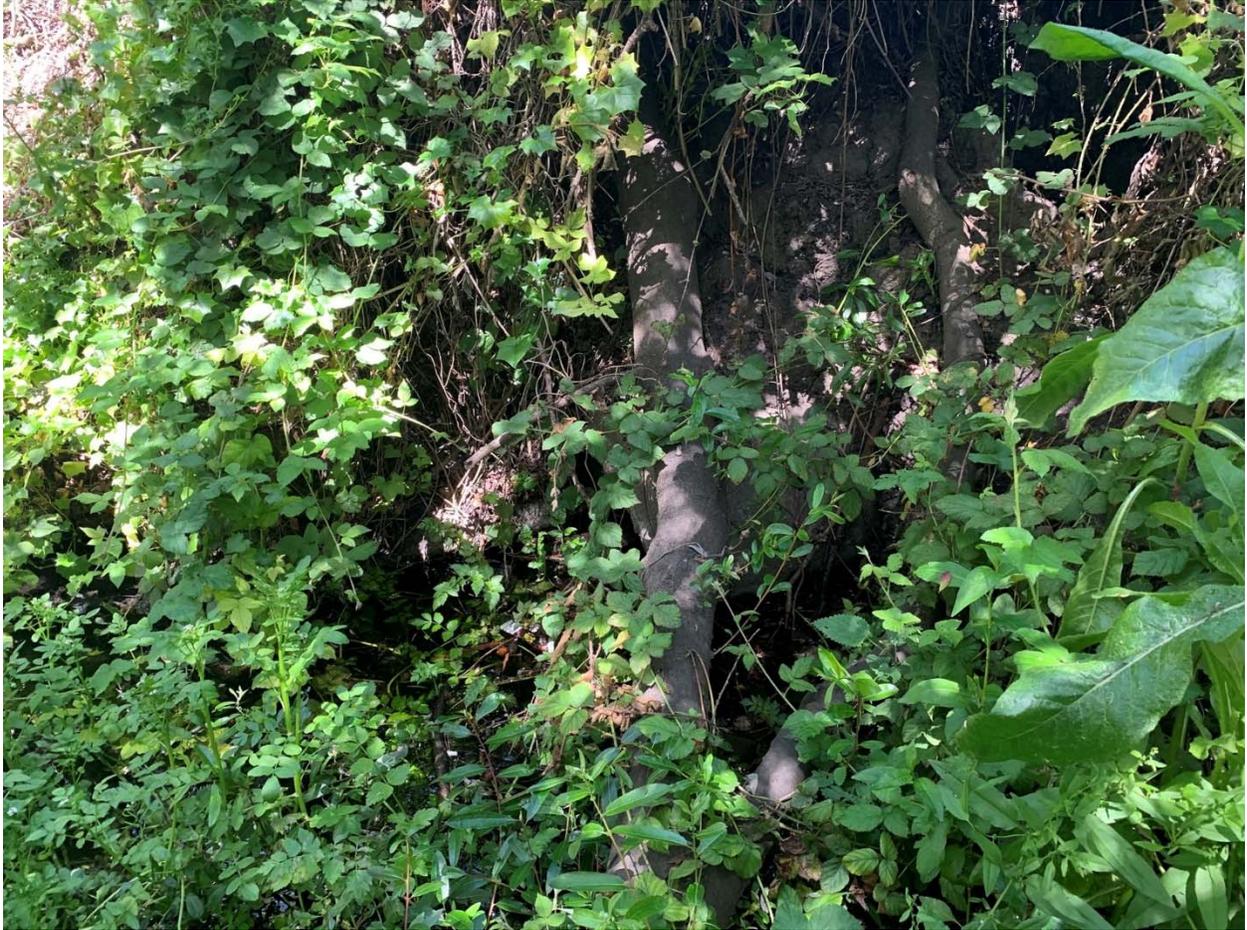
Photo 2: Existing Outfall 6/9/22

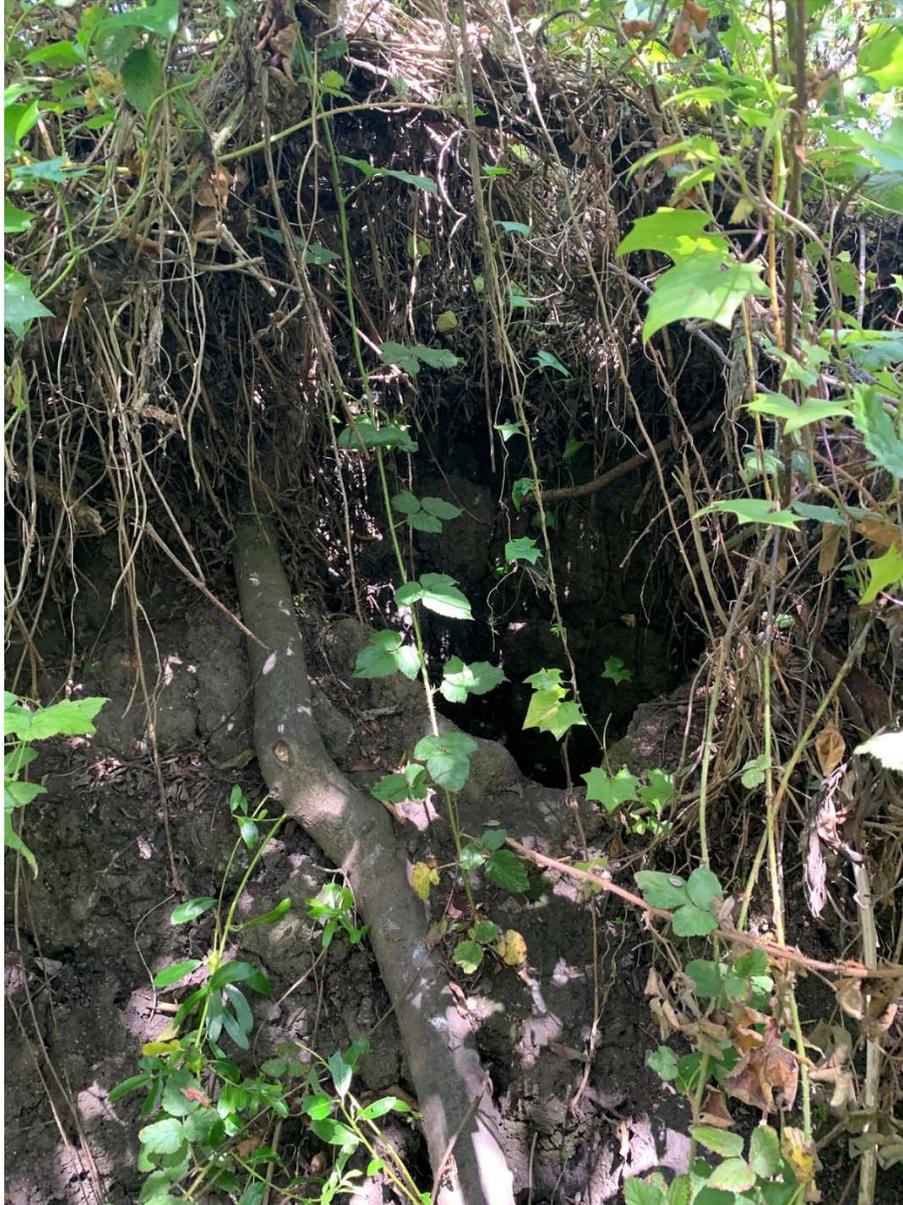
Schaaf & Wheeler visited the site on June 9, 2022 to observe and document existing conditions of the culvert and channel adjacent to the outfall. The culvert consists of 24-inch diameter reinforced concrete pipe (RCP) with pipe segments that are approximately 4 feet long. The final 4-foot segment extending to the bank of the channel has subsided and the top of the separated pipe joint is exposed. There is an existing 8-foot long sakrete wall extending from the outfall along the toe of the channel bank (bottom of channel bank slope); a concrete apron also extends from the existing outfall approximately 8 feet. The concrete may have subsided over time, it is approximately 1-foot lower than the invert of the 24-inch RCP outfall pipe.

Photo 3: Erosion at Separated Pipe Joint 6/9/22

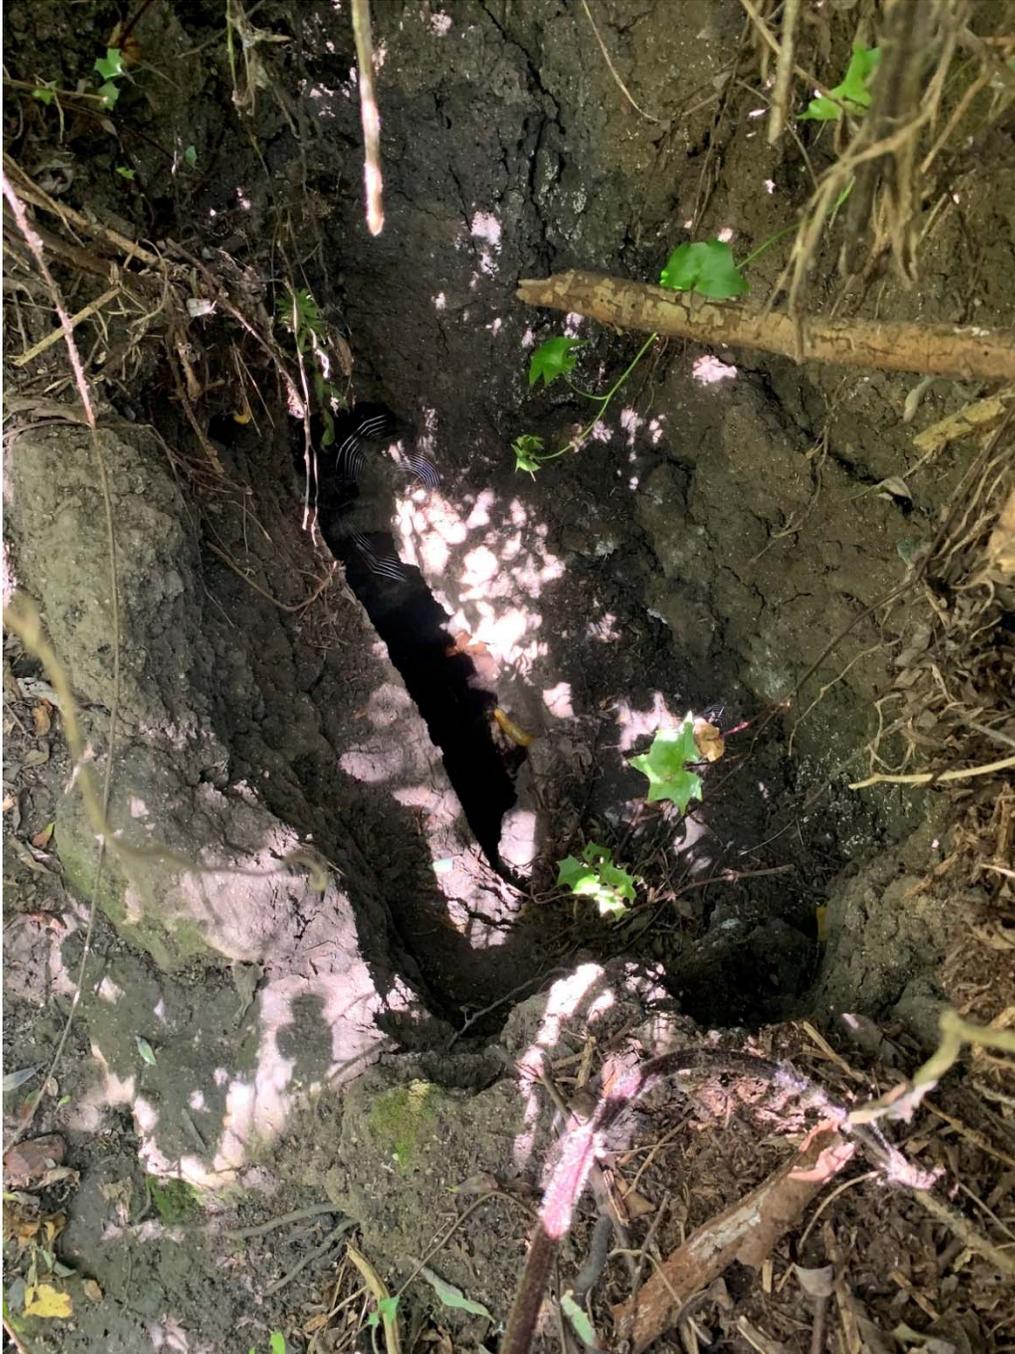
Photo 4: Separated Pipe Joint, 4 Feet Upstream of Outfall 6/9/22

Alternative 1 includes replacing the 4-foot-long pipe segment at the outfall with a new 6-foot-long, 24-inch diameter concrete culvert. The culvert would extend two feet into the channel beyond the existing outfall to reduce the slope of the channel bank and to better conform to the upstream and downstream channel contours. A reinforced concrete collar would be installed around the pipe joint connecting the new and existing pipe segments. The concrete collar would create a reinforced/sealed connection to minimize the potential for leakage through the pipe joint and to mitigate the potential for failure of the pipe joint.

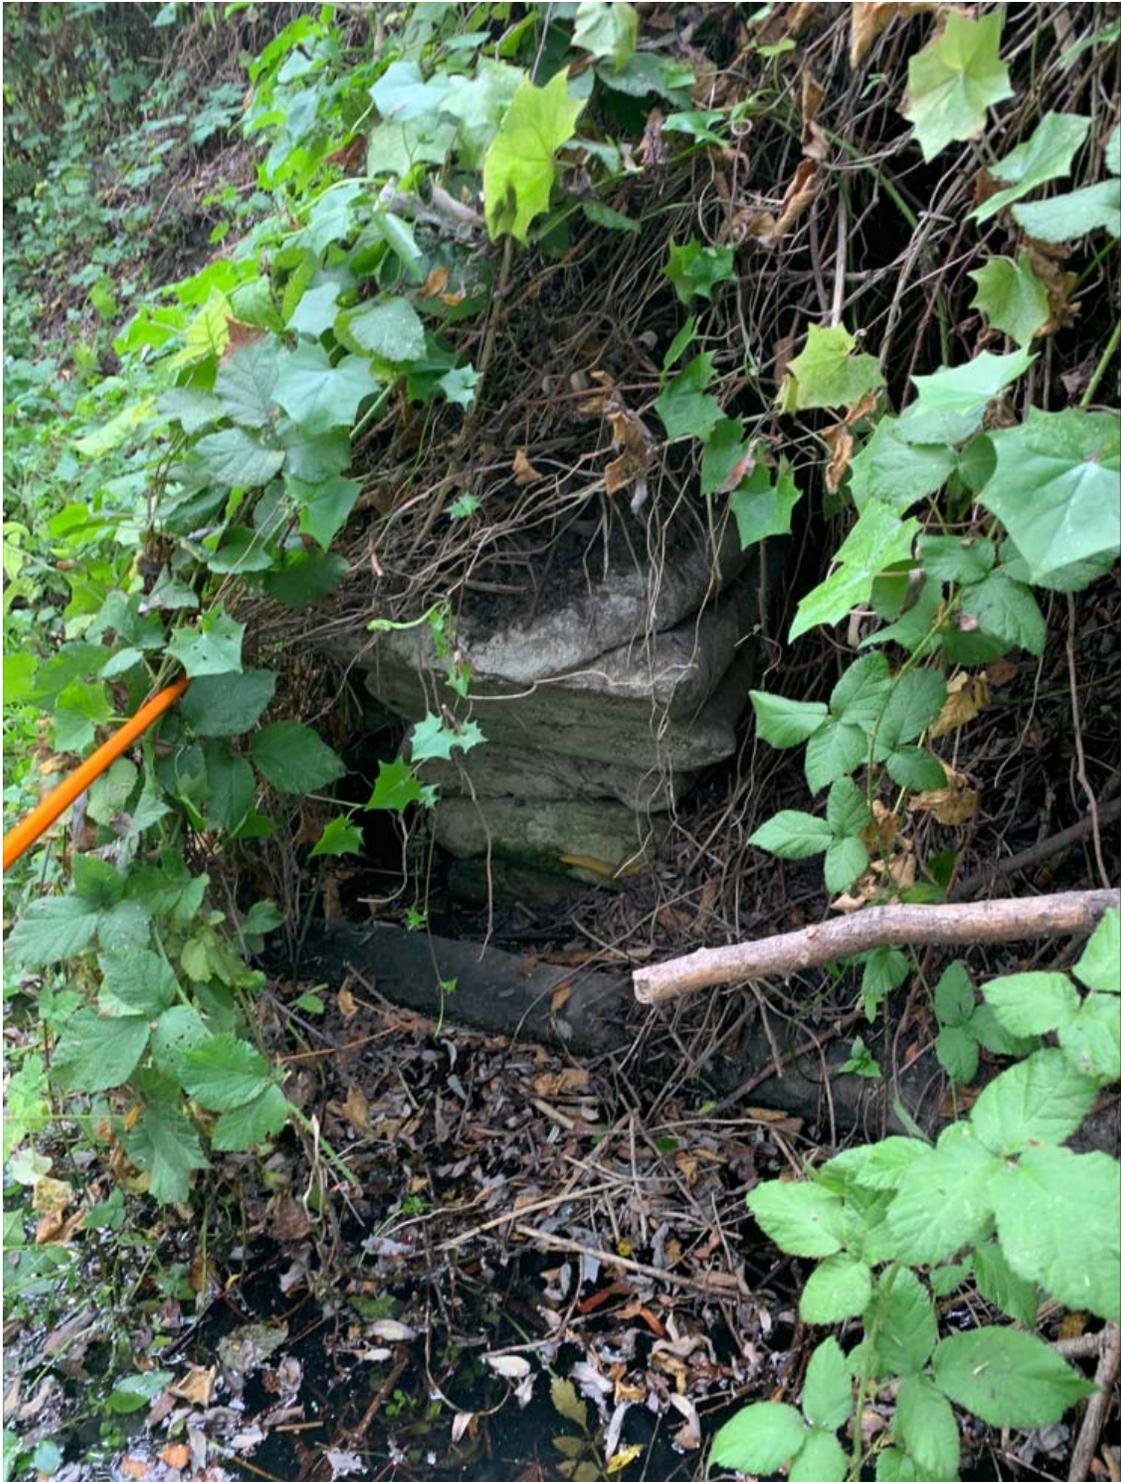
Photo 5: Existing Sakrete Wall Downstream of Outfall 10/5/22

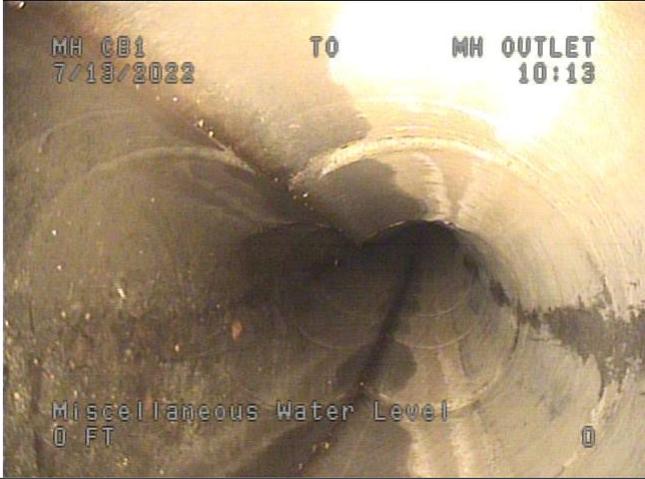
0.0	Miscellaneous Water Level Severity: None Percent: 10	00:00:51

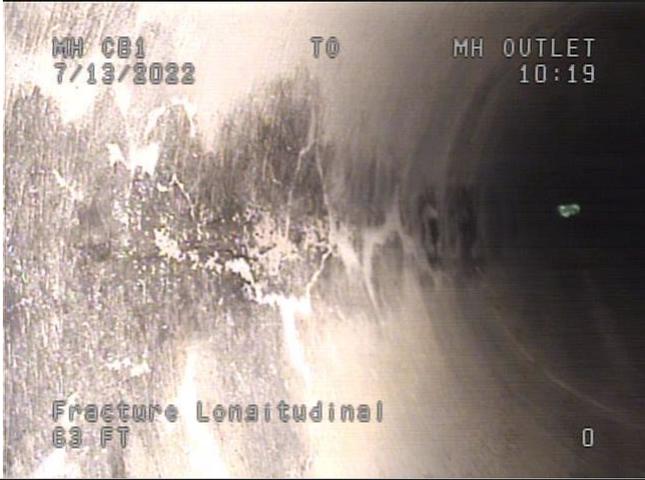
63.0	Fracture Longitudinal Position: 12 Severity: None Struct Weight: 3	00:07:09
