880 Stone Pine Road HMB Lot Arborist Report

County of San Mateo
Steven McGuckin

Leonardo Tuchman
Plant Health Care Arborist

AUGUST 21, 2023

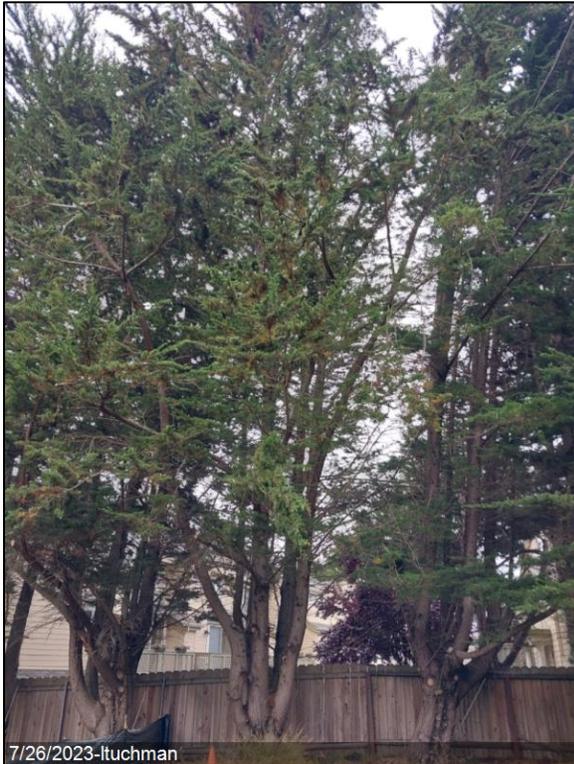
Photo 1: Monterey cypress #1 growing on the west perimeter of the property. It is growing in a dense row with other cypress.

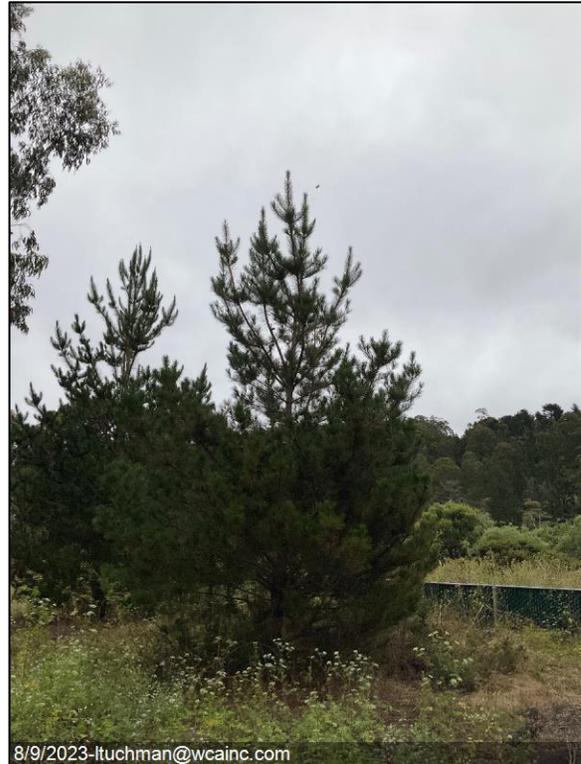
Photo 2: Monterey pine #50 growing on the south perimeter of the property on the edge of a cluster of trees. Trees of similar size are growing in this area.

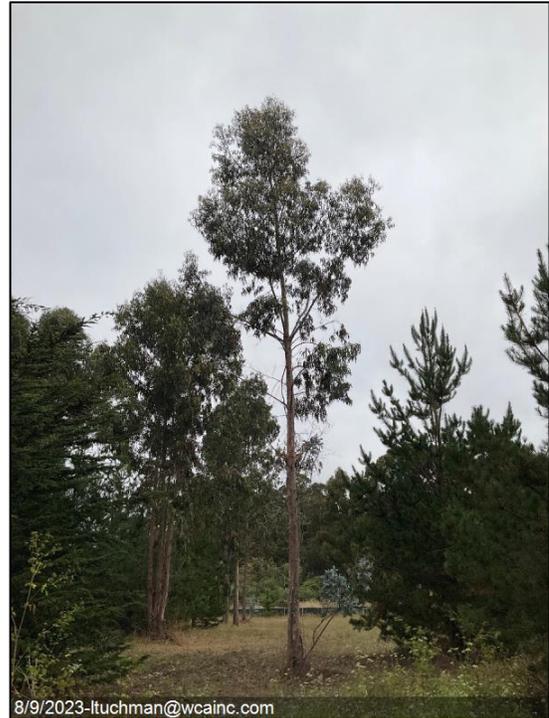
Photo 3: Blue gum eucalyptus #53 growing in the south side cluster of trees. It has a narrow upright form with good structure.

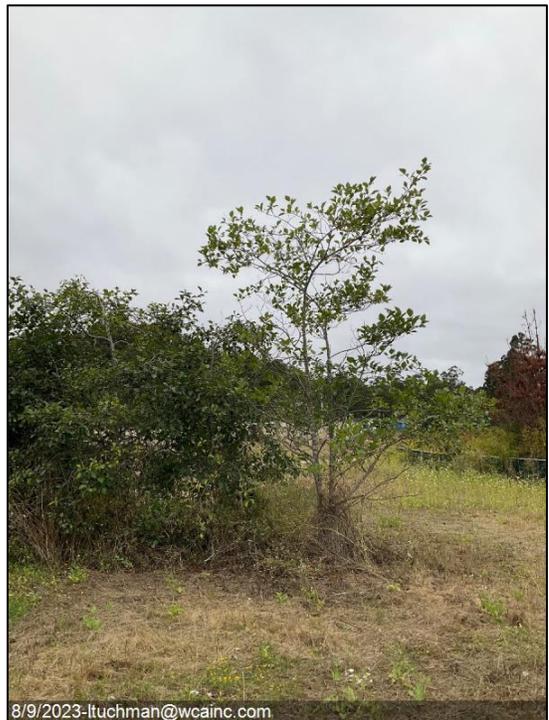
Photo 4: White alder #155 growing in a small row with white alders #156-158. It has codominant leaders with healthy foliage.
