City of Half Moon Bay, Miramontes Point

Sea Level Rise Vulnerability and Fiscal Impact Assessment

Prepared by
integral
consulting inc.

March 21, 2023

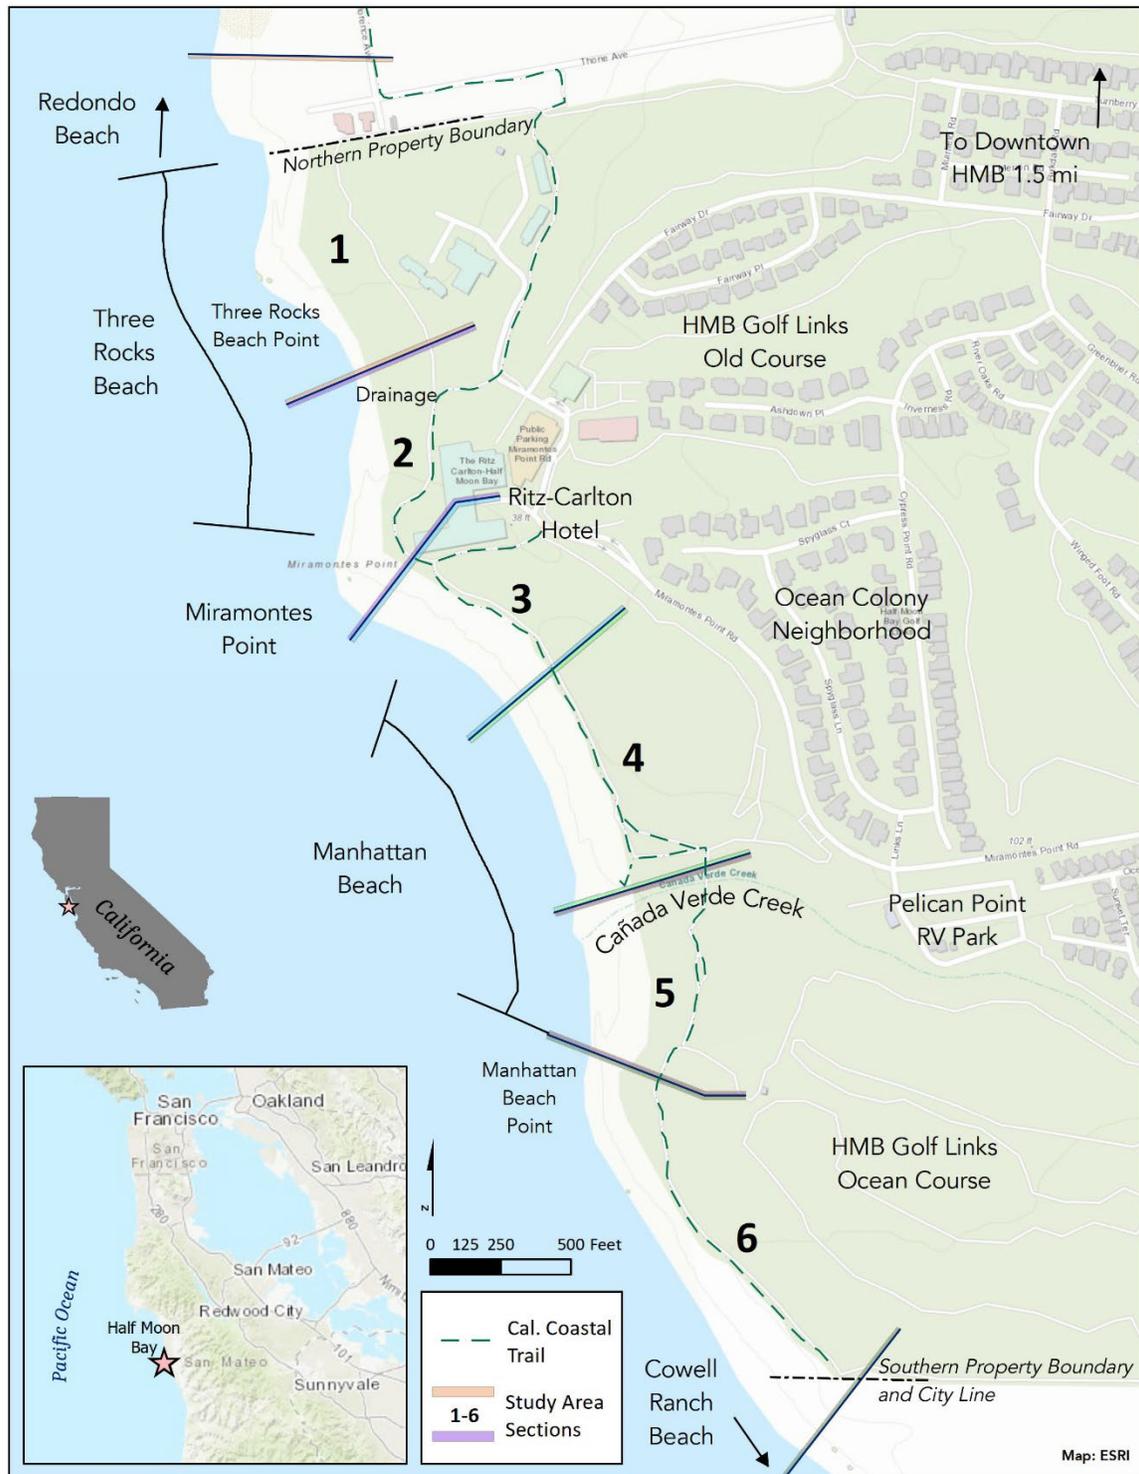
Figure 1-1. Study area.

The Miramontes Point study area is located at the southern end of the City of HMB adjacent to the Ocean Colony and Cañada Cove neighborhoods and encompasses a one-mile stretch of coast between Redondo Beach and the city limit to the south (Figure 1-1).

vulnerability assessment and the forecasts of future cliff retreat, the study area was divided into six sections (Figure 1-1).

The largest coastal promontory in the study area, Miramontes Point, is located in the southern portion of Section 2. Another small, unnamed point (referred to herein as Manhattan Beach Point) defines the boundary between Sections 5 and 6, south of Cañada Verde Creek. Manhattan Beach stretches along most of Sections 3–6 and can be accessed from the stairs at Cañada Verde Creek, although the southern stretch of the beach south of Manhattan Beach Point is narrow and is rarely accessible. Three Rocks Beach is a narrow stretch of beach within Sections 1–2 and is seasonally accessible from Manhattan Beach when tides are low enough for one to walk around Miramontes Point (Figure 1-1).

The one-mile study area is divided into six sections (Figure 1-1). The sections were delineated based on coastal orientation, geology, and beach width. Sections were then split into smaller subsection blocks by grouping transects with similar characteristics. The blocks are typically 50–150 ft alongshore and contain between three and six transects.

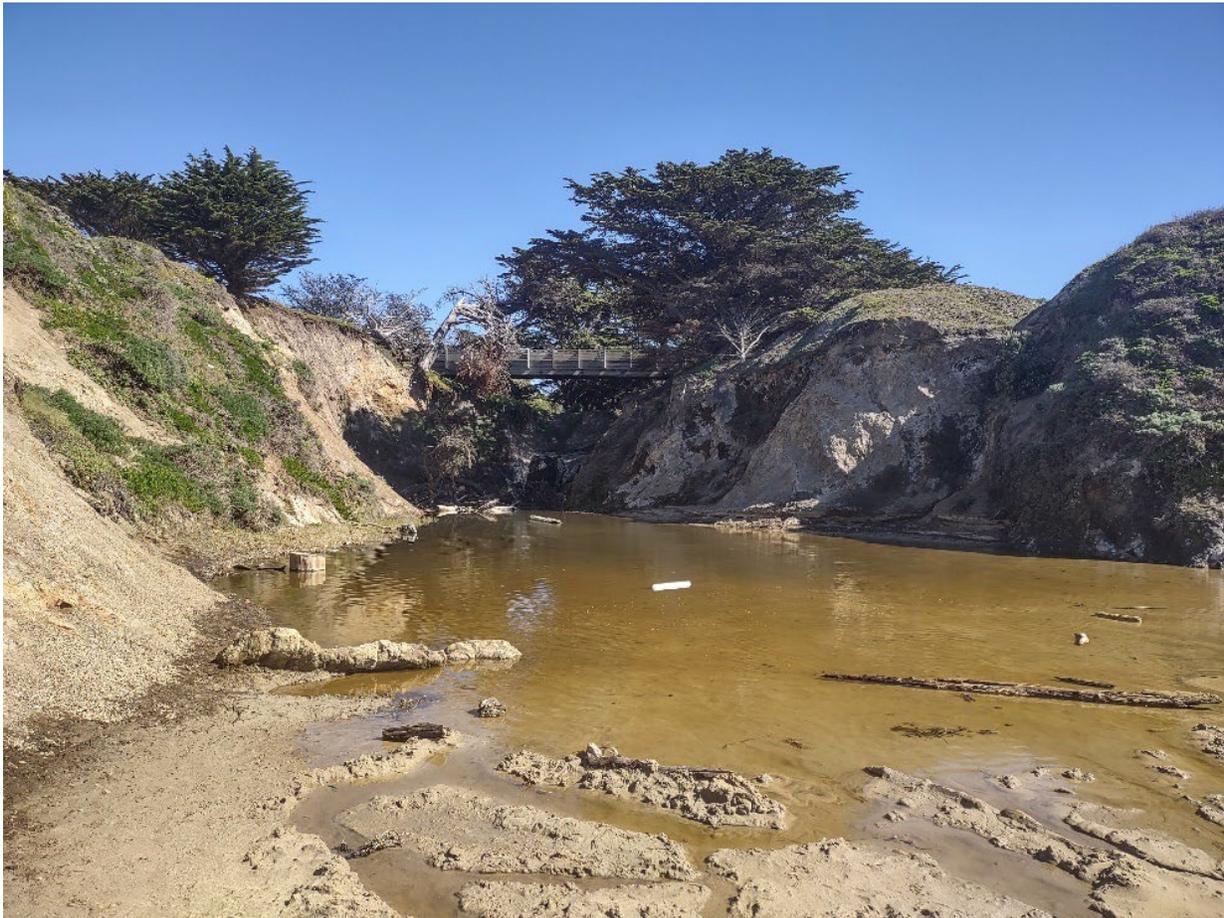
Figure 1-2. Drainage at Cañada Verde Creek. Source: *Integral Consulting, 2022*

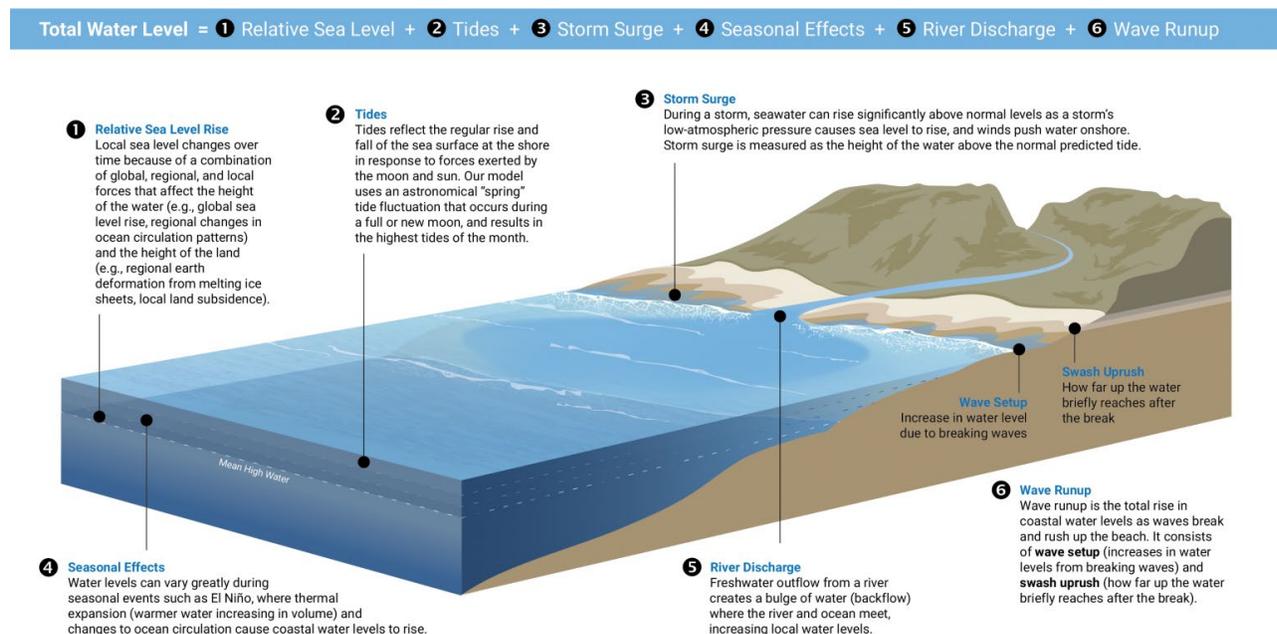
Figure 2-1. Conceptual diagram of the components of total water level. Image courtesy of Our Coast Our Future Web Platform (Point Blue and USGS 2021).

Coastal processes along the HMB coast that create coastal hazards include tides, waves, and related storm conditions. An important measure of coastal hazards is the total water level (TWL) elevation—the combined effect of wave run-up height, storm surge, tides, and sea level elevations (Figure 2-1). River discharge is not a contributing factor to TWL in the study area. A combination of large waves occurring at high tides during storm conditions poses the largest potential for coastal erosion; including beach erosion and bluff retreat. As sea levels rise, both the wave run-up dynamics and the tide elevations will change, leading to higher total water levels for longer durations. Each coastal process is summarized below.

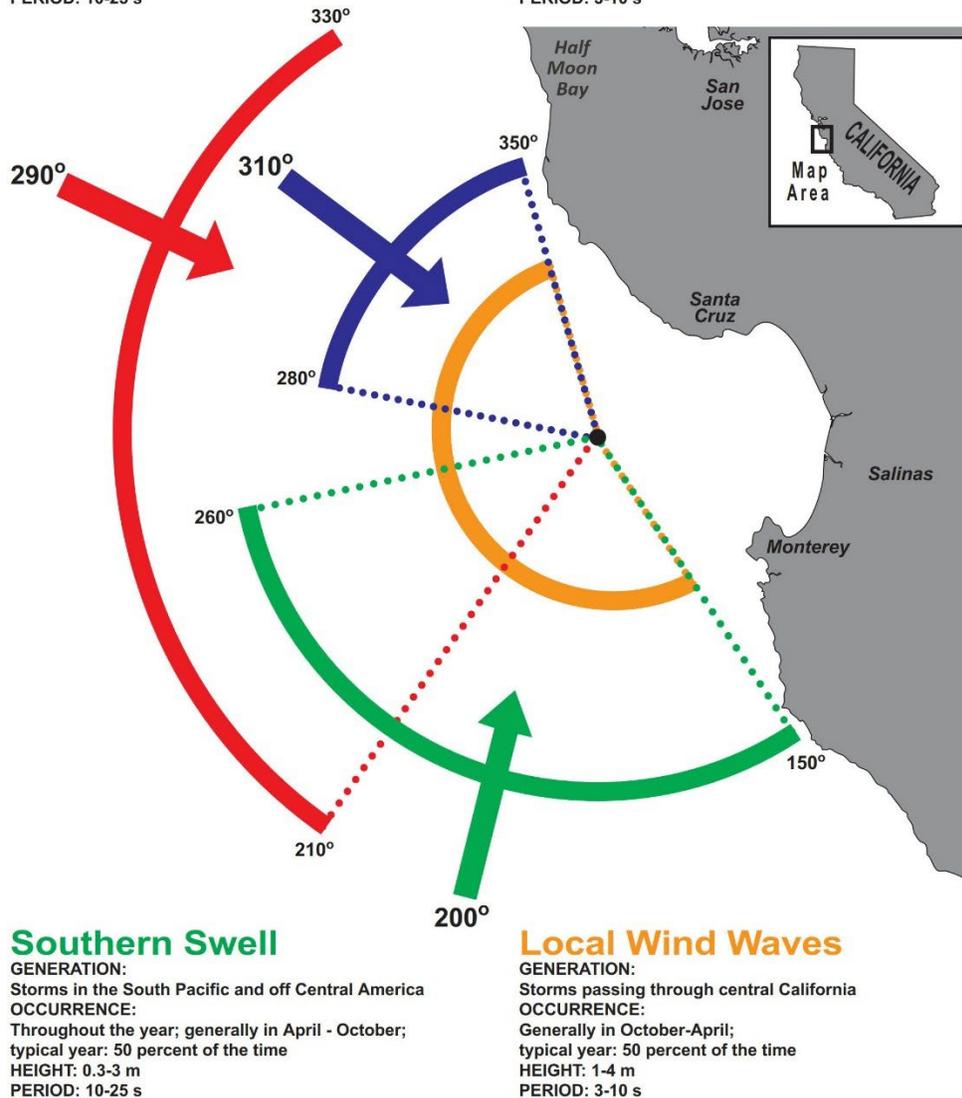
Figure 2-2. General wave patterns (degrees of azimuth) along the Central Coast (1993–2002) (Storlazzi and Wingfield 2005).

GENERATION:
Northwest winds generated by the California High blowing over the open ocean; sea breezes
OCCURRENCE:
Throughout the year; dominant in April-October; summer: 90-95 percent, winter: 55-65 percent of the time
HEIGHT: 1-4 m
PERIOD: 3-10 s

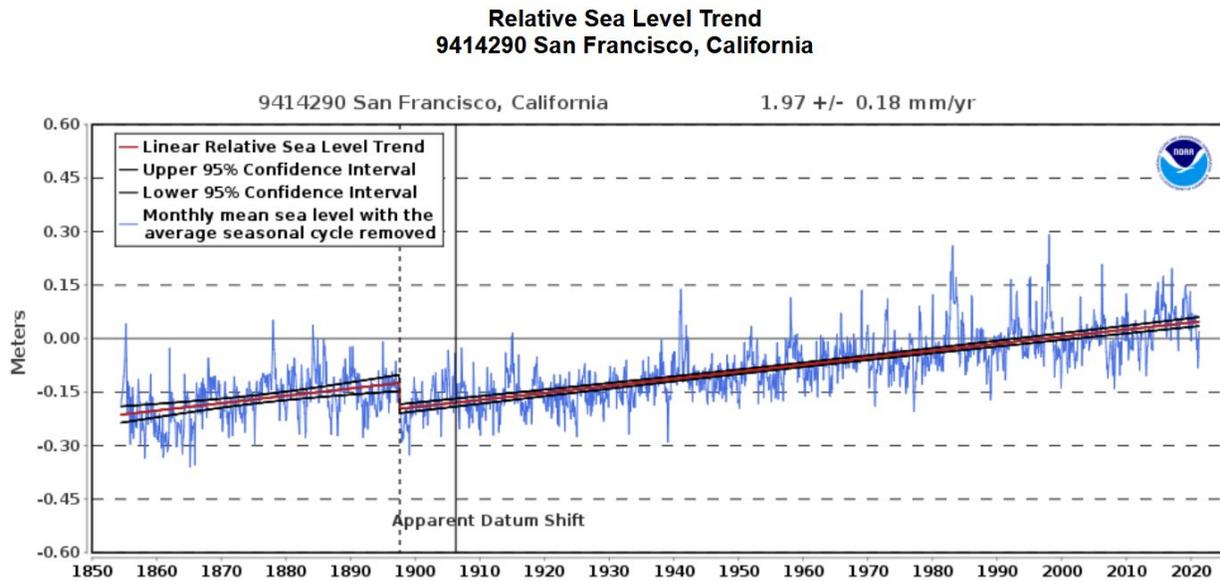
Figure 2-3. Relative sea level trend for the NOAA San Francisco tide gauge (Station 9414290)

Maximum water levels occur due to astronomical tides, wind surges, wave setup, density anomalies, long waves (including tsunamis), and El Niño and PDO events. On longer time scales, the tides will reach higher elevations as sea level rise rates accelerate. The San Francisco Station 9414290, the station nearest to HMB with readings extending to the mid-1800s, is shown below (Figure 2-3). The relative sea level rise trend in this graph shows 1.97 mm/yr. with a 95 percent confidence interval of ± 0.18 mm/yr. based on monthly mean sea level data from 1897 to 2020, which is equivalent to a change of 0.65 ft in 100 years. These measured local relative sea level rise trends when compared to the global average provide estimates of land motion, in this case, the land is rising, but just not as fast as sea levels.

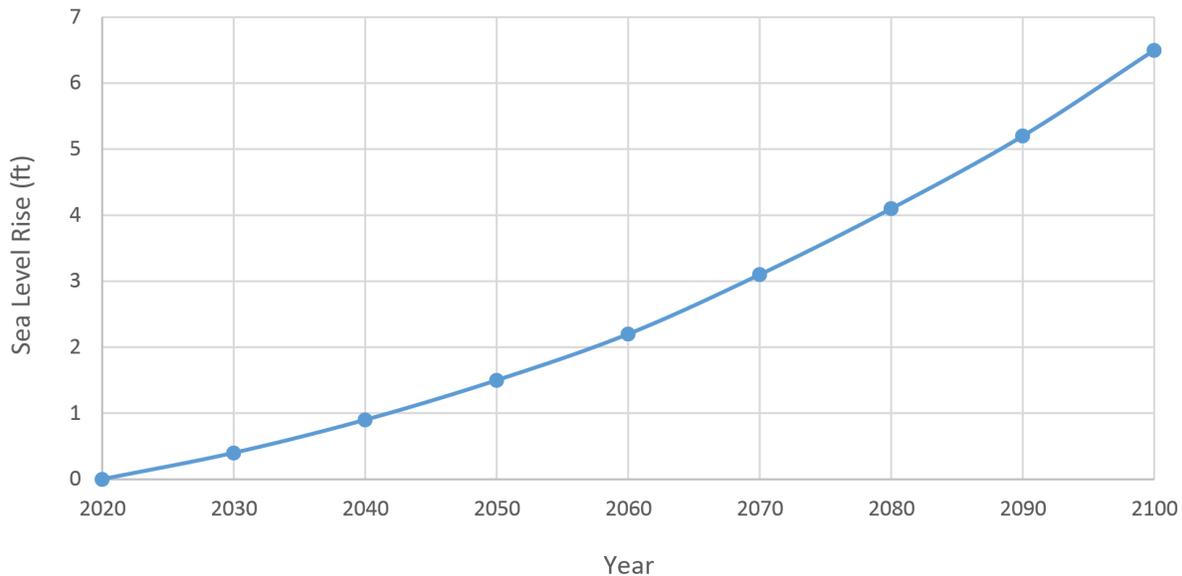
Figure 2-4. Study-specific rate of sea level rise from 2020 to 2100, based on OPC Guidance (2018).

Based on this guidance, this study used a medium–high-risk aversion scenario which sees 6.5 ft of sea level rise between 2020 and 2100 (Figure 2-4).

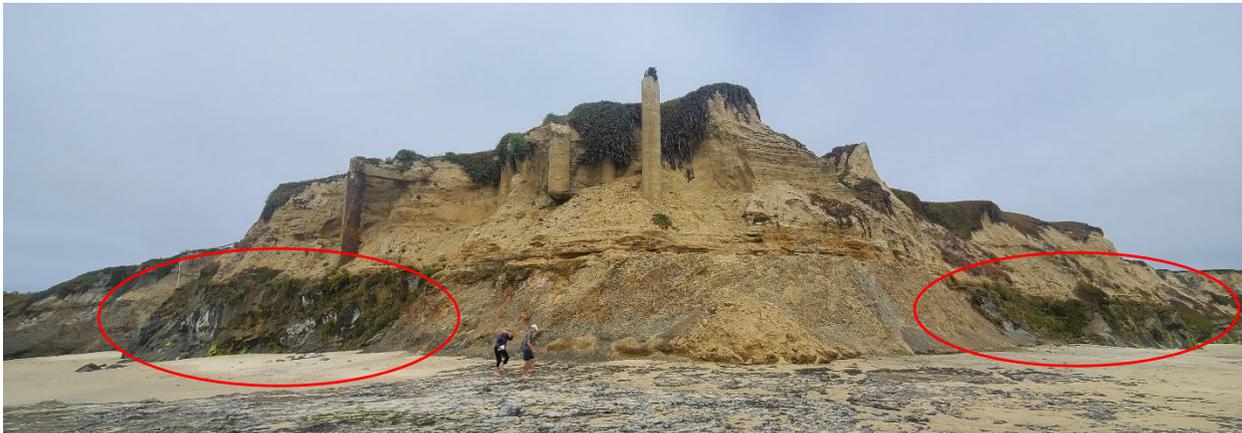
Figure 2-5. Miramontes Point (just under the hotel property) with patches of vegetation evidence of high groundwater highlighted by the red ovals. Source: *Integral Consulting, 2022*

One of the predominant ways that human activities can contribute to bluff retreat is by irrigation, especially near the bluff top. These activities are generally associated with landscaping or agriculture. In the study area, both the golf courses and the Ritz-Carlton Hotel irrigate their lawns and greens. Irrigation water, along with contributions from other sources such as non-irrigation stormwater runoff and drainage from areas higher in the local basin, can contribute to saturation through the basal unit. This is evident by the vegetation growing along the basal unit highlighted by the red ovals in Figure 2-5. Note that saturation through the basal unit is highly variable, as is apparent with the relative lack of vegetation growing at the point itself. Saturation of the basal unit and weaken it, thus accelerating erosion.

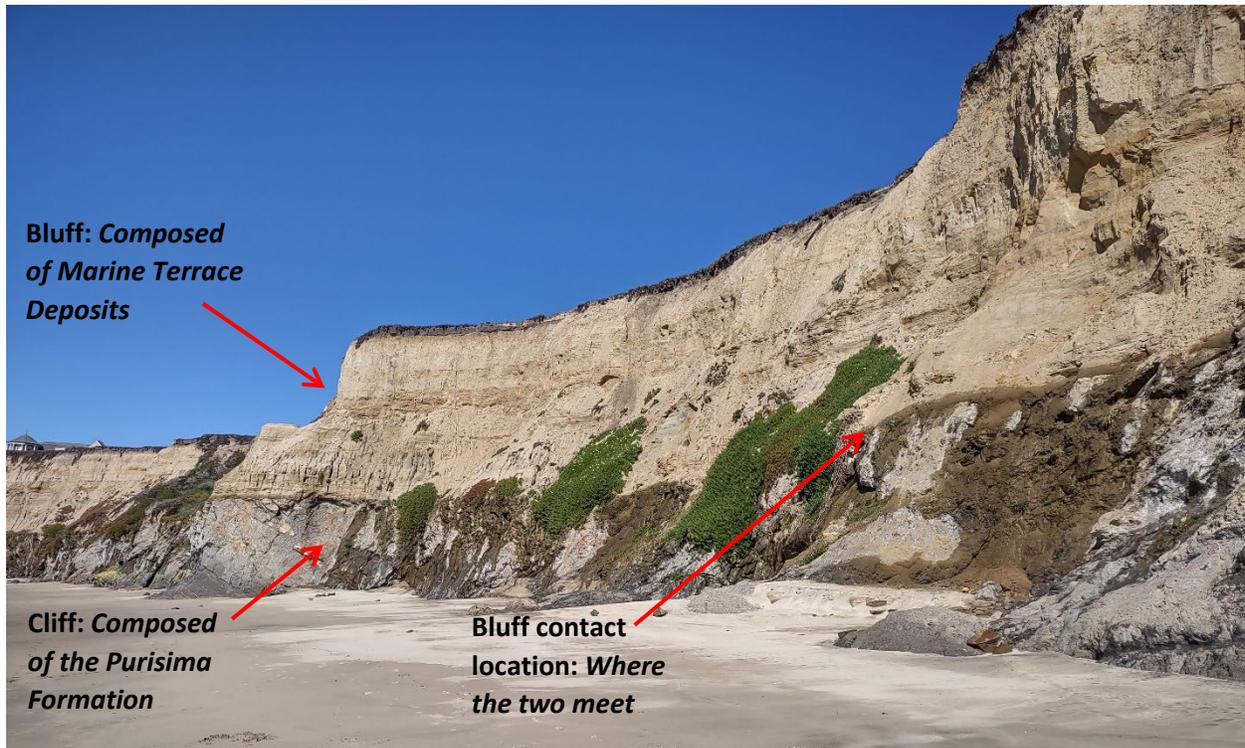
Figure 2-6. Lower portion of cliff is comprised of the Purisima Formation, which forms a steeper slope in most locales as compared to the upper bluff marine terrace deposits. Source: *Integral Consulting, 2022*

many areas, especially in the northern and central parts of the study area, the slopes of the two units are different, with the Purisima Formation forming a near-vertical face and the marine terrace deposits generally more gently sloping (Figure 2-6). In some areas, the marine terrace deposits have eroded more quickly than the underlying Purisima Formation creating a ledge or platform. The Purisima Formation dips to the northeast and as a result, the thickness of the basal unit exposed varies significantly along the length of the study area, ranging from only a thin layer less than three ft thick in the north to more than 30 ft thick in the southern area (Figure 2-7).

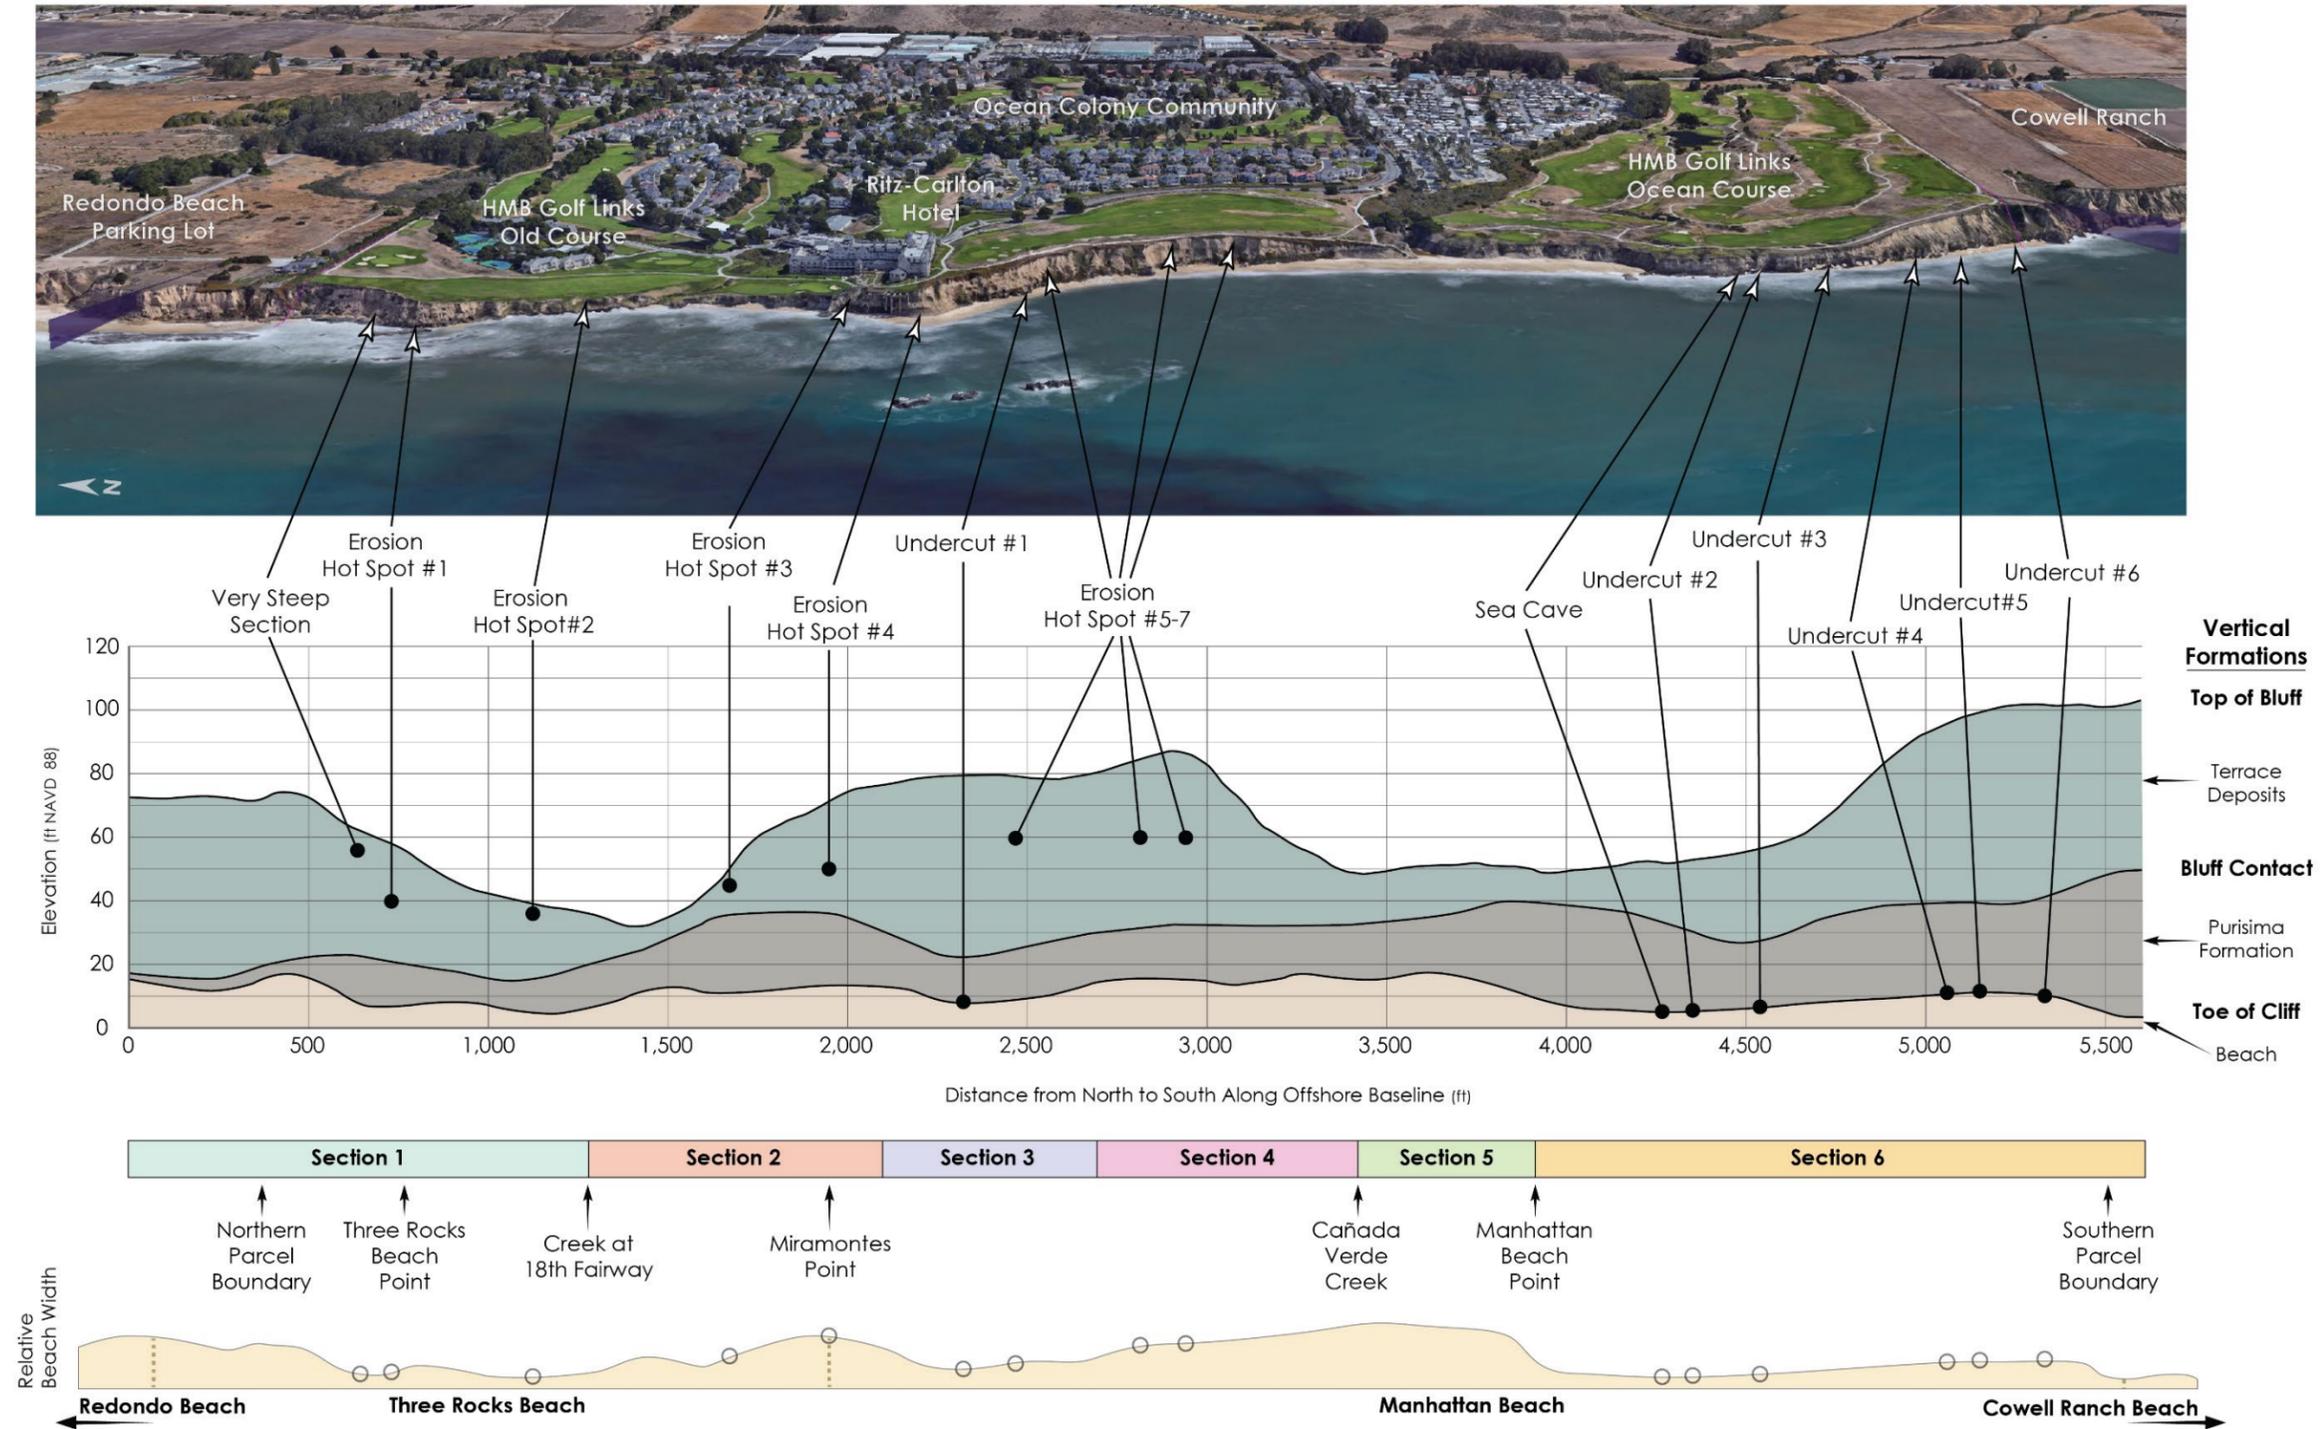
Figure 2-7. Site characteristics showing major points of interest and erosion features.

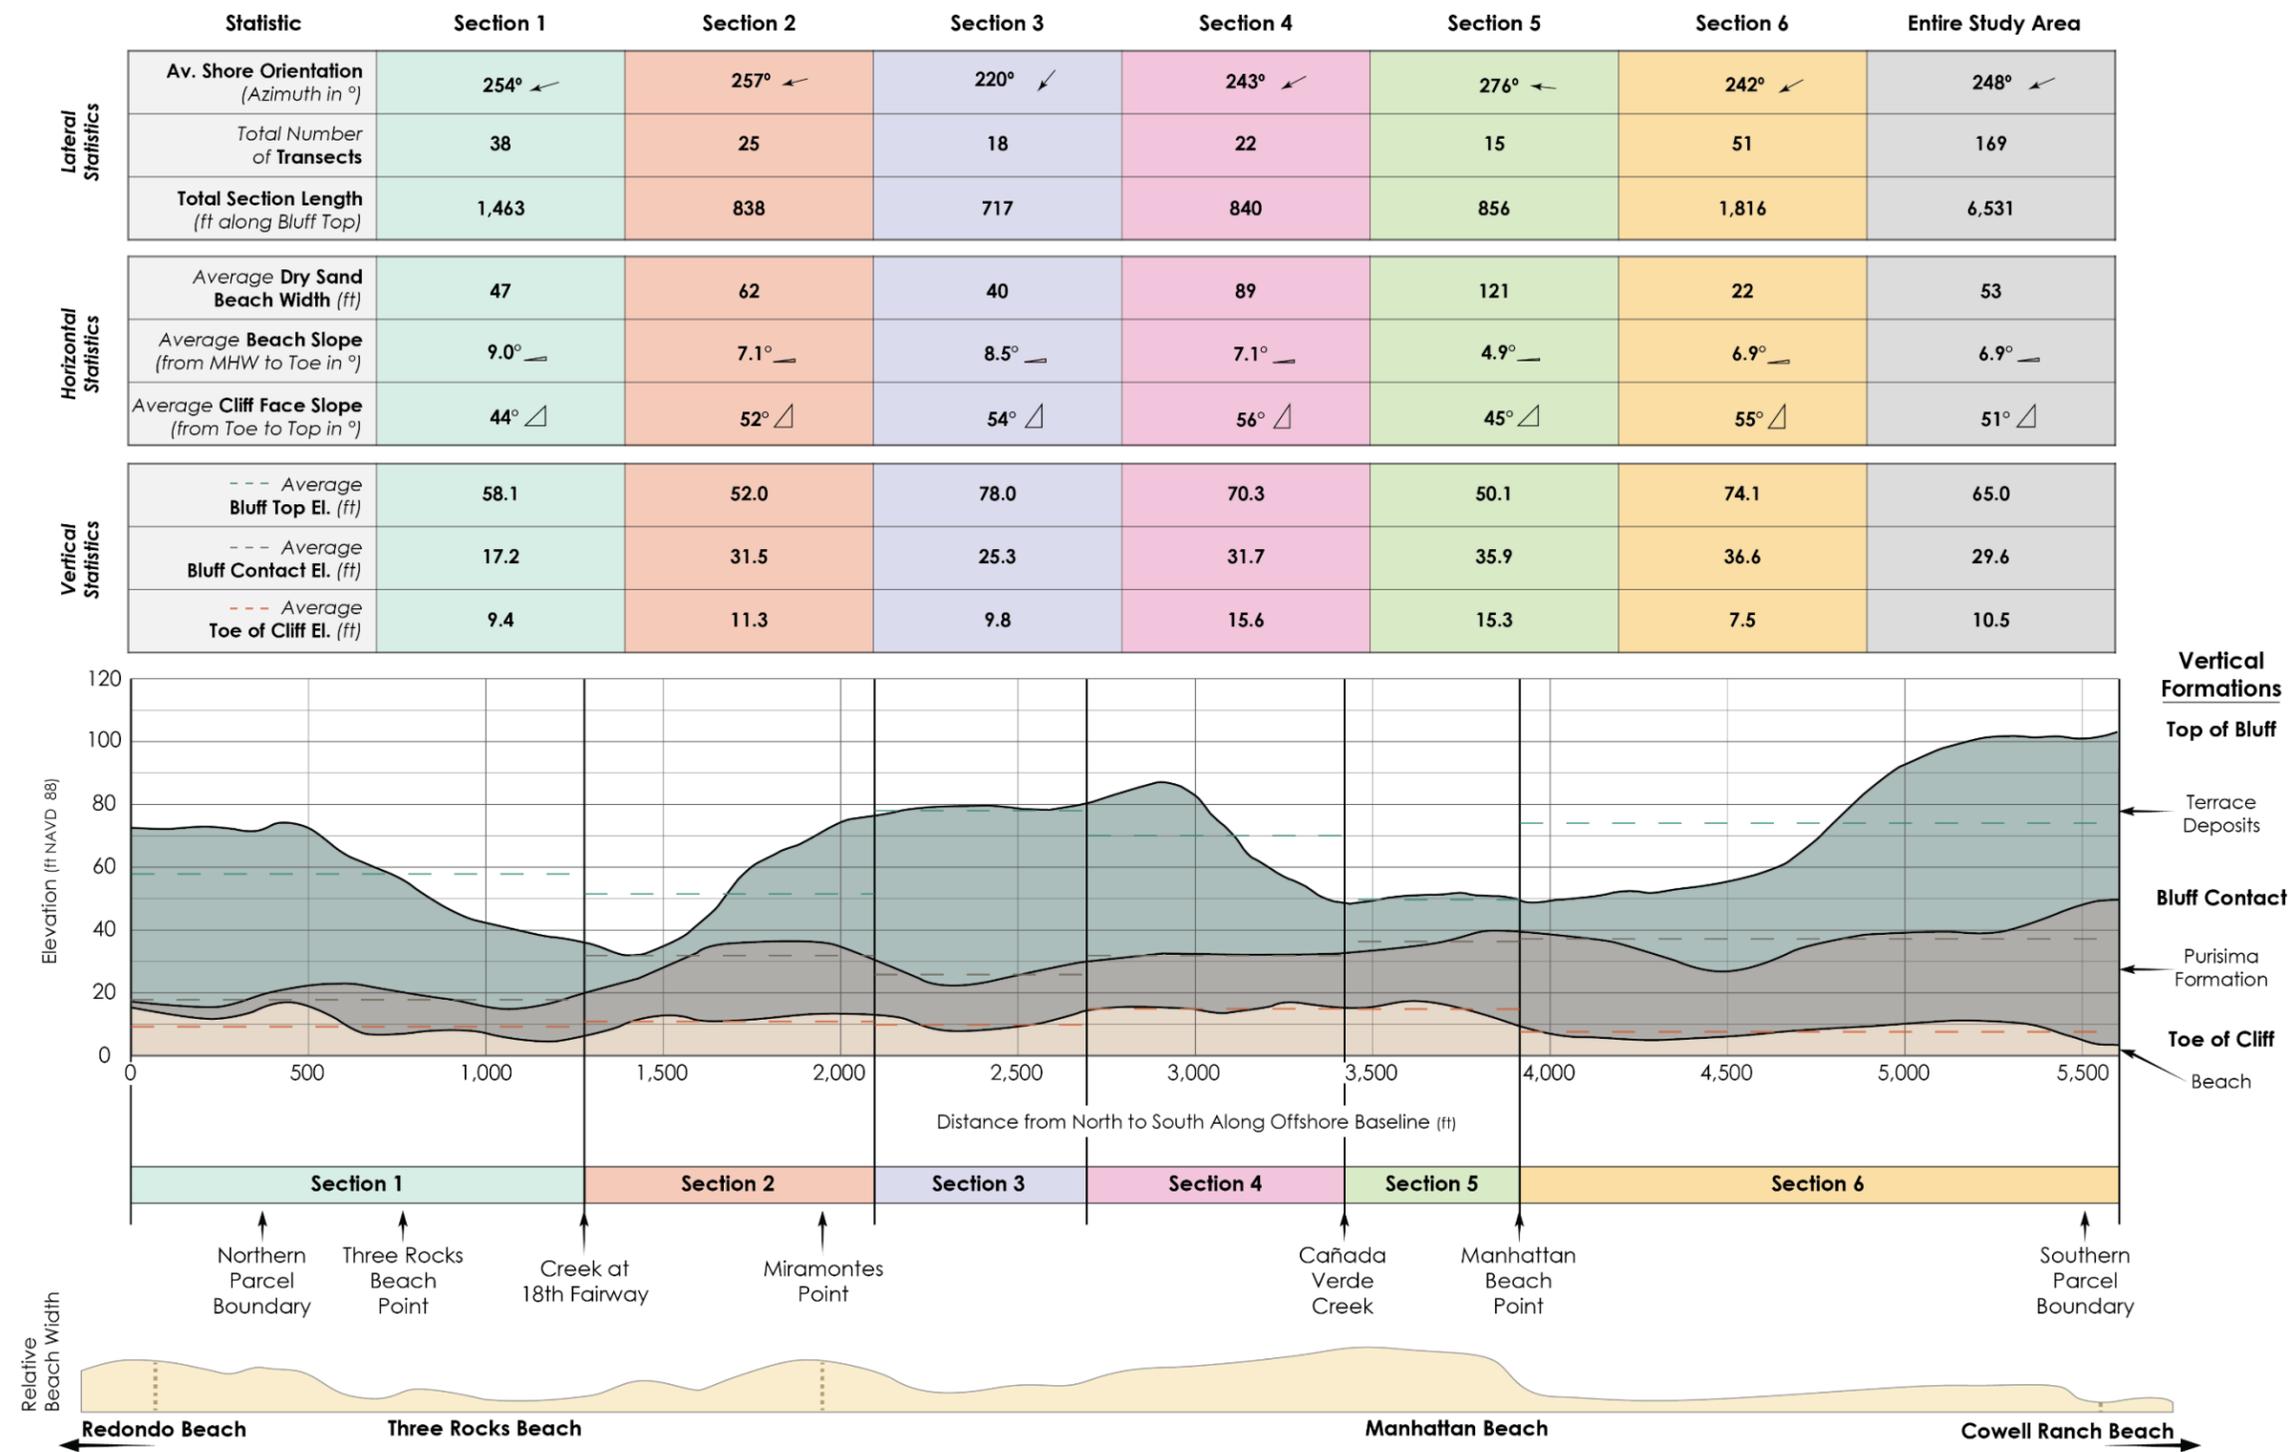
Figure 2-9. Site characteristics showing section-by-section geomorphic parameters.

This section is oriented north–northeast along its northern half and north–northwest south of Three Rocks Beach Point. The exposure of the Purisima Formation in this section ranges from less than three ft at the northern end and thickens to ~ 10 ft on the southern end, and the bluff is more than 70 ft in elevation to the north and slopes down to a low of ~38 ft in the south towards the small creek (Figure 2-9 and Figure 2-10).

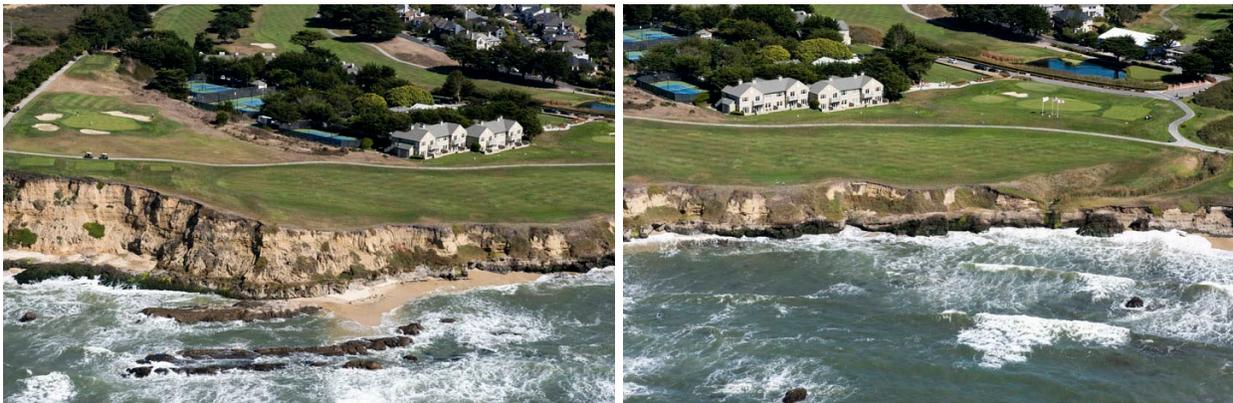
Figure 2-10. Section 1. Source: *Kenneth & Gabrielle Adelman, 2019*

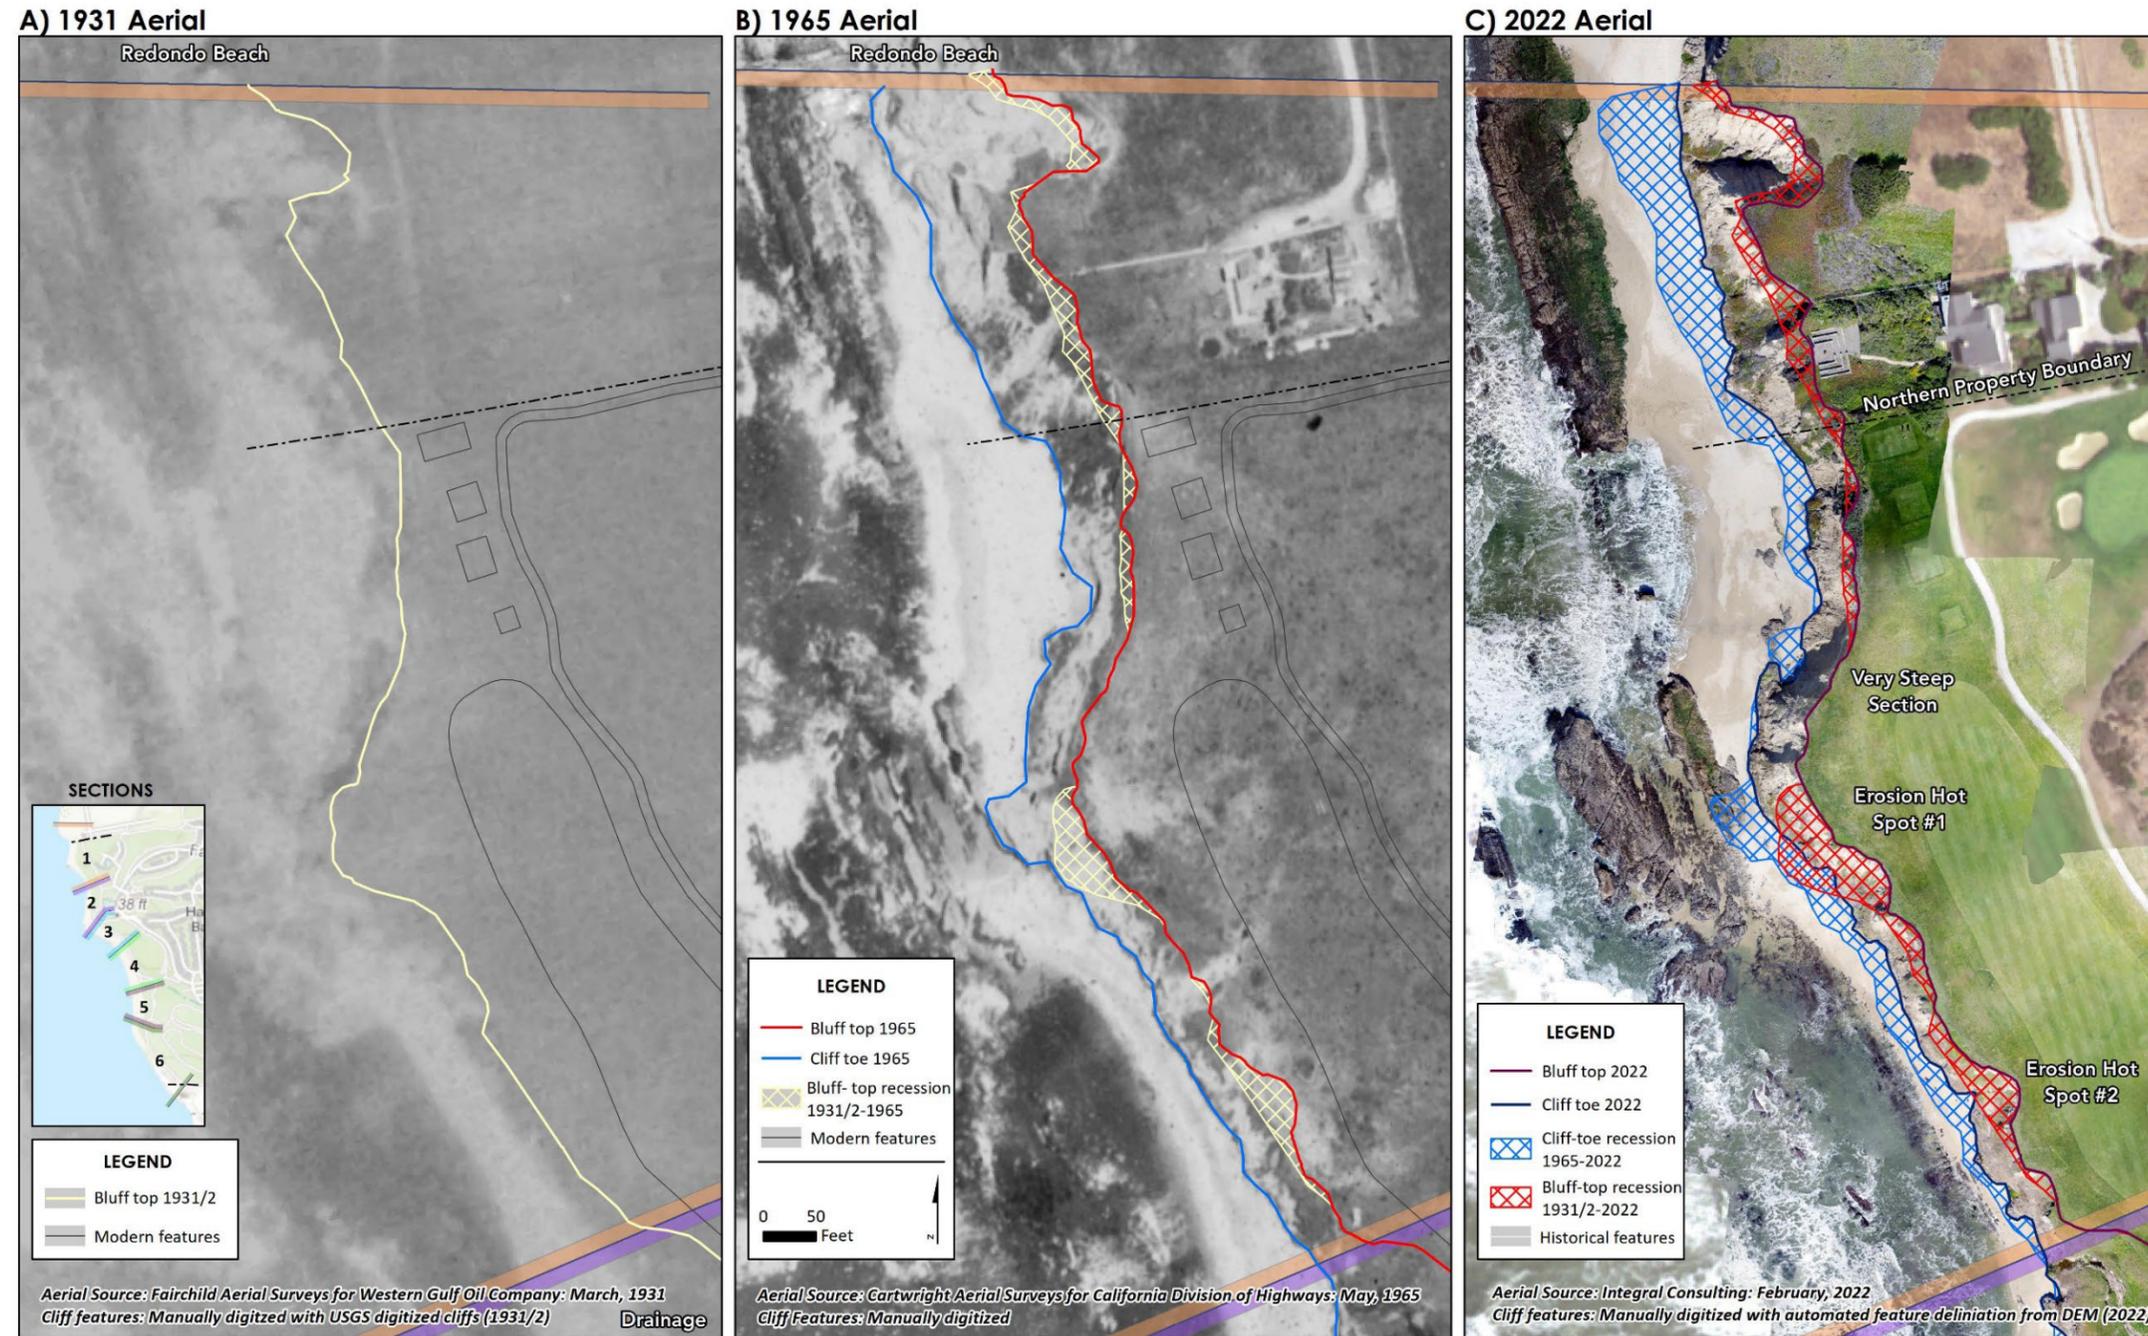
Figure 2-11. Historical and modern aerial photographs from 1931 (A), 1965 (B), and 2022 (C) of Section 1, the northernmost section of the study area. The hatched areas in panels B and C represent areas where there has been retreat of the cliff toe or bluff-top edge.

Figure 2-11 shows aerial images of Section 1 from 1931 (A), 1965 (B), and 2022 (C). The hatched areas, which are areas of retreat of the cliff toe and bluff-top edge indicate a substantial amount of toe retreat between 1965 and 2022, and gradual retreat of the bluff top edge, except for two erosion hot spots directly at and just south of Three Rocks Beach Point. Significant loss of the toe can be seen after 1972, as at this point the toe can still be seen to extend to the location of the first set of lateral offshore rock (Figure 2-12).

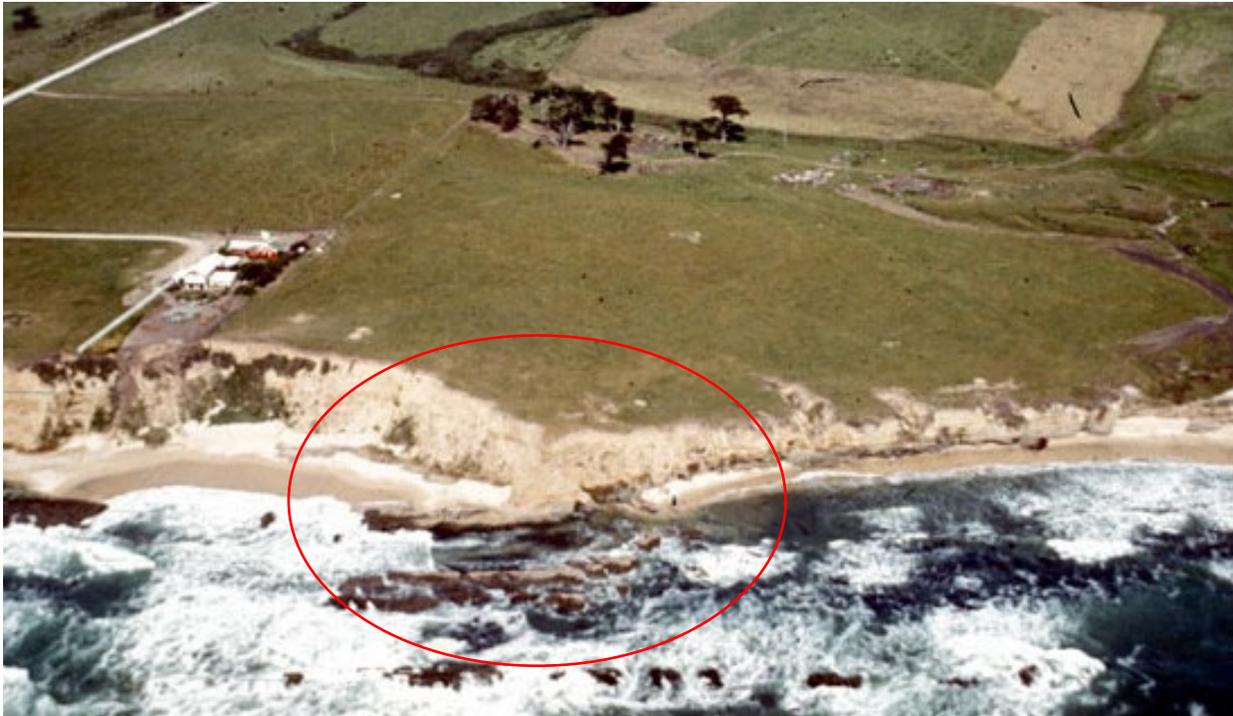
Figure 2-12. The location of the toe at Three Rocks Beach Point can be seen to extend out the location of the offshore rock. Source: *Kenneth & Gabrielle Adelman, 1972*

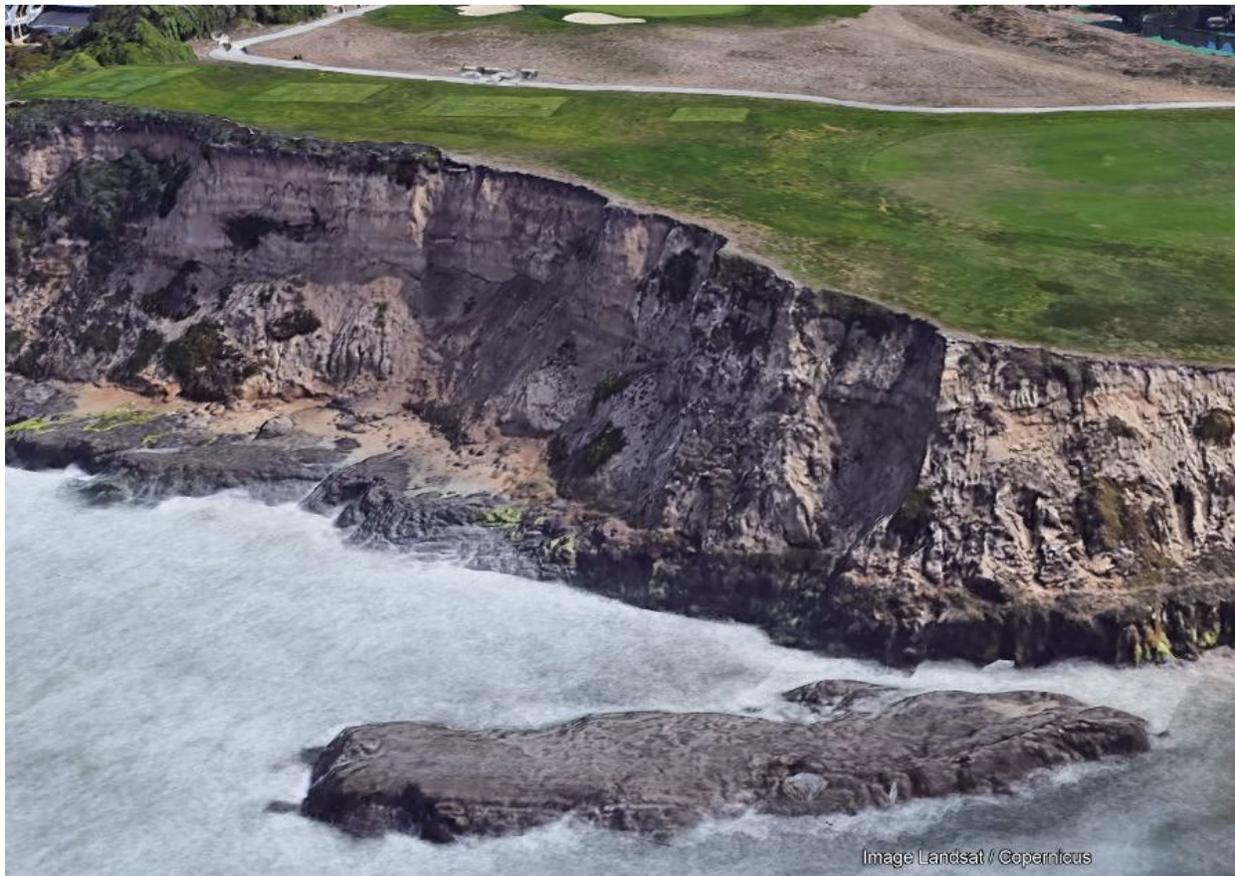
Figure 2-13. Very steep section near the 18th hole tee boxes. Source: *Google Earth, 2022*

The area just shoreward of the 18th hole tee boxes, extending ~60 ft long and ~20–25 ft high above a wave-cut platform, is a very steep section of bluff that is near-vertical towards the top of the bluff face (see 'Very Steep Section' in Figure 2-11 panel C, Figure 2-13). Despite significant erosion at Three Rocks Beach Point, there has been very little change in the bluff-top location in this stretch from 1931/2 to 2022. This location may be protected due to the offshore rock, a more protected shore orientation, and a wider beach than the area to the immediate south. Despite this, the area may be at increased vulnerability to erosion as sea levels rise and wave attack of soft bluff accelerates.

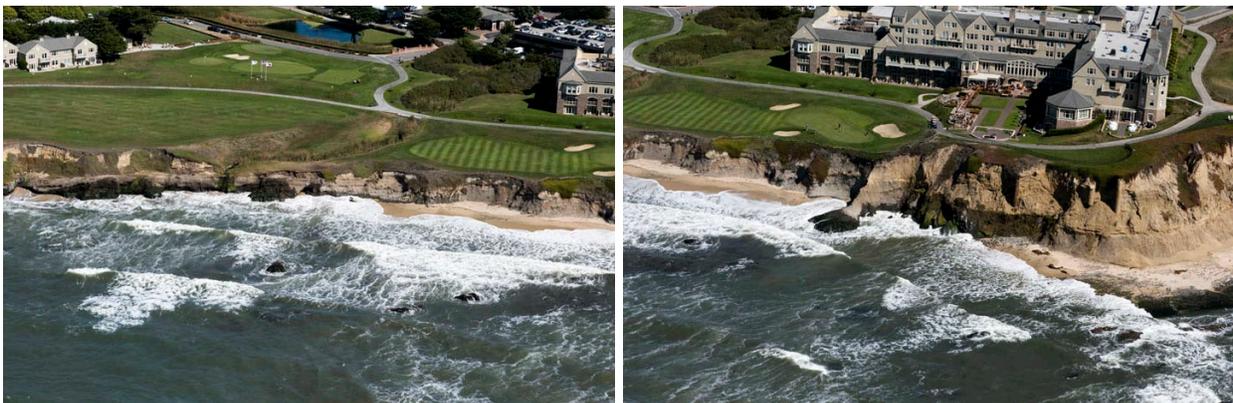
Figure 2-14. Section 2: Three Rocks Beach to Miramontes Point. *Source: Kenneth & Gabrielle Adelman, 2019*

Section 2 extends from the creek at the 18th fairway to Miramontes Point and the Ritz-Carlton Hotel (Figure 2-14). Historically, a parking lot and vehicle turnaround terminated at Miramontes Point and are visible in historical aerials between the early 1960s to the 1980s. Due to the threat of coastal erosion, the golf course was redesigned and in 2006 changes to the approach to the green, the green itself, and two sand traps that were close to the bluff-top edge were replaced with a single trap further from the bluff-top edge². Due to continued erosion, the Miramontes Point overlook lawn has been moved inland about 15 ft. The previous layout of both the golf course and the overlook lawn can be seen in Figure 2-18.

This section is concave alongshore to Miramontes Point in the southern portion of the section, where the orientation takes a sharp turn to orient north–northwest. The average elevation of the bluffs in Section 2 is 52 ft but there is a significant increase from north to south, with the lowest bluff elevation in the study area of ~30 ft where a small drainage exists in the 18th fairway. In the southern portion of Section 2, the bluffs increase to more than 75 ft in elevation at Miramontes Point. A rock outcrop, known as Three Rocks, is located in the nearshore.

The thickness of the Purisima Formation is also quite variable in Section 2, increasing from ~10 ft in the north to a maximum of 36 ft in thickness at Miramontes Point. The marine terrace deposits also thicken from north to south contributing to the overall increase in bluff height to the south. The average cliff face in Section 2 is also steeper than in Section 1.
