City of Half Moon Bay, Miramontes Point

Sea Level Rise Vulnerability and Fiscal Impact Assessment

Prepared by
integral
consulting inc.

March 21, 2023

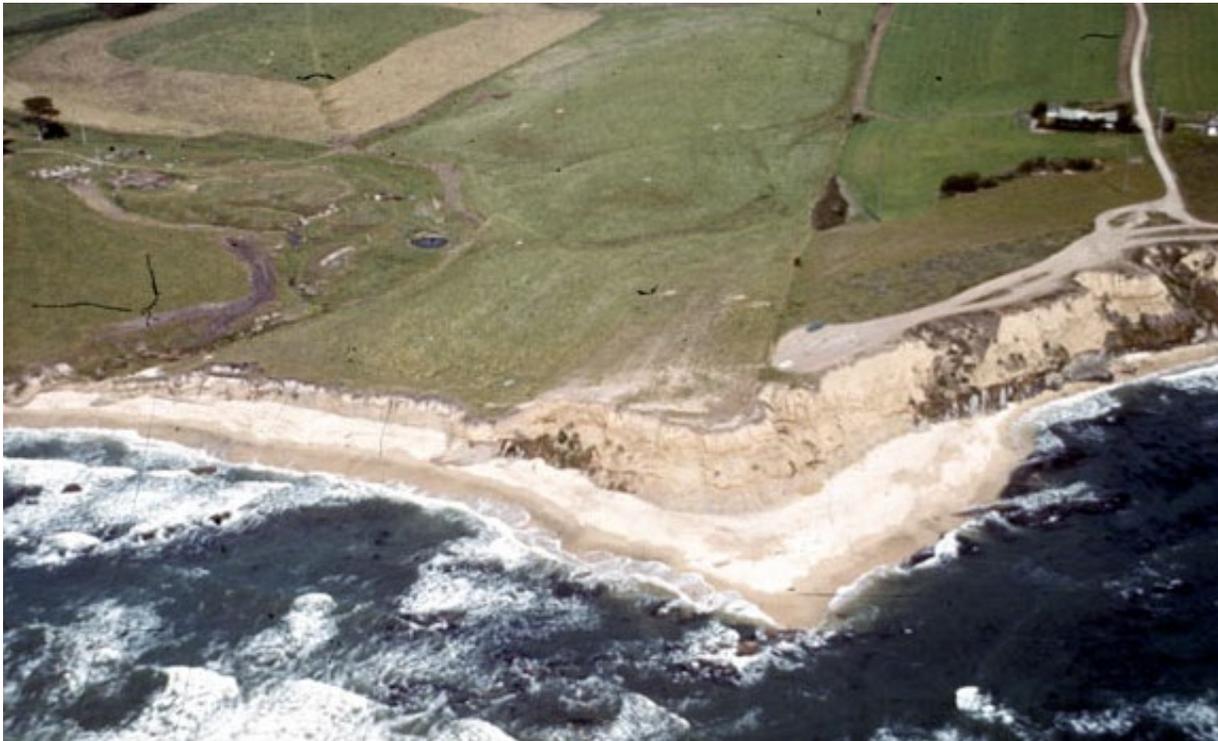
Figure 2-15. Miramontes Point before the development of Ocean Colony. Source: *Kenneth & Gabrielle Adelman, 1972*

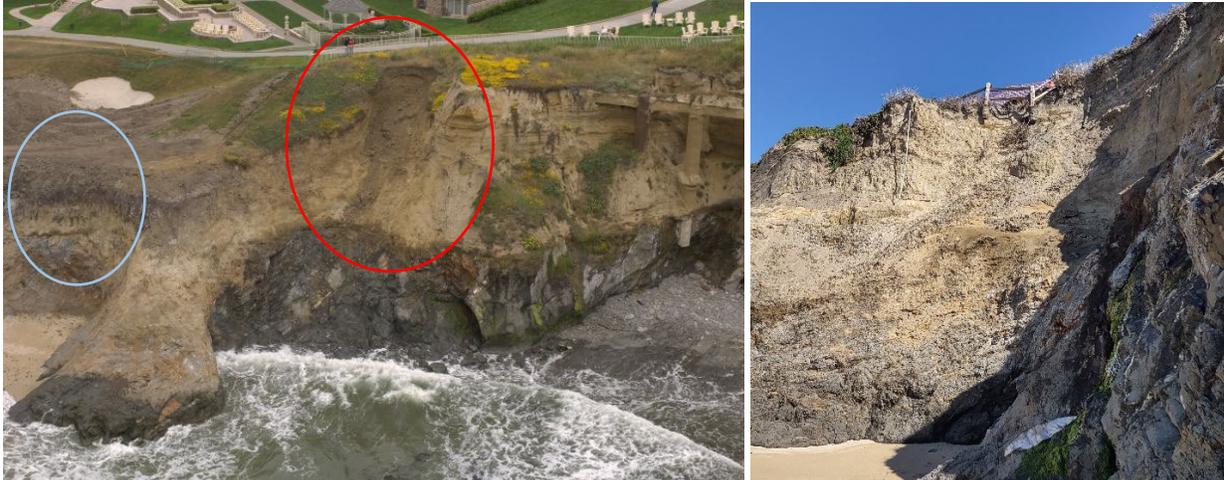
Figure 2-17. Left: Blue circle – Location of Bay Area Geotechnical Study. Red circle – Location of erosion near the Ocean Lawn of the Ritz-Carlton Hotel. Right: A fence was erected, which has been subsequently undermined. Source: *Kenneth & Gabrielle Adelman 2006 & Integral Consulting, 2022.*

The Bay Area Geotechnical Group led a study in 2002 focused on the area fronting the Old Course 18th Green (Erosion Hot Spot #3 on the maps, and the blue circle in Figure 2-17), and it noted 30 ft of erosion between 1963 and 1973 with a dramatic erosion event in the winter of 1972–1973, where ~15 ft of the bluff was lost. It also noted that between 1973–1998, approximately 10-15 ft of erosion occurred, for total erosion of ~45ft between 1963 and 1998 (CCC 2005). This corresponds to our analysis, albeit at a slightly higher rate, where we found ~10 ft between 1931/2 and 1956, ~15 ft between 1956 and 1965, and ~15 ft between 1965 and 2020, for total erosion of ~40 ft between 1931/2 and 2022.

Just south of the 18th hole green there is a fence that is currently overhanging the bluff by up to three feet and is indicative of more recent erosion, likely following the winter of 2017–2018. The Coastal Trail is now located within ~18 ft of the top edge of the bluff near this location (Figure 2-17).

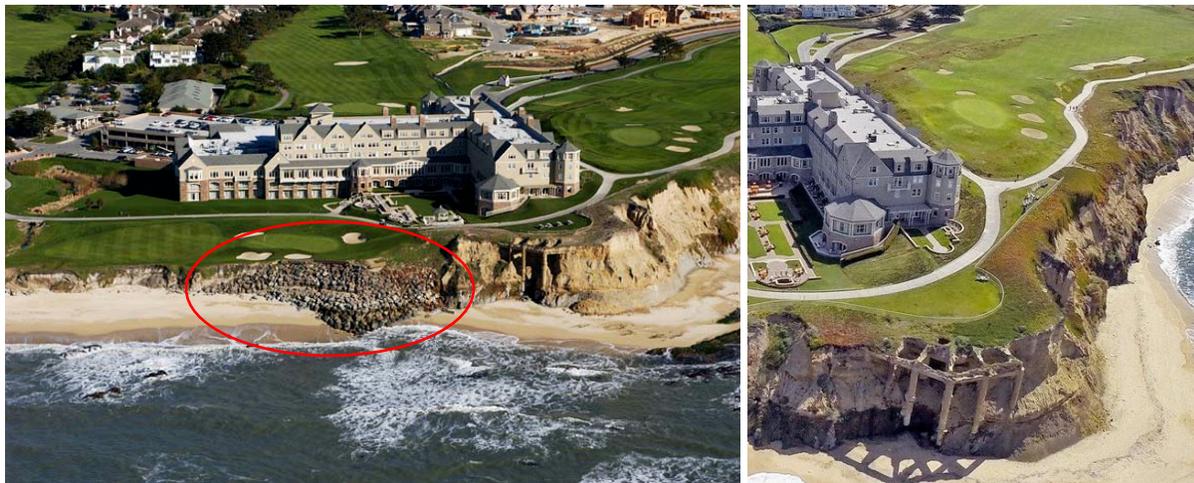
Figure 2-18 Left - Riprap in place in 2002. Exposed pier foundation structure in the late 2000s. Source: Kenneth & Gabrielle Adelman, 2002, VisualHunt.com CC.

Armoring, in the form of riprap, was in place here from 1998 to 2006. Ocean Colony Partners observed that the armoring led to redirected wave energy and significant sand displacement leading the bluff face on each side of the riprap to deteriorate at a more rapid rate and contributed to several episodic incidents of bluff top failure (OPC 2022). At the time of removal in 2006, Ocean Colony Partners implemented the following site improvements:

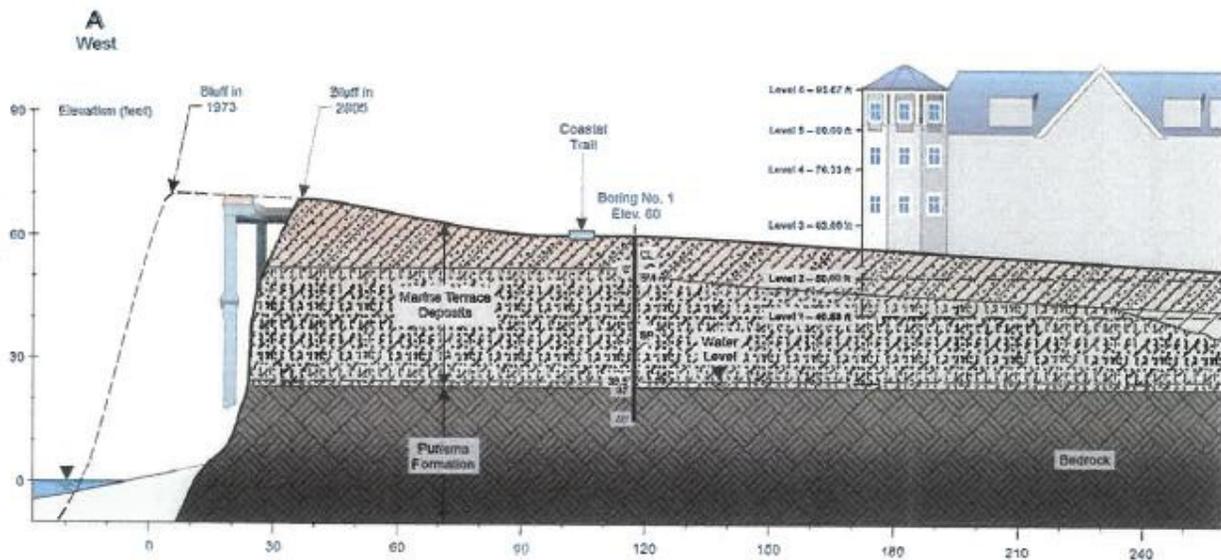
Figure 2-19. Geologic cross section at the Miramontes Point from the AECOM study, 2017.

Due to concerns about erosion, the Ritz-Carlton Hotel contracted AECOM to study and monitor erosion at Miramontes Point. In its 2018 report, AECOM reported ~45–55 ft of erosion since 1973, just over a foot per year on average (Simpson 2017) (Figure 2-19). From our analysis, we have found a net bluff-top recession of ~30–40 ft over a similar period (1964 and 2022), and 50–70 ft since 1931/2, which corresponds to a slightly lower rate of 0.5–0.9 ft a year.

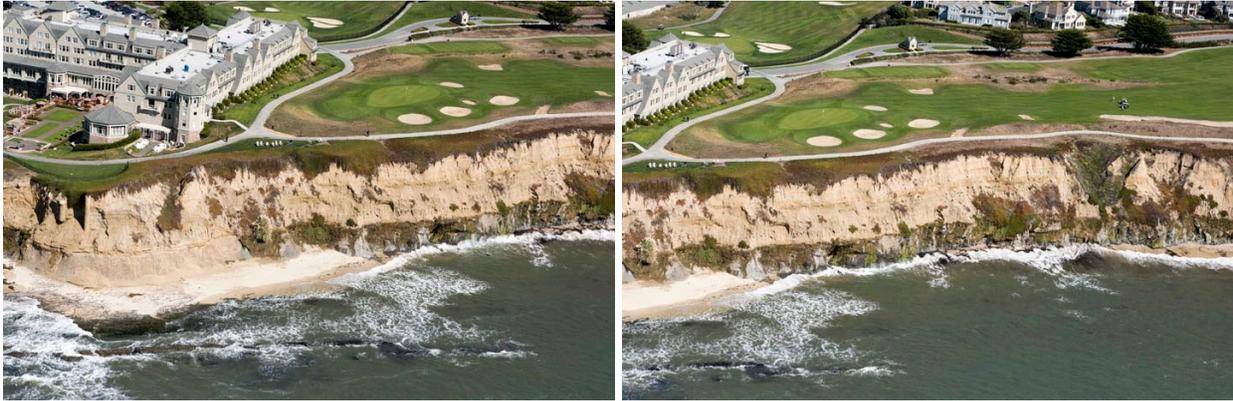
Figure 2-20. Section 3: Miramontes Point to Manhattan Beach North. Source: *Kenneth & Gabrielle Adelman, 2019*

stretch of beach. The elevation where the terrace deposits make contact with the Purisima Formation (bluff contact) is around 25 ft, and the bluff top is ~70 ft in elevation. The Coastal Trail runs throughout this section and is as close as 20 ft from the bluff-top edge in some locations.

The bluff has small undercuts where the beach is very narrow, and there is less rock in the offshore than in other areas. With little rock to dissipate waves, more wave energy reaches the bluff toe, abrading out small undercuts.

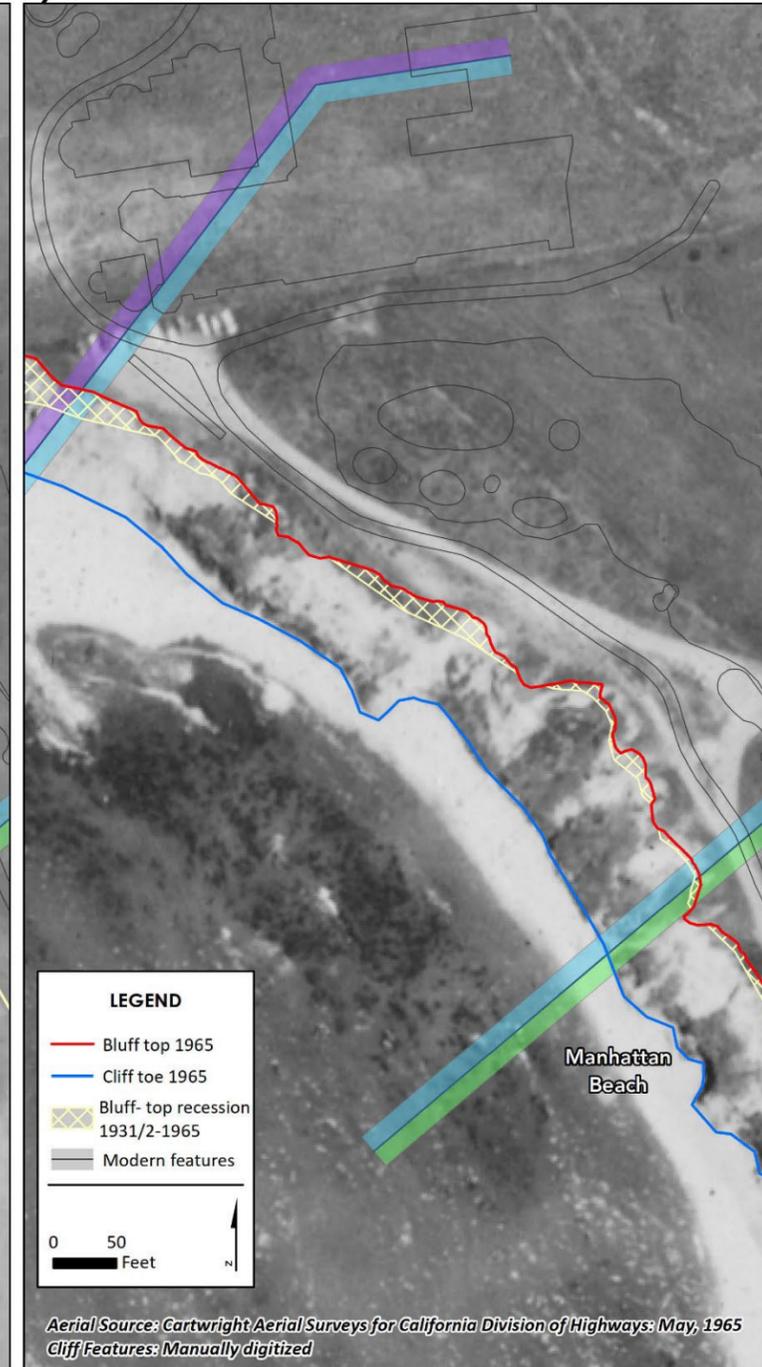
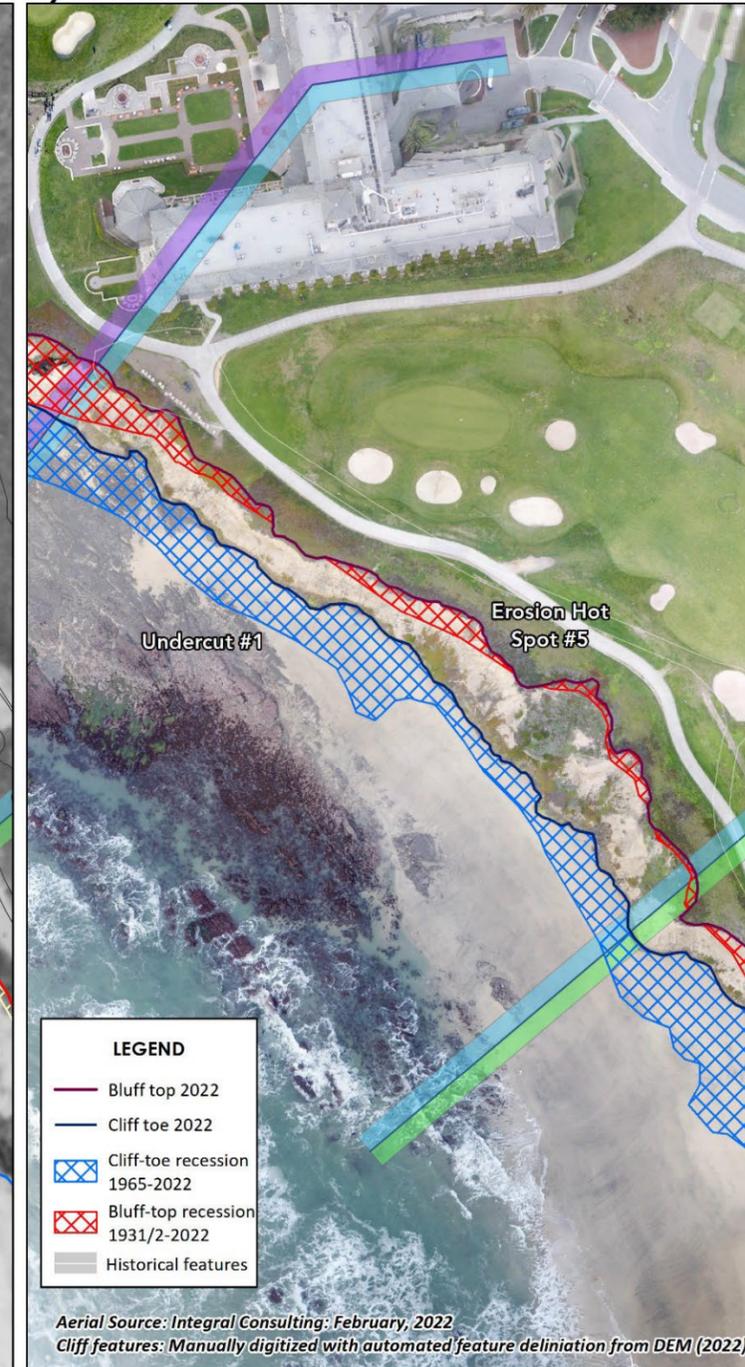
Figure 2-21. Historical and modern aerial photographs from 1931 (A), 1965 (B), and 2022 (C) of Section 3.

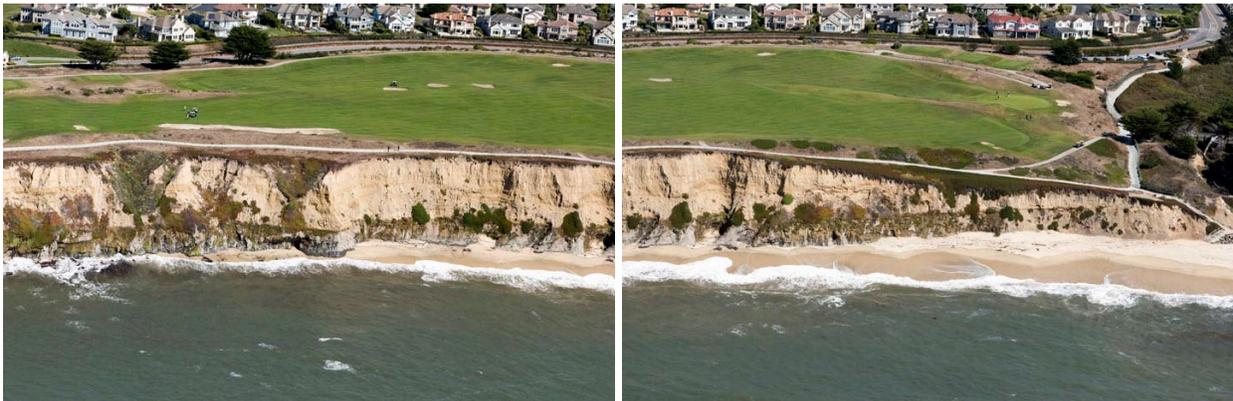
Figure 2-22. Section 4: Manhattan Beach North to Cañada Verde Creek. Source: *Kenneth & Gabrielle Adelman, 2019*

Section 4 extends from the 18th hole fairway of the HMB Golf Links Old Course to Cañada Verde Creek, is oriented north–northwest, and encompasses an area with a wider stretch of beach than Section 3. The wider beach provides more protection to the base of the cliff from wave attack. The average elevation of the bluffs is ~32 ft, with the bluff-top approximately 85 ft high in the northern area, then gently sloping downward towards Cañada Verde Creek in the south where it is approximately 50 ft in elevation. The Coastal Trail runs throughout this section and is as little as 20 ft from the bluff-top edge in some areas (Figure 2-20). Historically, a parking lot and vehicle turnaround were located in the lower area near the current beach access stairway and are visible in historical aerials between 1960 and 1980 (Figure 2-22). Before the stairway was built, informal beach access trails were visible.

There is little change in the position of the bluff top between 1931/2 and 1956. Between 1956 and 1965, however, ~ 10 ft of bluff-top recession is observed in some places, and between 1965 and 2010, another 10 ft of erosion is observed in the same locations. Currently, the area identified as erosion hot spot #7 is very steep and the concave shape where bluff failures have occurred is indicative of recent, rapid erosion (Figure 2-23). There has been a significant amount of cliff toe erosion in the area stretching between erosion hot spots #6 and #7, as measured between 1965 and 2022 (Figure 2-22).

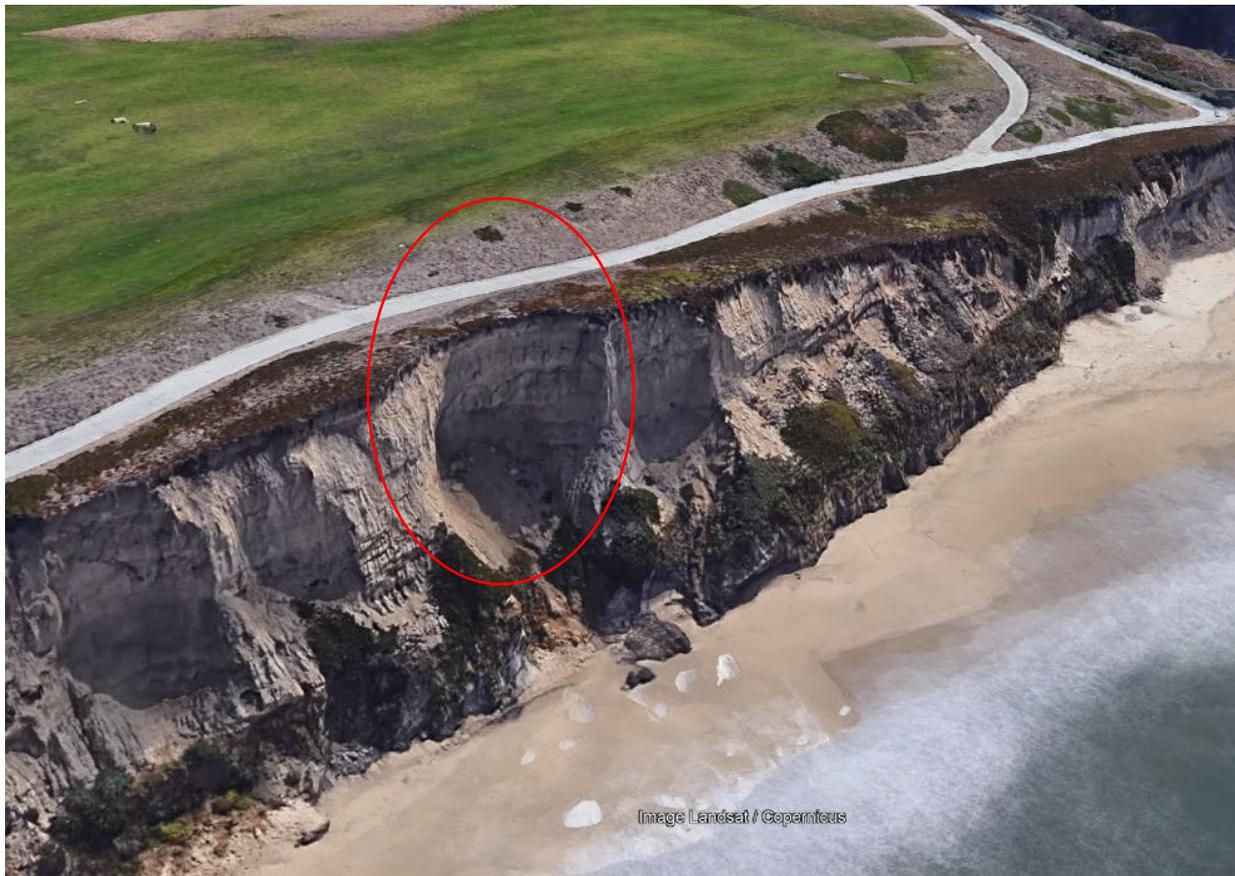
Figure 2-23. Steep and concave bluff is indicative of recent, rapid erosion at hot spot #7. Source: *Google Earth, 2022*

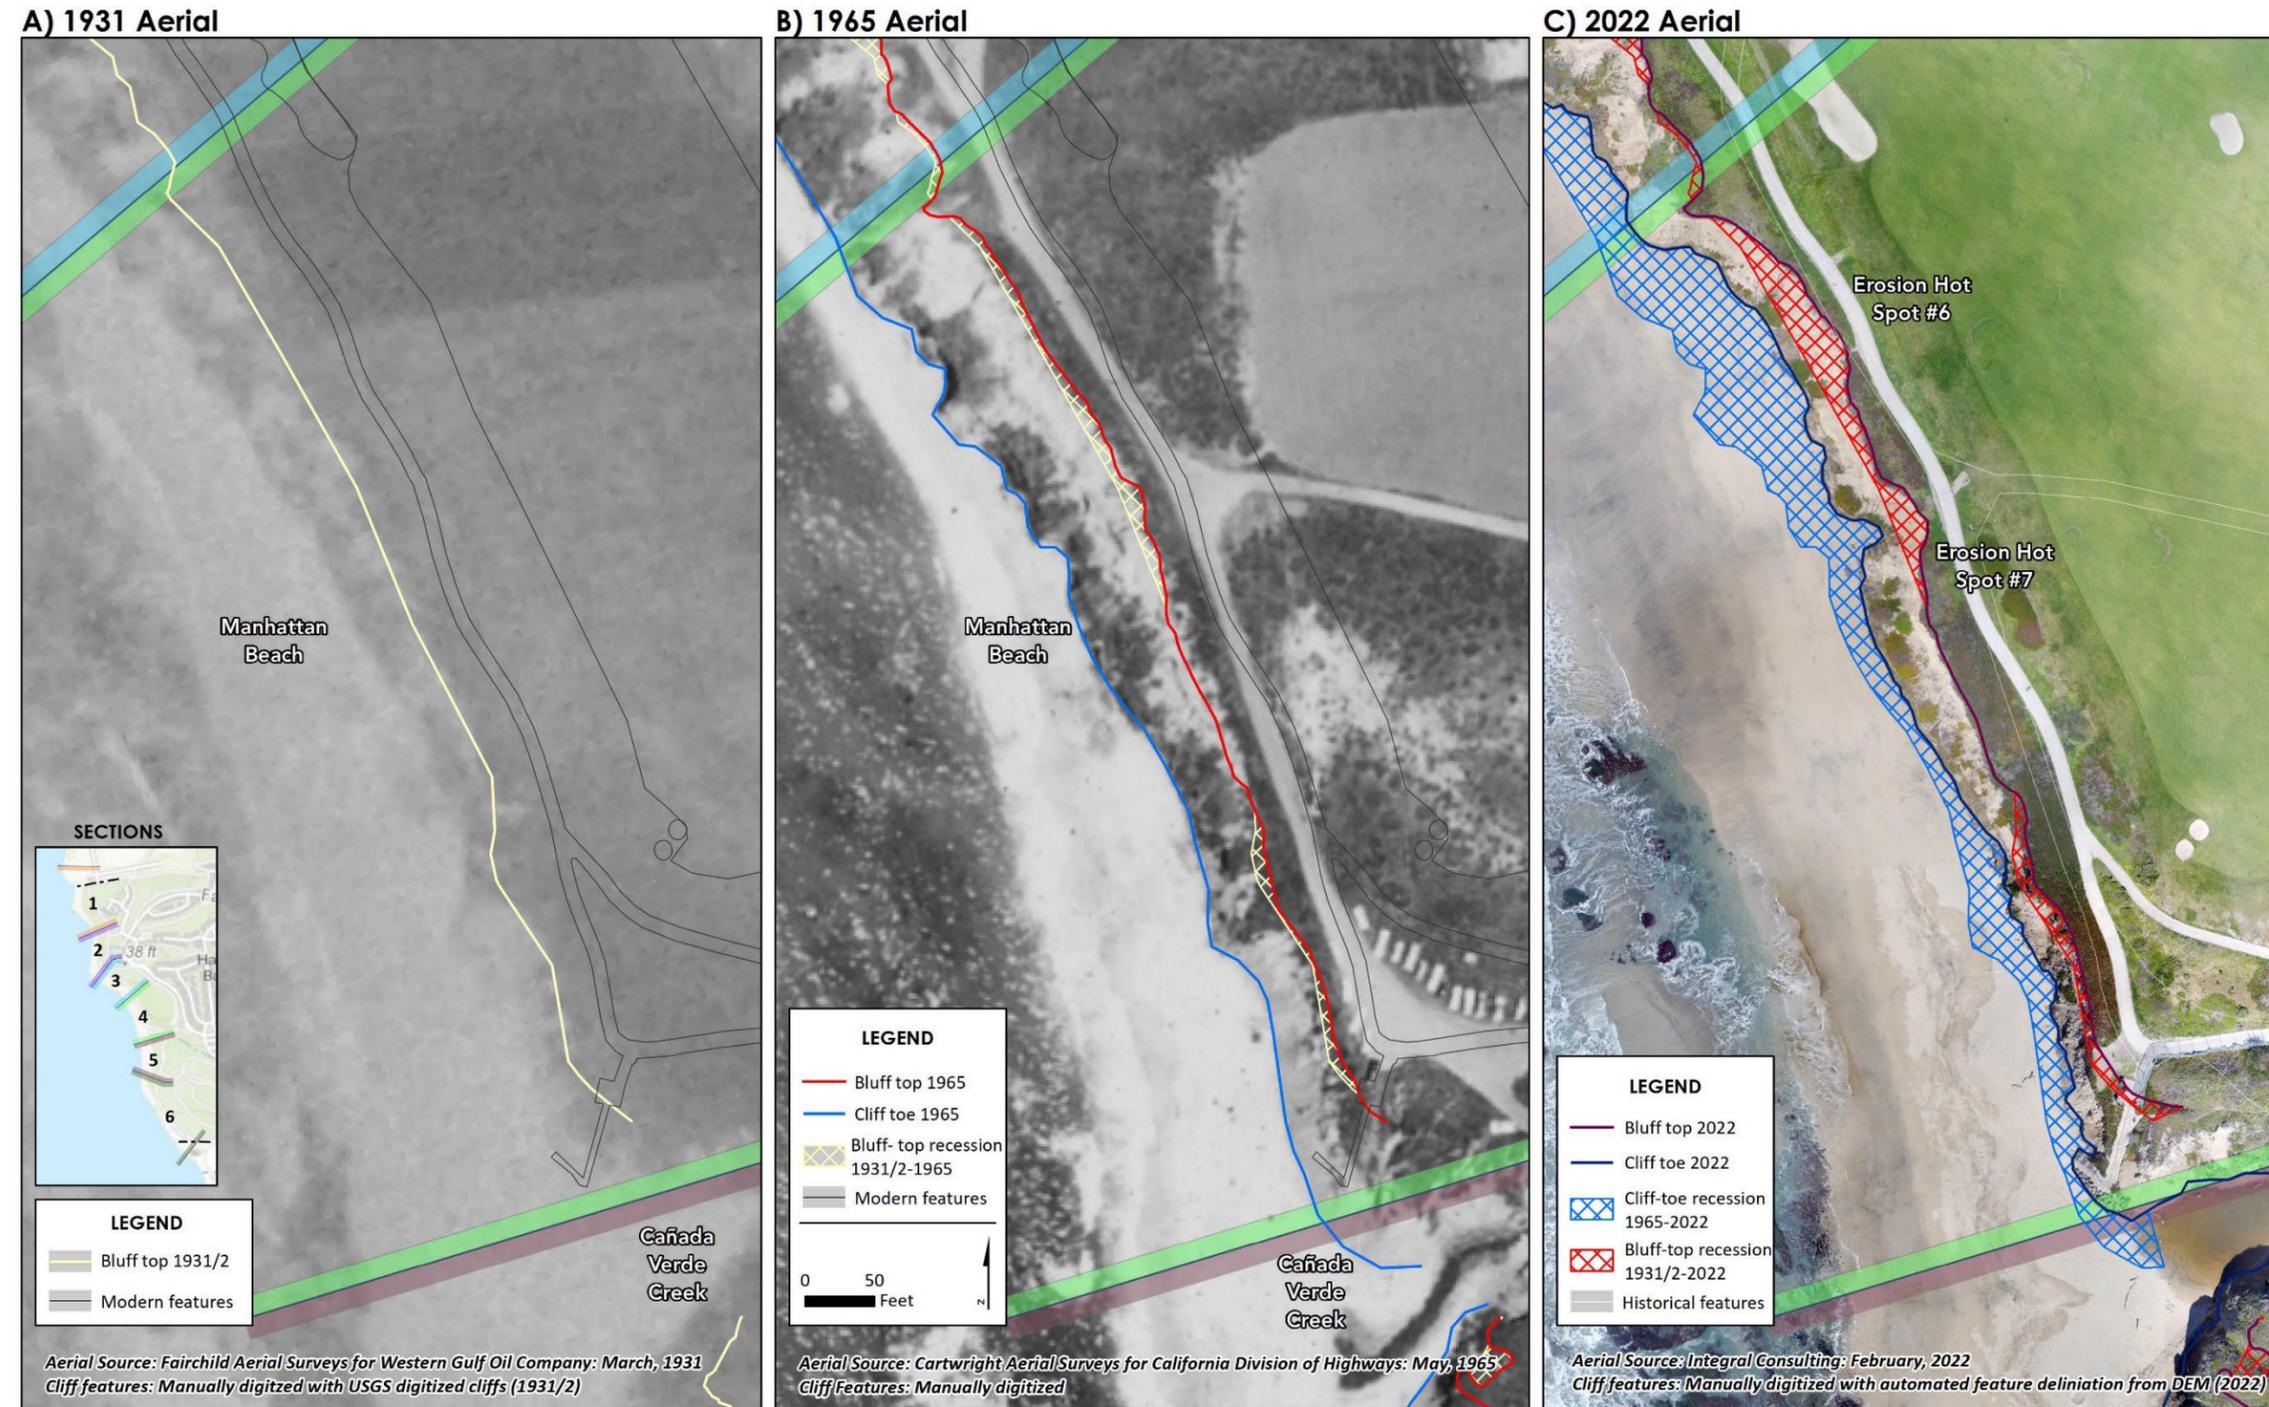
Figure 2-24. Historical and modern aerial photographs from 1931 (A), 1965 (B), and 2022 (C) of Section 4

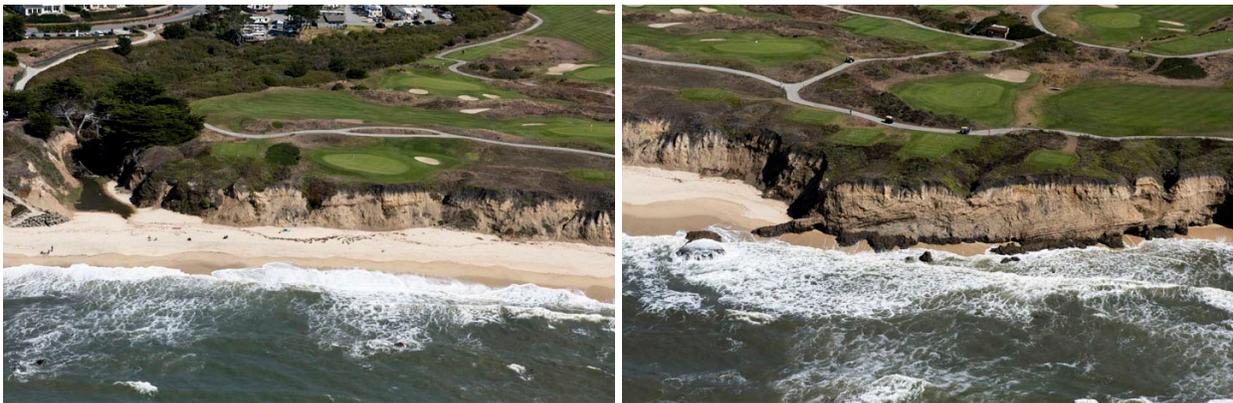
Figure 2-25. Section 5: Manhattan Beach North to Cañada Verde Creek. Source *Kenneth & Gabrielle Adelman, 2019*

Section 5 is located between Cañada Verde Creek and a small point where there is a change in shore orientation, referred to in this report as Manhattan Beach Point (Figure 2-23). The 17th hole of the Ocean Course is located at the top of the bluff in Section 5. The section is concave and oriented north to north–northeast with the orientation taking a turn in the southern part of the section. The beach is wide to the north and narrows to the south. The basal Purisima Formation is relatively thick in this section accounting for about 70 percent of the total cliff height. The average bluff-top elevation is 50 ft, and the elevation of the marine terrace deposit contact is around 36 ft. The section is characterized by numerous gullies cutting down through the marine terrace deposits and into the Purisima Formation in some locations. Gullying is indicative of overland flow cutting channels into the surficial material, although an investigation of specific processes is beyond the scope of this study.

The historical rates of cliff toe erosion are relatively low compared to the more northern sections (Figure 2-23), and most erosion of the bluff top is in the southern portion of Section 5 and appears to have occurred primarily between 1931/2 and 1965, with little additional retreat in the period from 1965 to 2002.

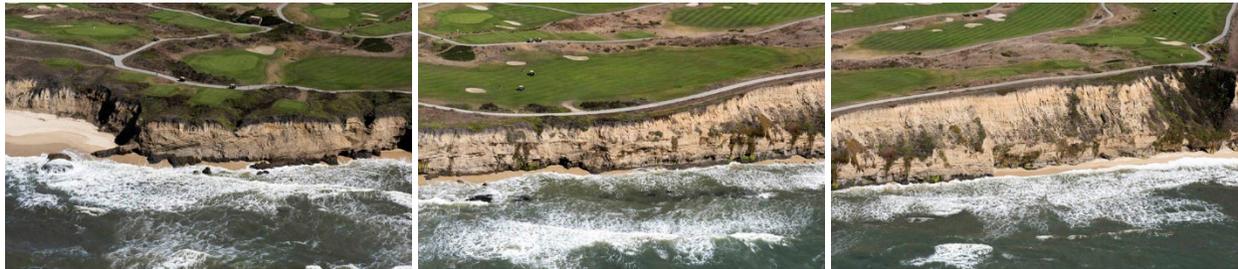
Figure 2-27. Section 6: Manhattan Beach South to HMB City Line. Source: *Kenneth & Gabrielle Adelman, 2019*

Section 6 extends from Manhattan Beach Point to the HMB City line (Figure 2-27). The Coastal Trail is as close as 10 ft from the bluff-top edge in some areas of this section. There is a small drainage at the northern end of the section between the 17th hole tee boxes where there is a small bridge for the Coastal Trail.

The section is oriented north–northwest and gradually increases in elevation from approximately 50 ft in the south to just over 100 ft in the southern portion of the section. As the height of the bluff increases, the slope of the bluff face of the terrace deposits decreases. The beach is very narrow in this section and there are numerous undercuts at the base of the cliff. Waves frequently impact the base of the bluff due to the narrow beach, as is evidenced in Figure 2-28, where waves reach the base of the bluff and the wave splash has created a wetted surface on the lower portion of the cliff. However, the area is protected by offshore rock that dissipates wave energy, so that the waves reaching the base of the cliff are fairly low in energy. The Purisima Formation is fairly thick in this section (~30 ft) and as such, the elevation of the contact between the marine terrace deposits and the Purisima Formation is relatively high, especially on the southern end.

Erosion rates overall are low throughout this section based on the historical imagery (Figure 2-27). The rates of bluff retreat in Section 6 are so low that they are within the range of positional uncertainty of our ability to delineate bluff features. The greatest toe recession in this section has occurred in the northern area in proximity of a sea cave and undercut #2. The sea cave is visible in Figure 2-28 below the southern tee box for the 17th hole.

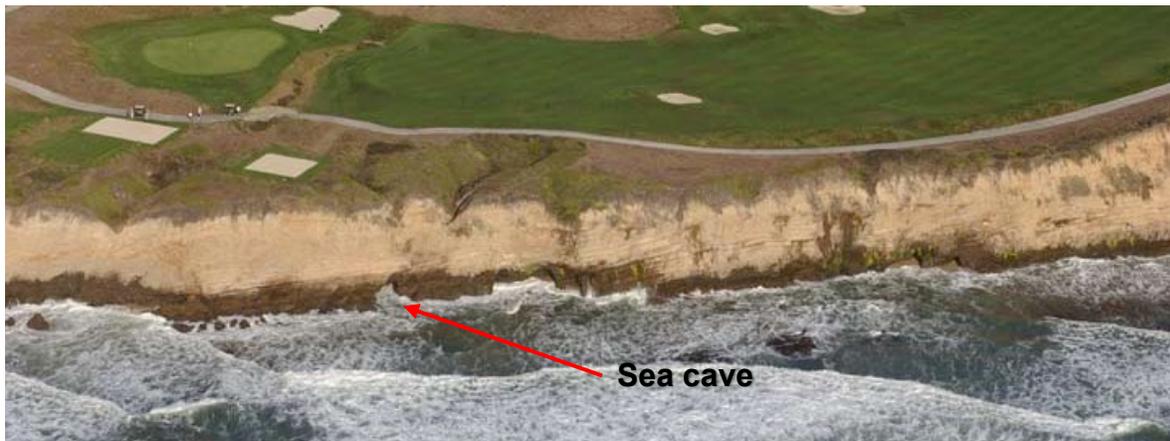
Figure 2-28. Waves crashing along the cliff of Section 6 near the 17th tee boxes. Source: *Kenneth & Gabrielle Adelman, 2002*

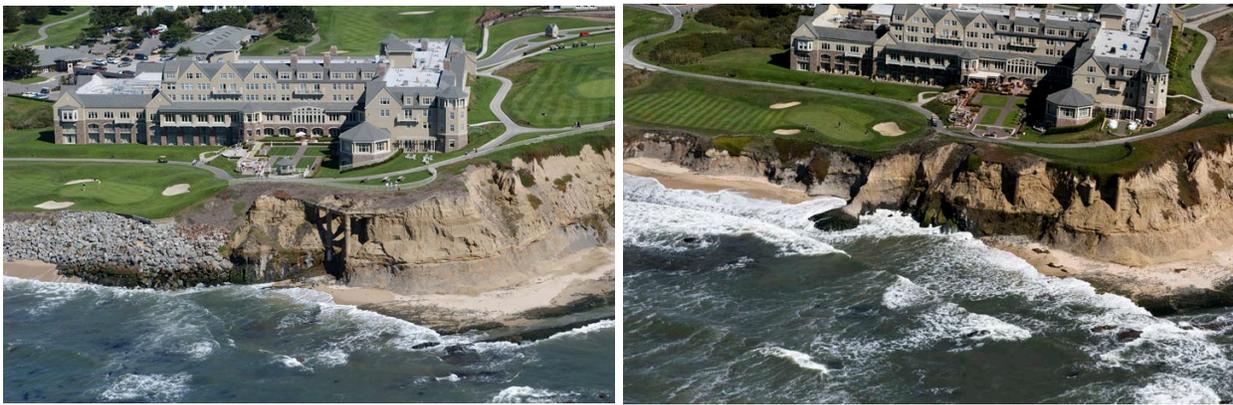
Figure 2-30. Left: Riprap structure and foundation piers in place, 2004. Right: Riprap is no longer present and some of the foundation piers were removed in 2019. Source: *Kenneth & Gabrielle Adelman 2004 & 2019*

In the early 1970s, a developer erected a 7,300 sq ft concrete and steel foundation structure at Miramontes Point. Over the years the pier and grade structure became exposed due to erosion and collapsed on the beach, and ~160 linear feet of concrete and steel piers fronting the Ritz-Carlton were removed in 2018 (Simpson 2017) (Figure 2-30, Figure 2-31). The original 1973 hotel foundation may have included upwards of 20 piers with connecting grade beams and/or slab, and many piers, grade beams and slab foundation elements are still unexposed and underground beneath the seaward hotel landscaping, coastal trail, and hotel improvements.

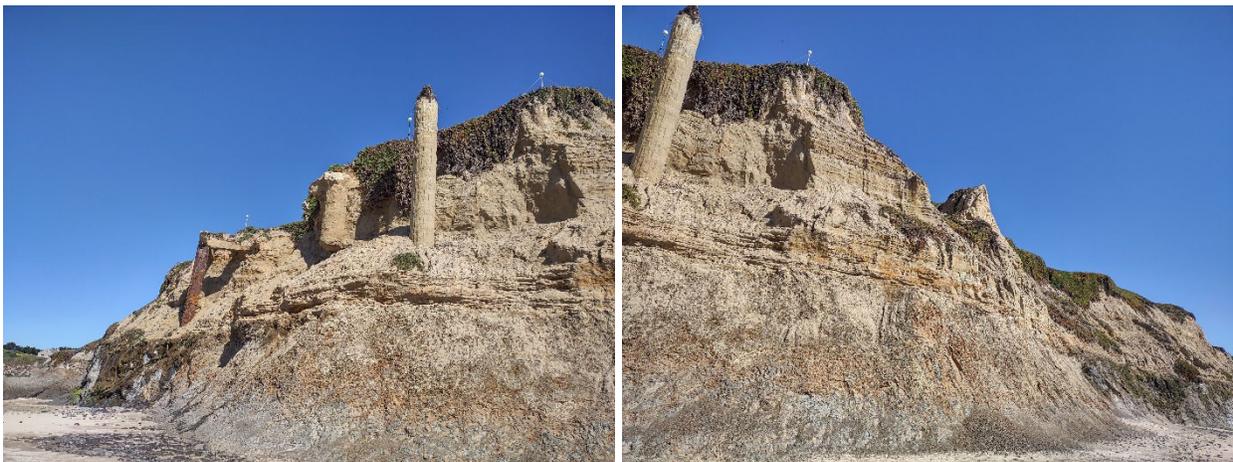
Figure 2-31. Remnants of the foundation piers that remain, 2022. These piers were not fully exposed from the bluff in the 2004 image. Source: *Integral Consulting, 2022*

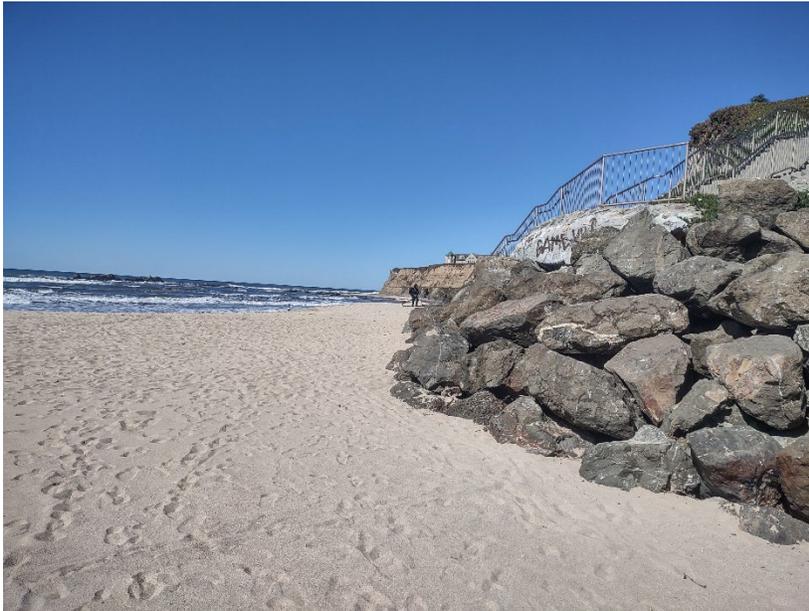
Figure 2-32. Toe protection of beach access stairway. Source: *Integral Consulting, 2022*

Toe protection in the form of engineered riprap is located at the base of the beach access stairway at Cañada Verde Creek (Figure 2-32). This stairway is vulnerable to erosion from both coastal storm wave events and overland flow, and the toe protection riprap may become increasingly vulnerable to scouring and structural failure in the future.

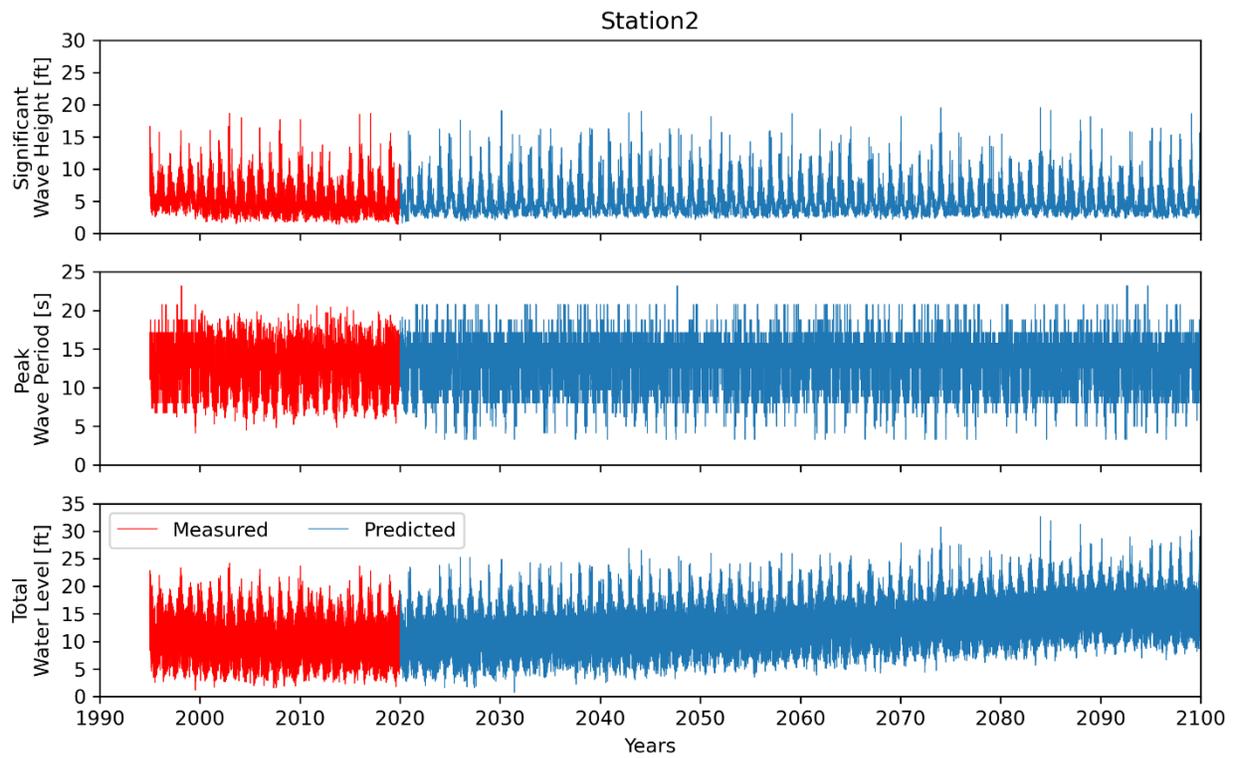
Figure 3-1. Example of wave parameters including significant wave height, peak period, as well as total water level for the nearshore at Station 2 (corresponding to Section 2).

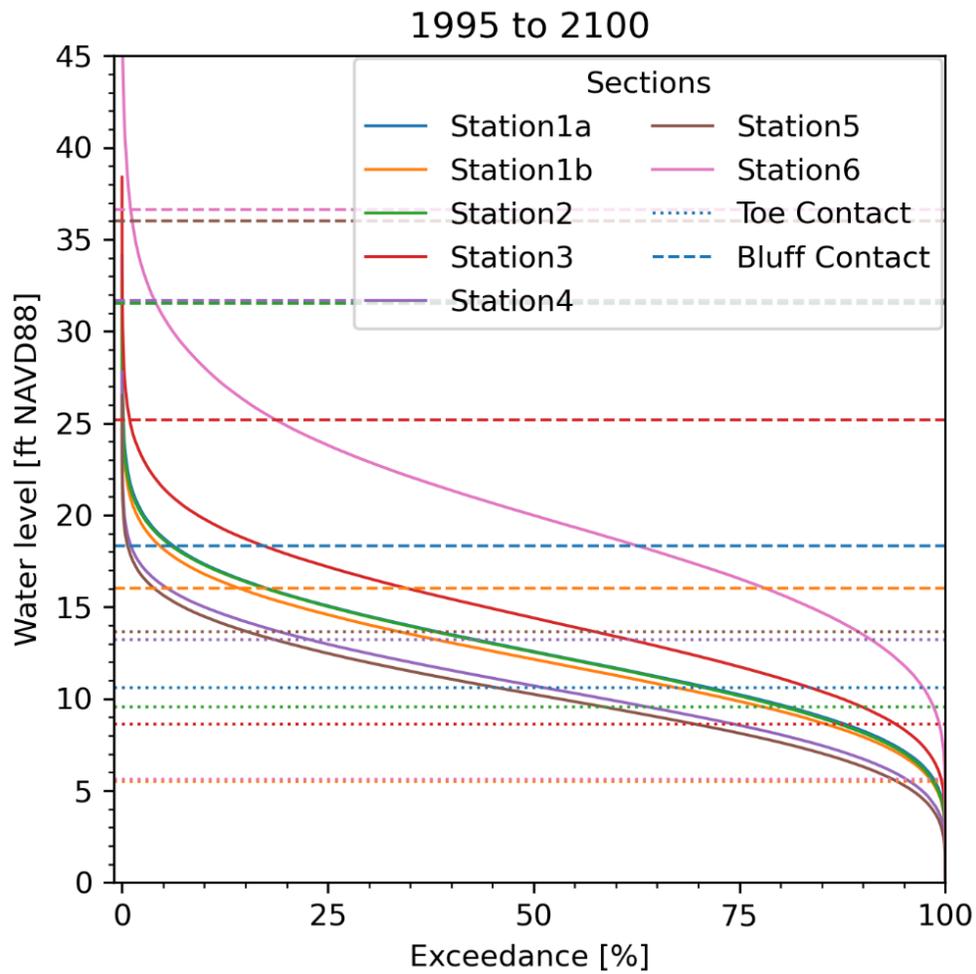
Figure 3-2. Total water level exceedance curve for each section (station) for 1995 to 2100 along with toe and bluff contact elevations for each section.

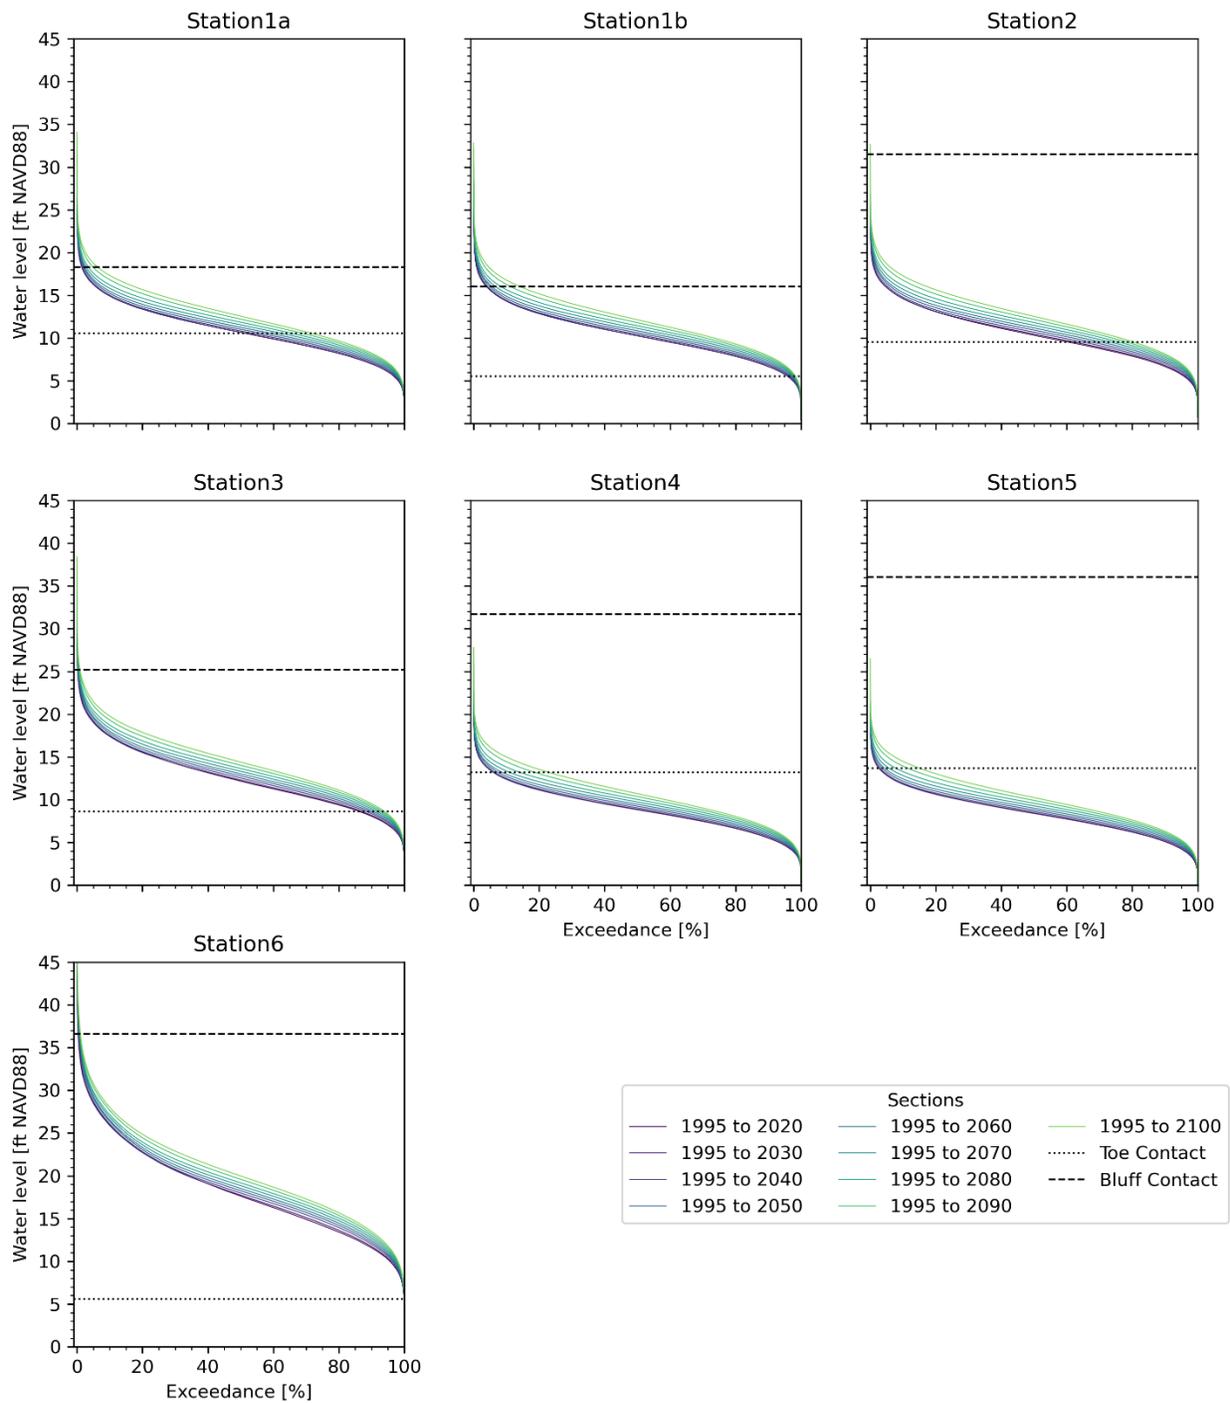
Figure 3-3. Total water level exceedance curves for each section (station) for each period of time.

Once these curves are generated for existing conditions, then the curves are elevated with the projected sea level rise for each decade (Figure 3-3). The difference in the area below the decadal sea level rise adjusted exceedance curves represents an increase in the cumulative hours of wave attack and is used to accelerate erosion rates in the modeling effort (see Section 3-5).

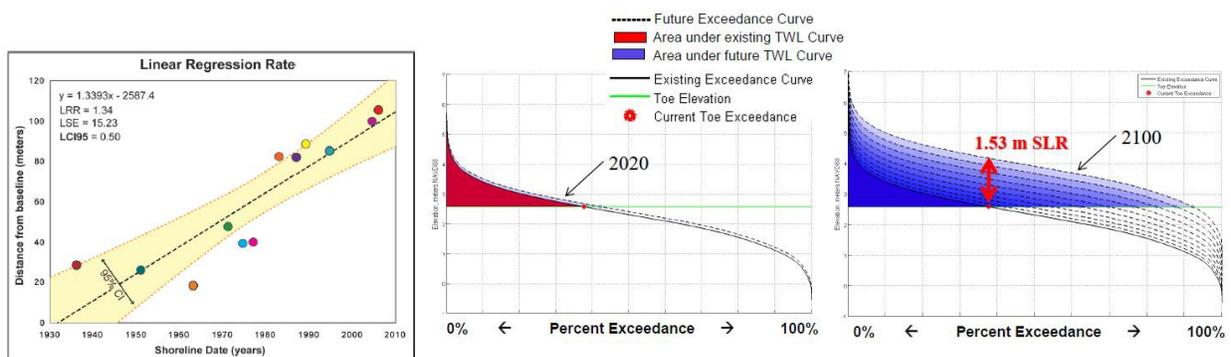
Figure 3-4. Left: Example of a DSAS linear regression rate statistic represented as a best-fit regression line (dotted line) among the bluff-top locations (colored points). The yellow shaded line represents the 95 percent confidence band for the position of the regression line. This band was used to determine the factor of safety. Right: Example of the area represented under both the existing (red) and future (shades of blue) exceedance curve and above the toe elevation (green line).

To account for the risk of localized block failures that could not be captured by the long-term average erosion rate, an additional factor of safety was included in the erosion calculation (see the yellow band in Figure 3-4 at left). Two different factors of safety were used for the study area. For areas with a higher degree of certainty and where more historical erosion has been observed, the study utilized one standard deviation of the historical erosion rate times the planning horizon. For areas with less certainty and where very little historical erosion has been observed, the study used two standard deviations of the historical erosion rate. This was done to minimize bias in areas where erosion is not well documented over the 90-year historical timeframe, as well as to account for the potential for localized near-term failures.

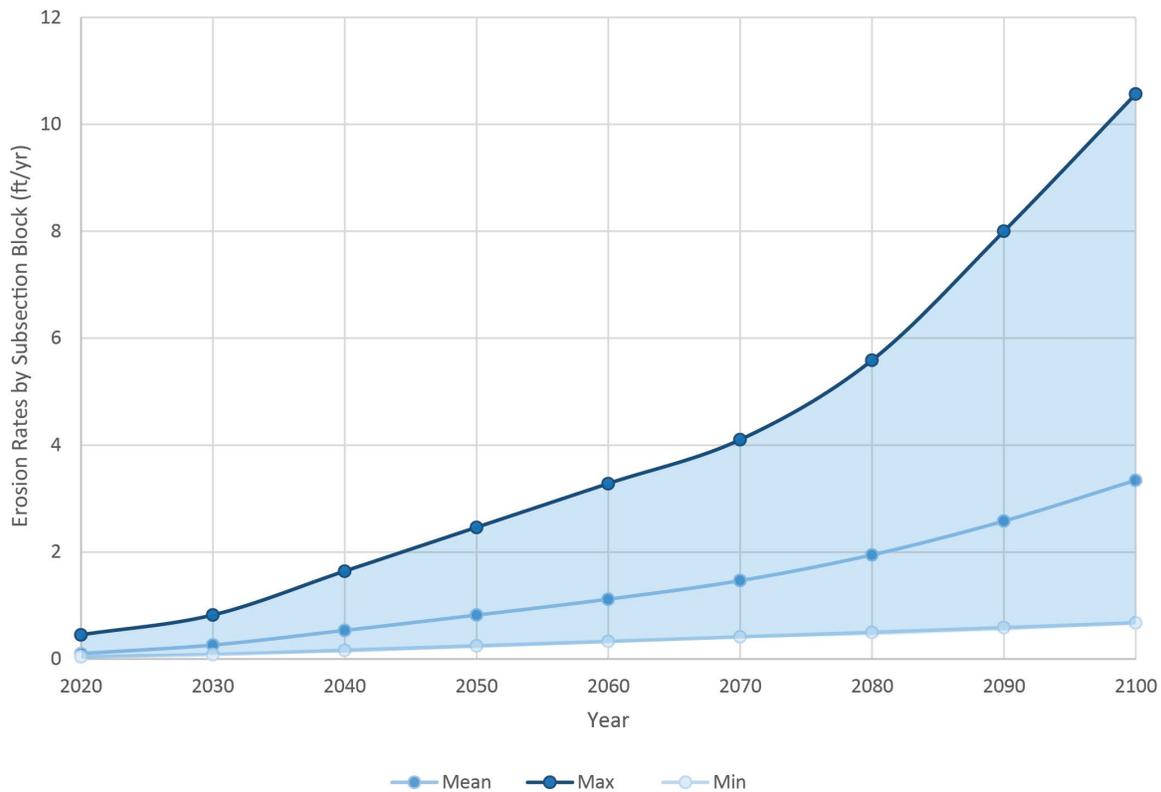
Figure 4-1. Acceleration of erosion rates. The blue shaded area represents the range of erosion rates among all subsection blocks.

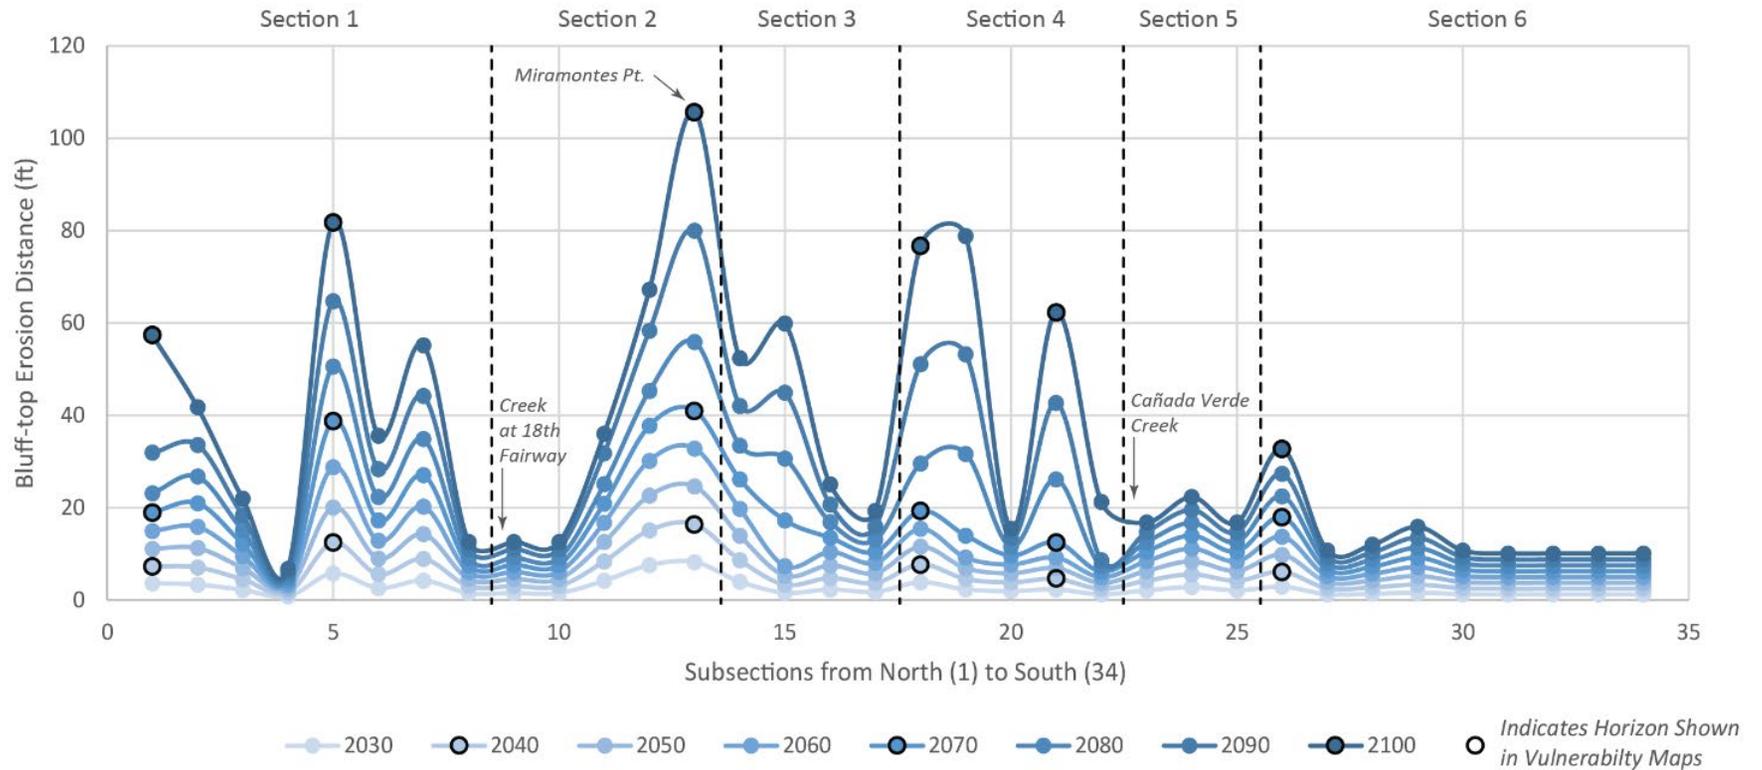
Figure 4-2. Erosion rates by study area subsection blocks. Not particularly in Sections 2 and 4 that sea level rise tends to accelerate the projected erosion distances more rapidly.
