City of Half Moon Bay, Miramontes Point

Sea Level Rise Vulnerability and Fiscal Impact Assessment

Prepared by
integral
consulting inc.

March 21, 2023

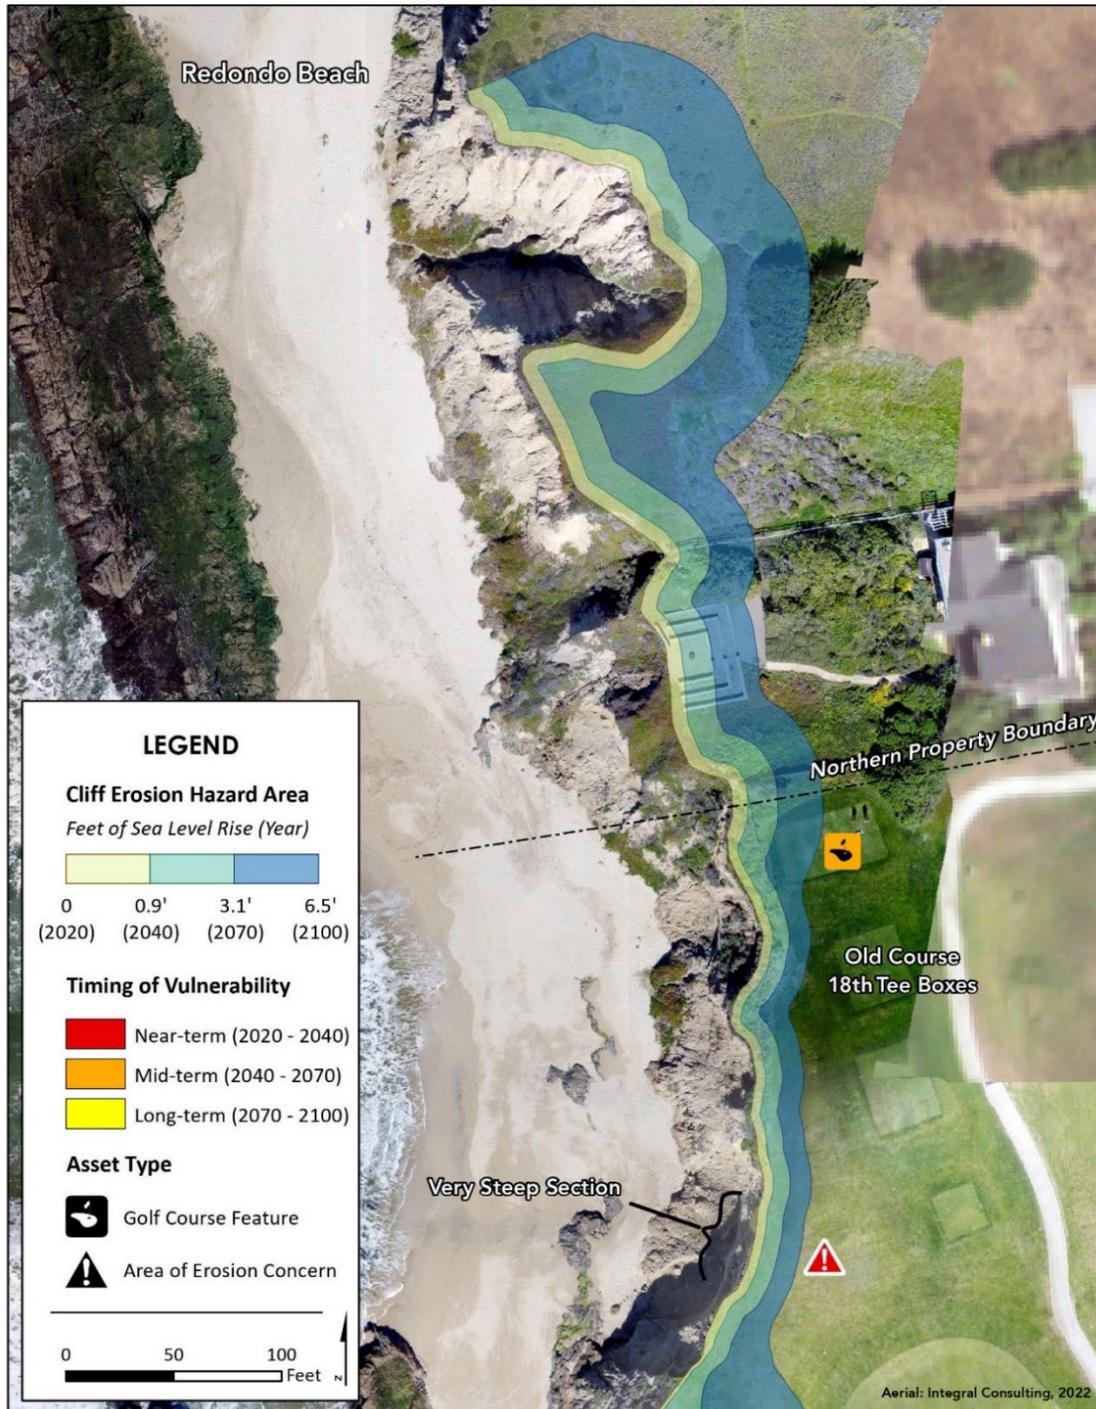
Figure 4-3. Future bluff position envelope for near-, mid-, and long-term within the northern portion of Section 1 (Section 1a).

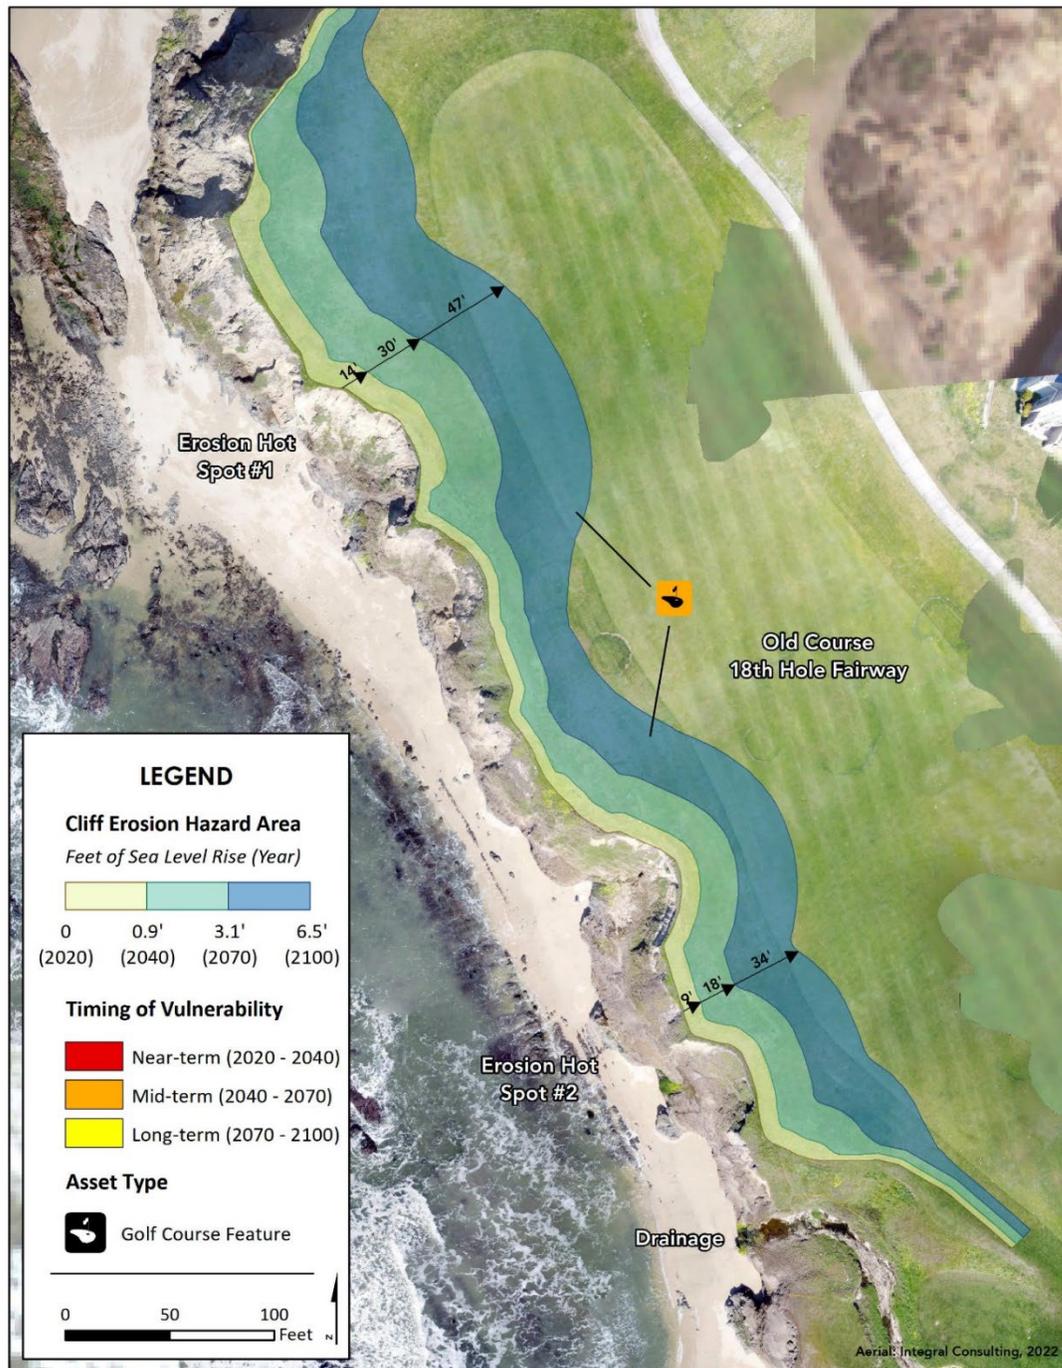
Figure 4-4. Future bluff position envelope for near-, mid-, and long-term within the southern portion of Section 1 (Section 1b).

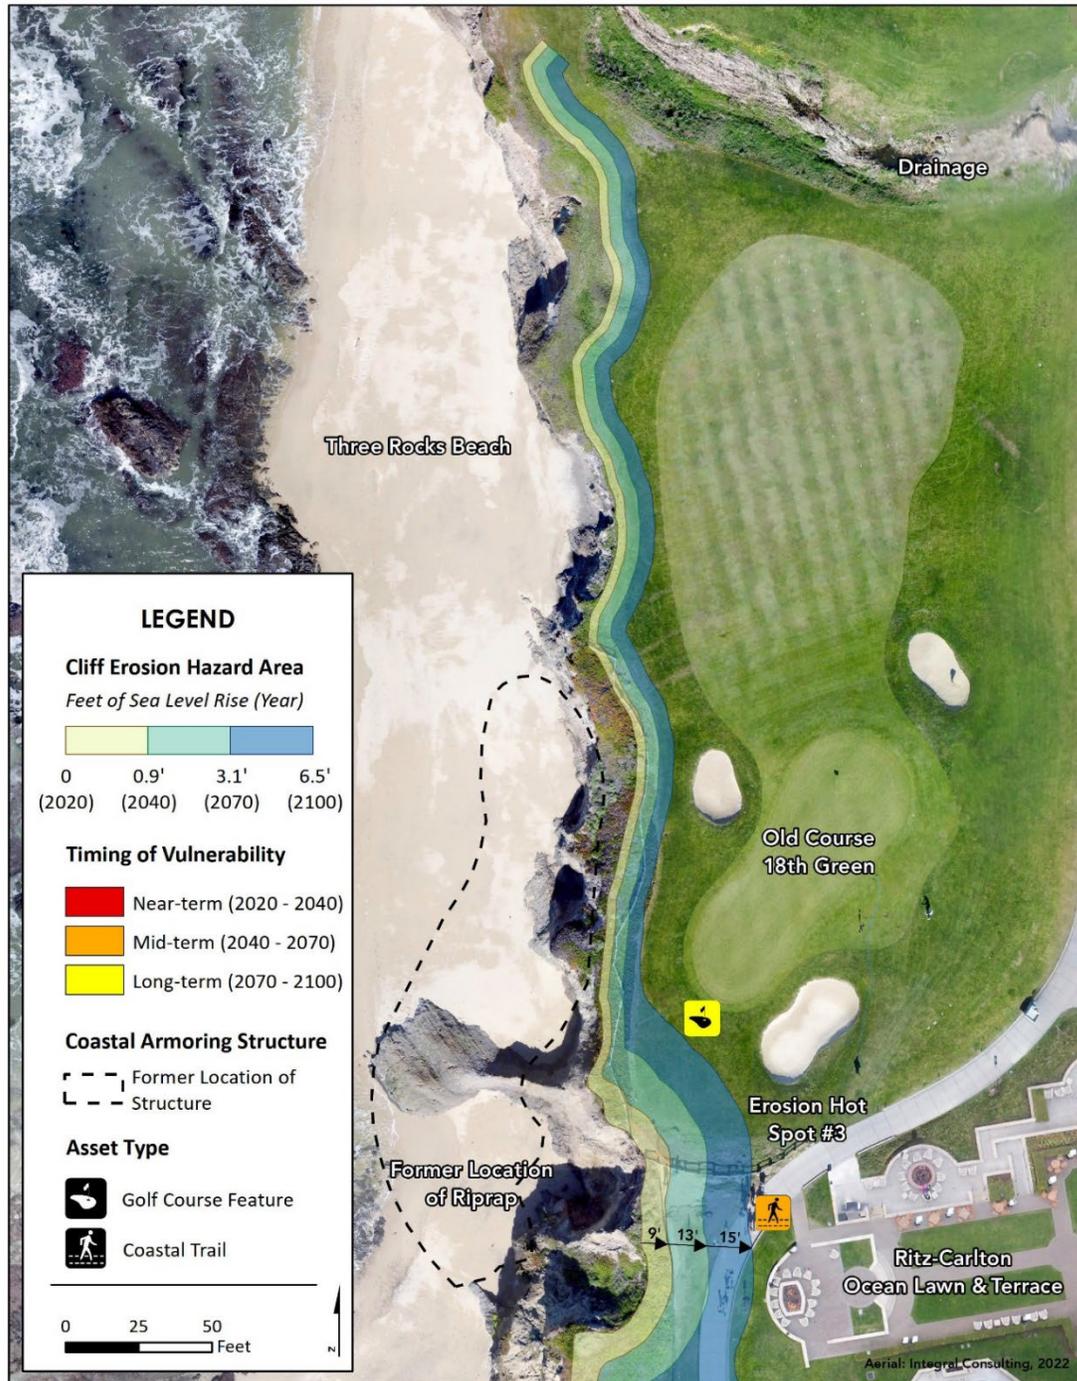
Figure 4-5. Future bluff position envelope for near-, mid-, and long-term within the northern portion of Section 2 (Section 2a).

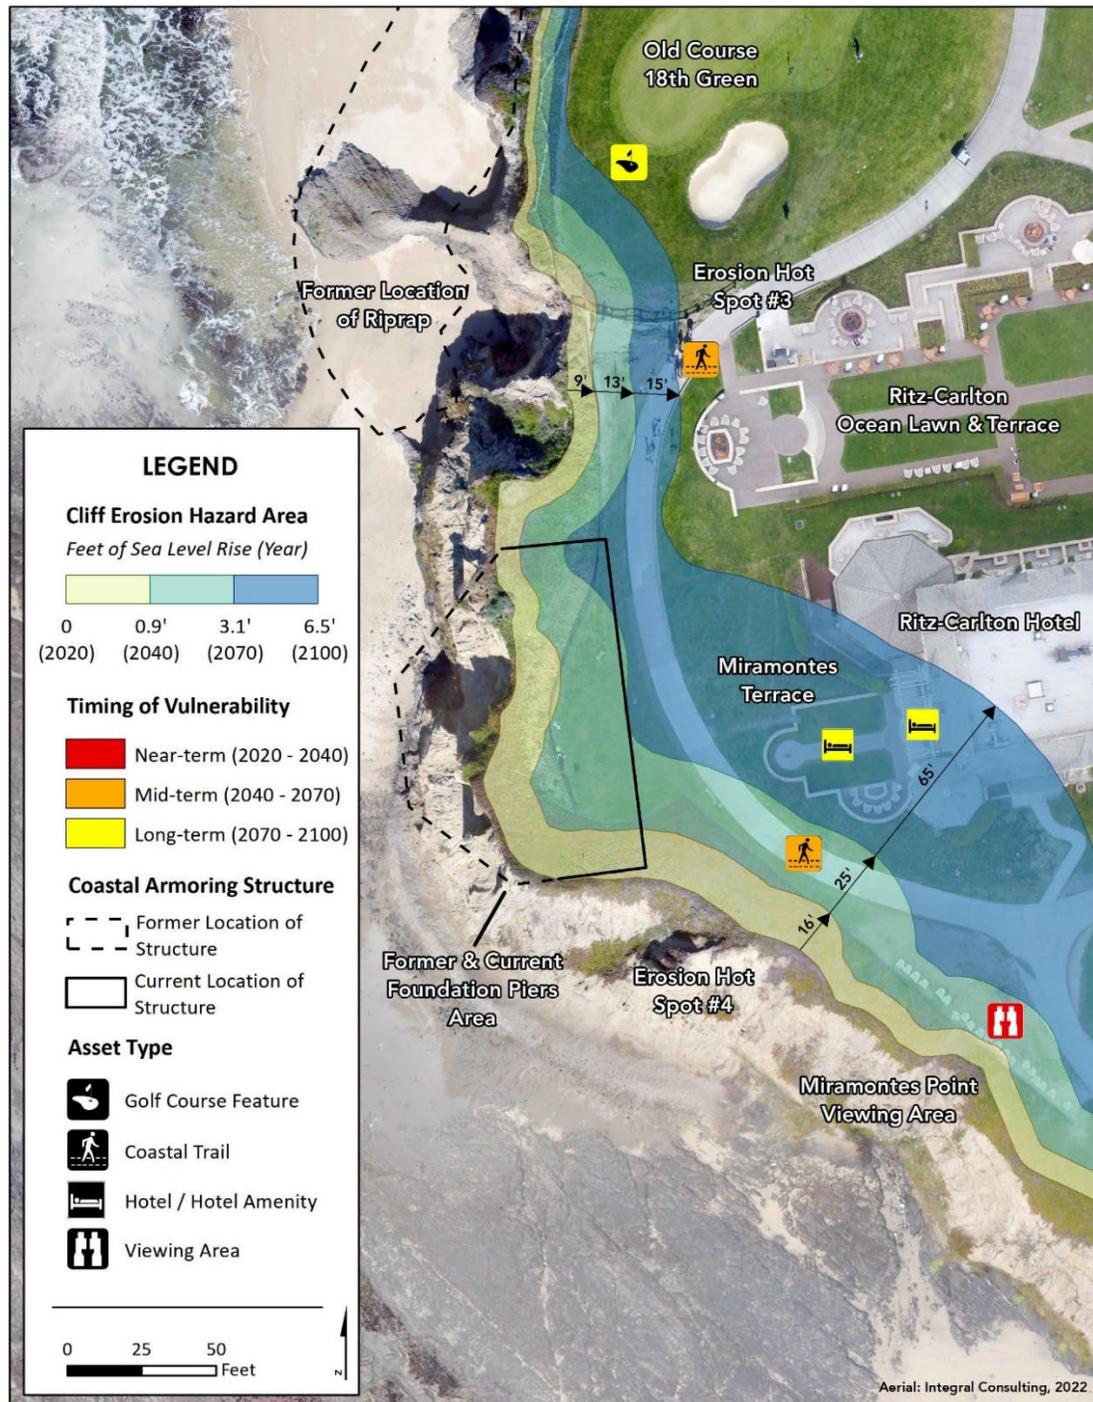
Figure 4-6. Future bluff position envelope for near-, mid-, and long-term within the southern portion of Section 2 (Section 2b).

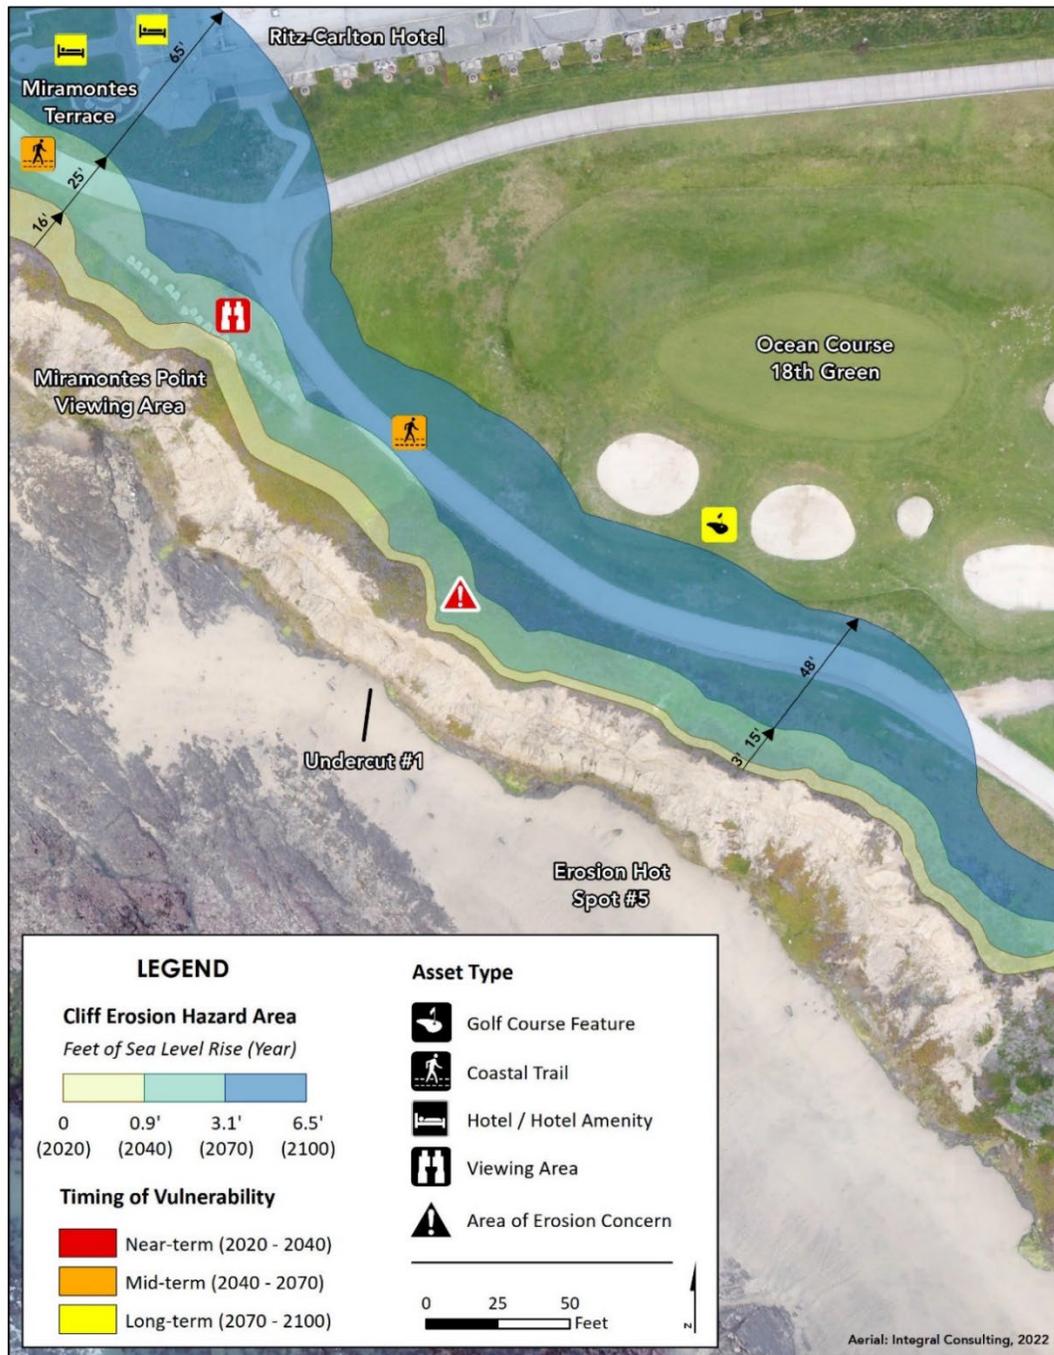
Figure 4-7. Future bluff position envelope for near-, mid-, and long-term within the northern portion of Section 3 (Section 3a).

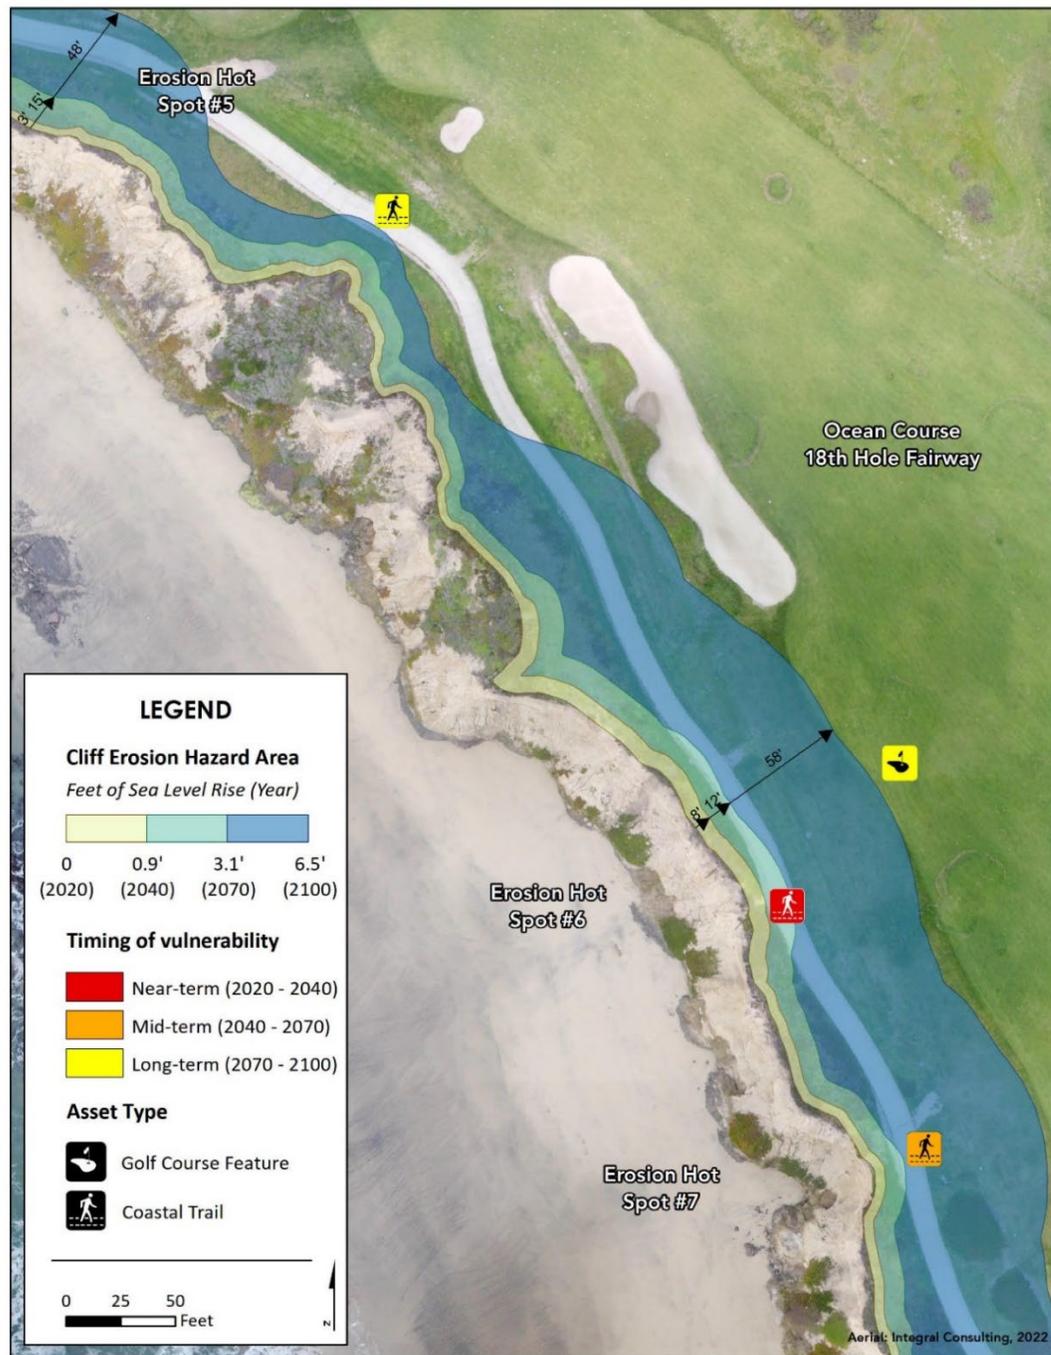
Figure 4-8. Future bluff position envelope for near-, mid-, and long-term bluff position envelope within the southern portion of Section 3 (Section 3b) and the northern portion of Section 4 (Section 4a).

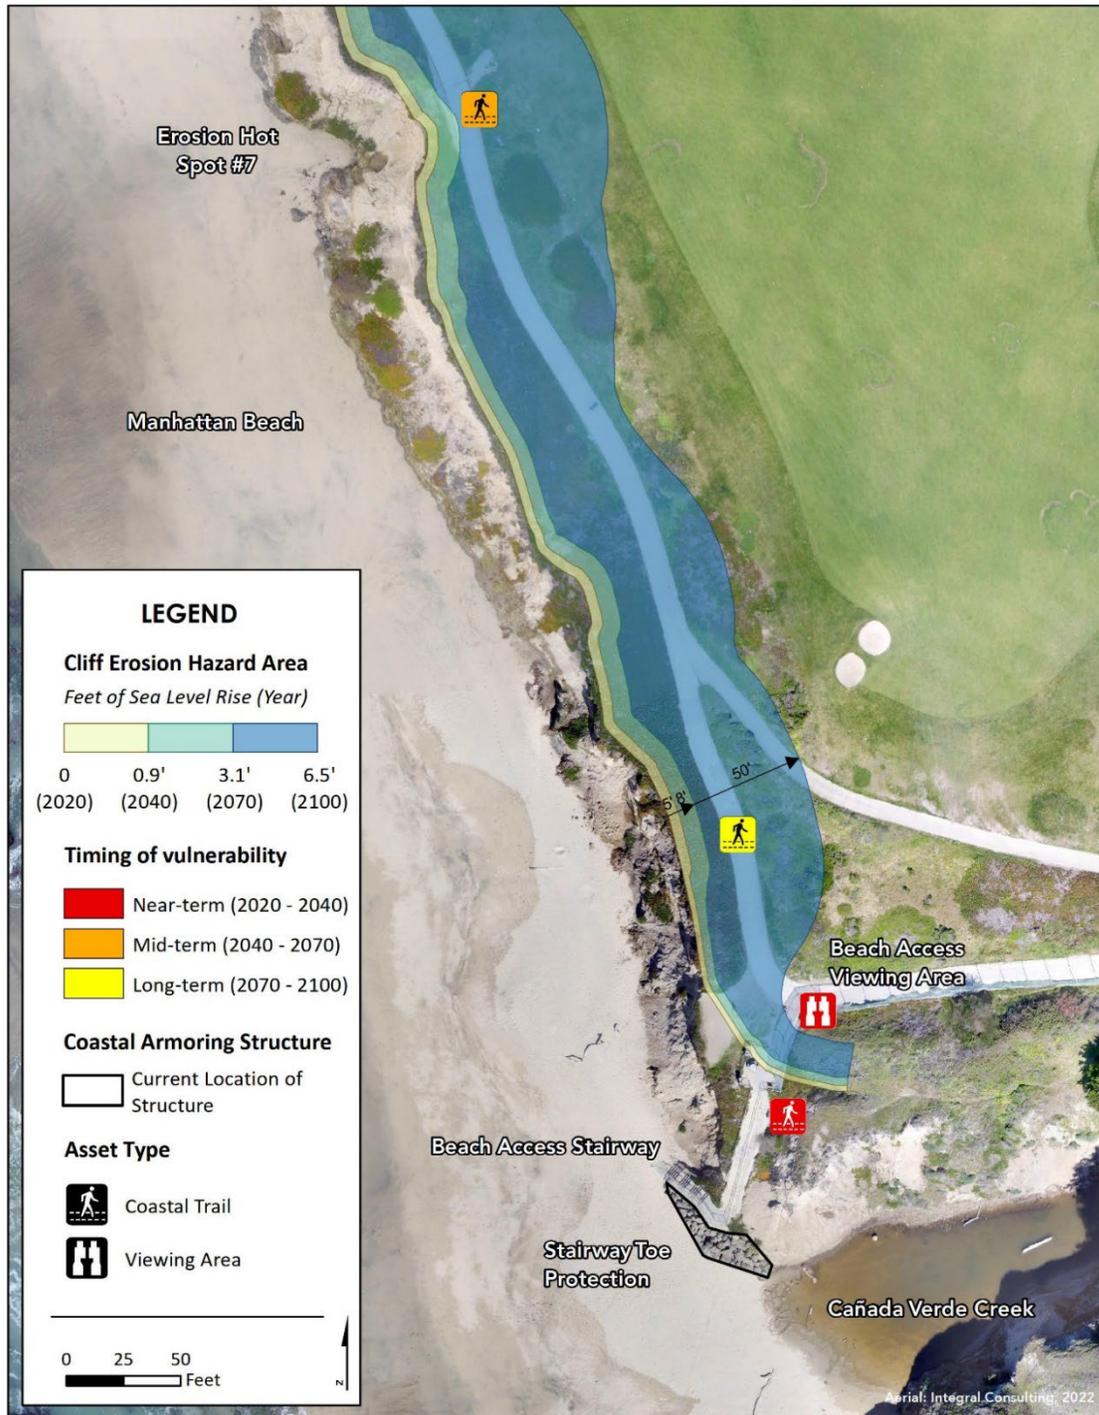
Figure 4-9. Future bluff position envelope for near-, mid-, and long-term within the southern portion of Section 4 (Section 4b).

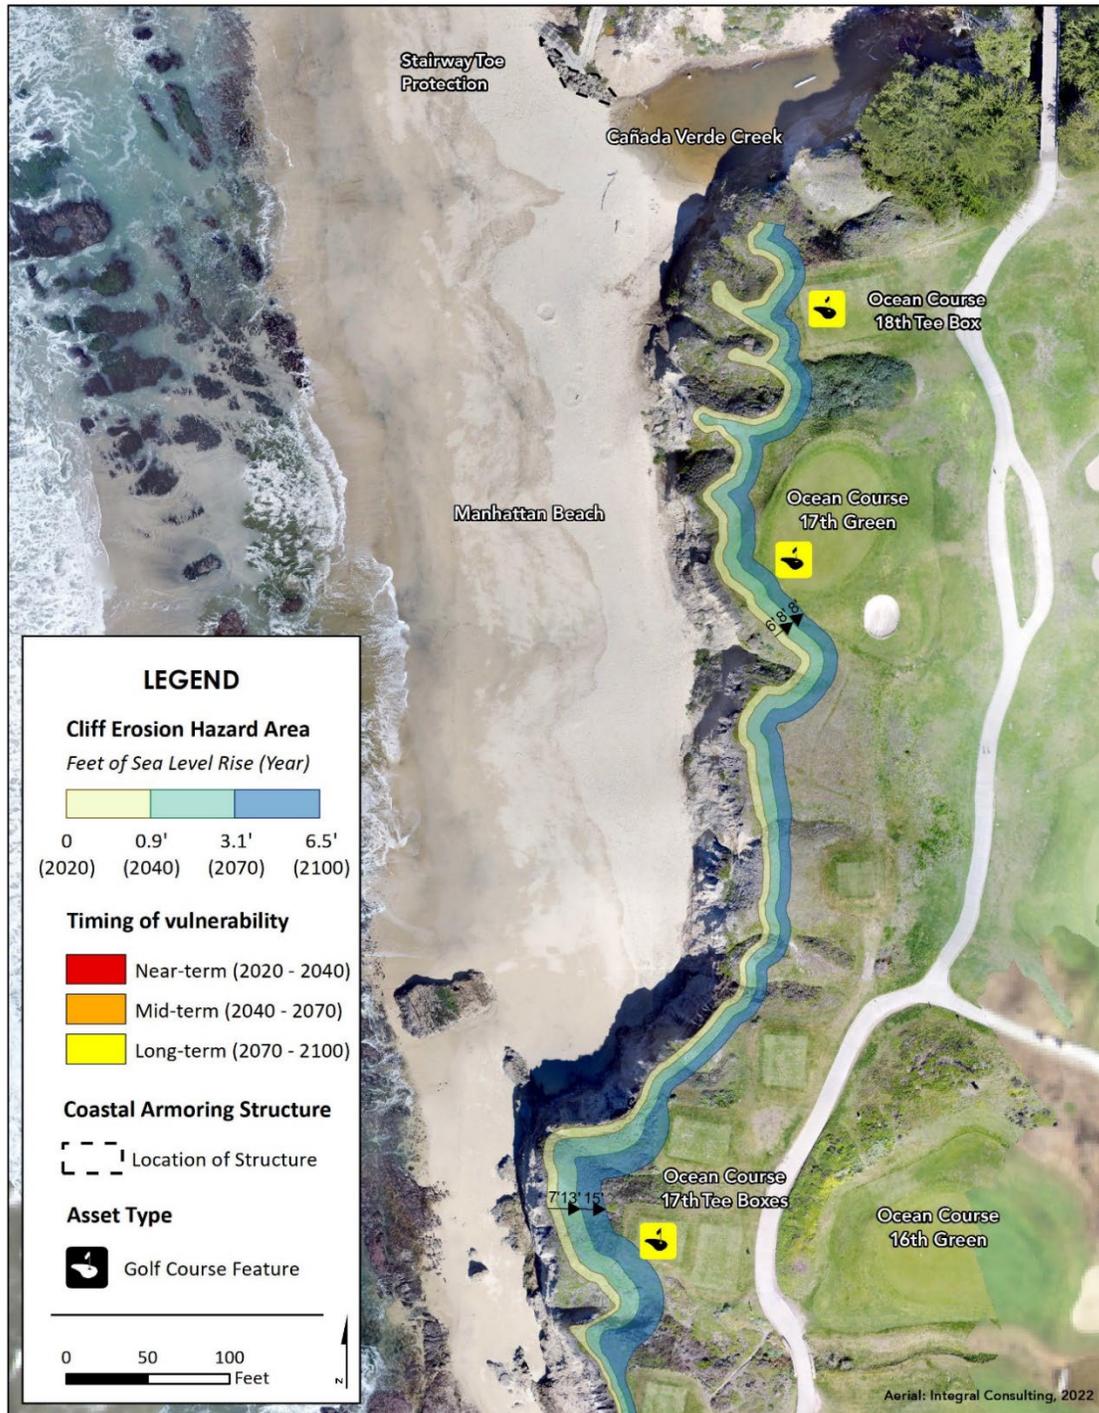
Figure 4-10. Future bluff position envelope for near-, mid-, and long-term within Section 5.

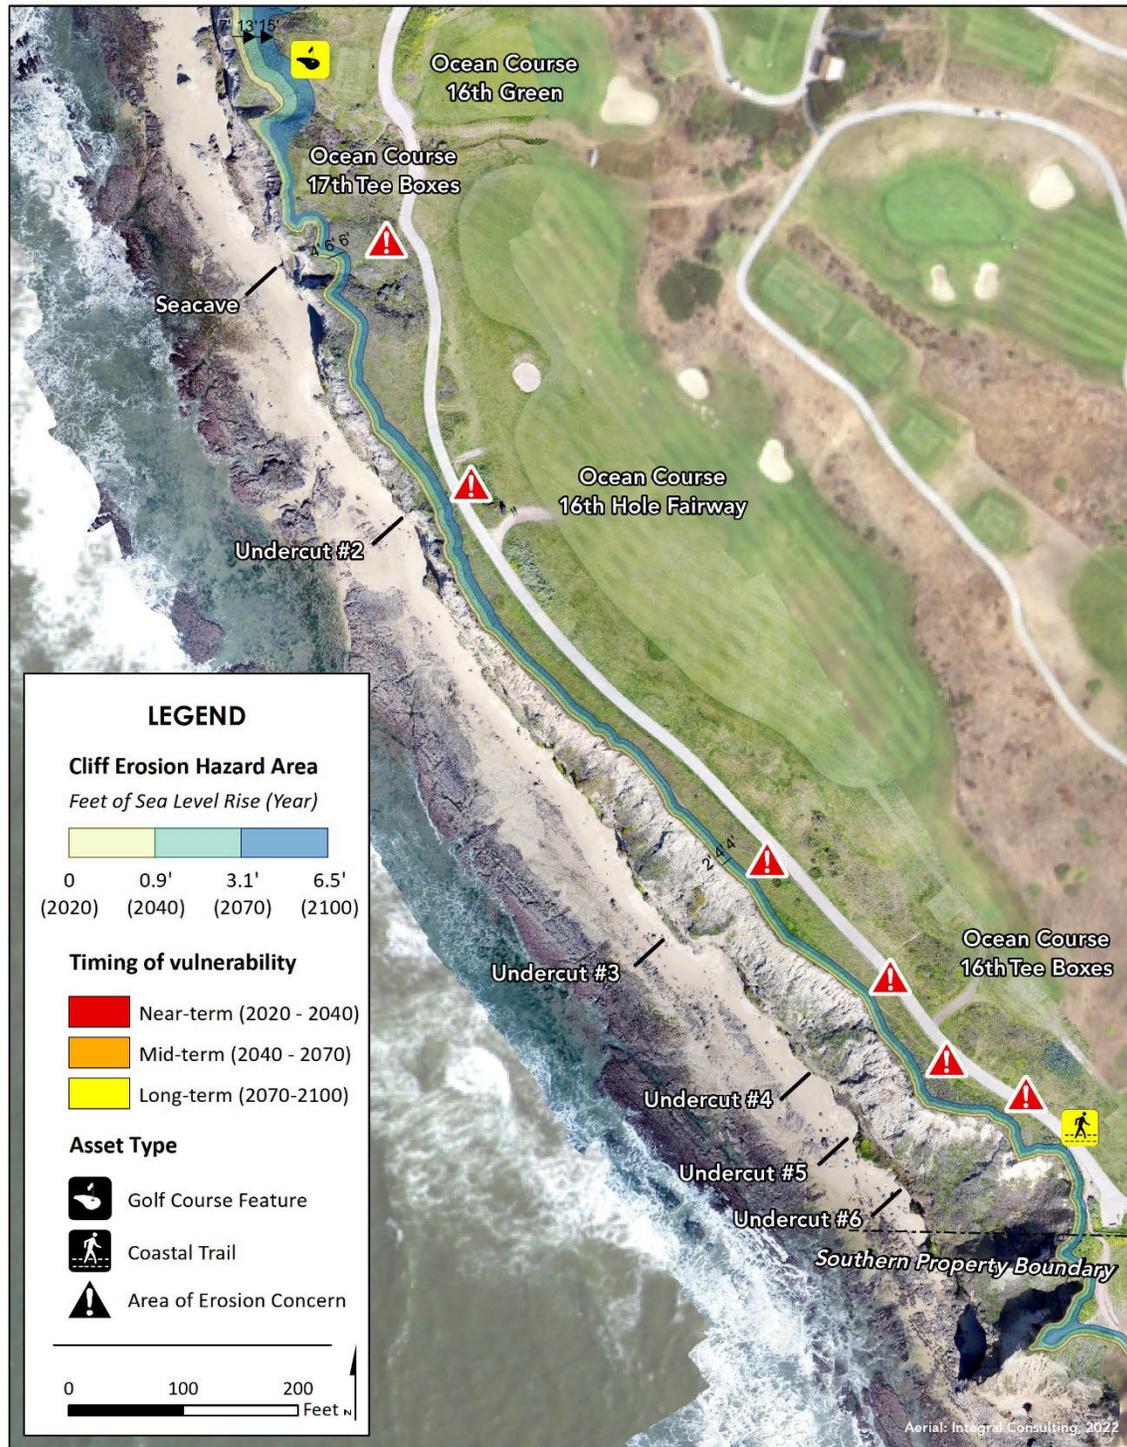
Figure 4-11. Future bluff position envelope for near-, mid-, and long-term within Section 6.

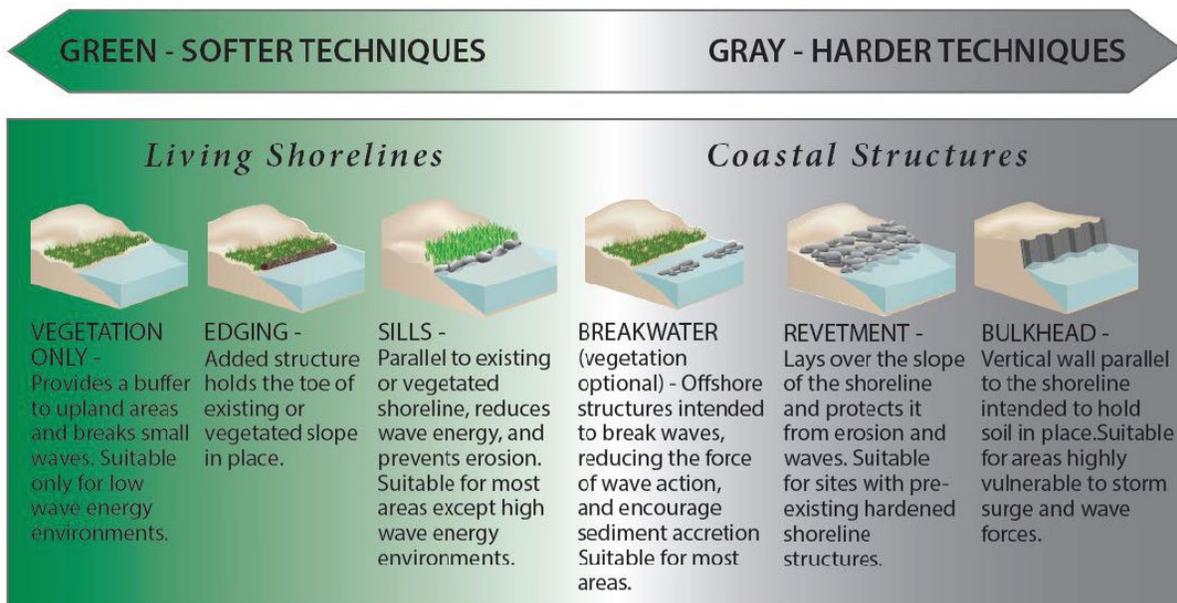
Figure 6-1. A range of green to gray adaptation strategies intended to mitigate erosion, flooding, or both
 Source: www.habitatblueprint.noaa.gov/living-shorelines.

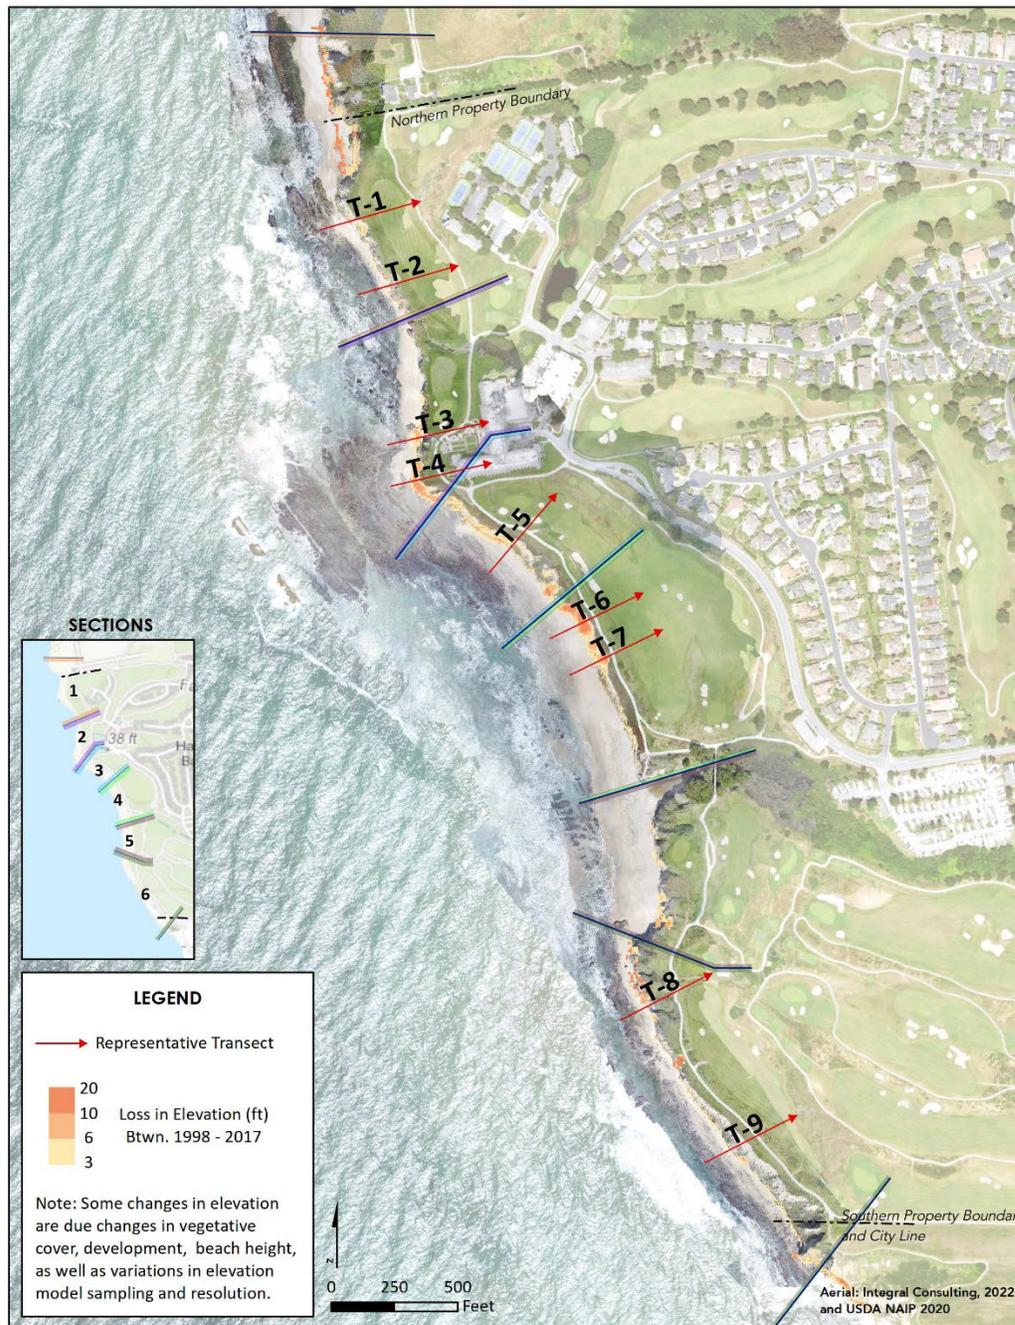
Digital Elevation Transect Model Comparison

Units in ft (NAVD 88). Horizontal and vertical distances vary.
