Appendix E. Aquatic Resources Delineation Report and Preliminary Jurisdictional Wetland Delineation

State Route 1 Multi-Asset Roadway Rehabilitation Project

Aquatic Resource Delineation

04-01-SM-PM 27.5/34.8

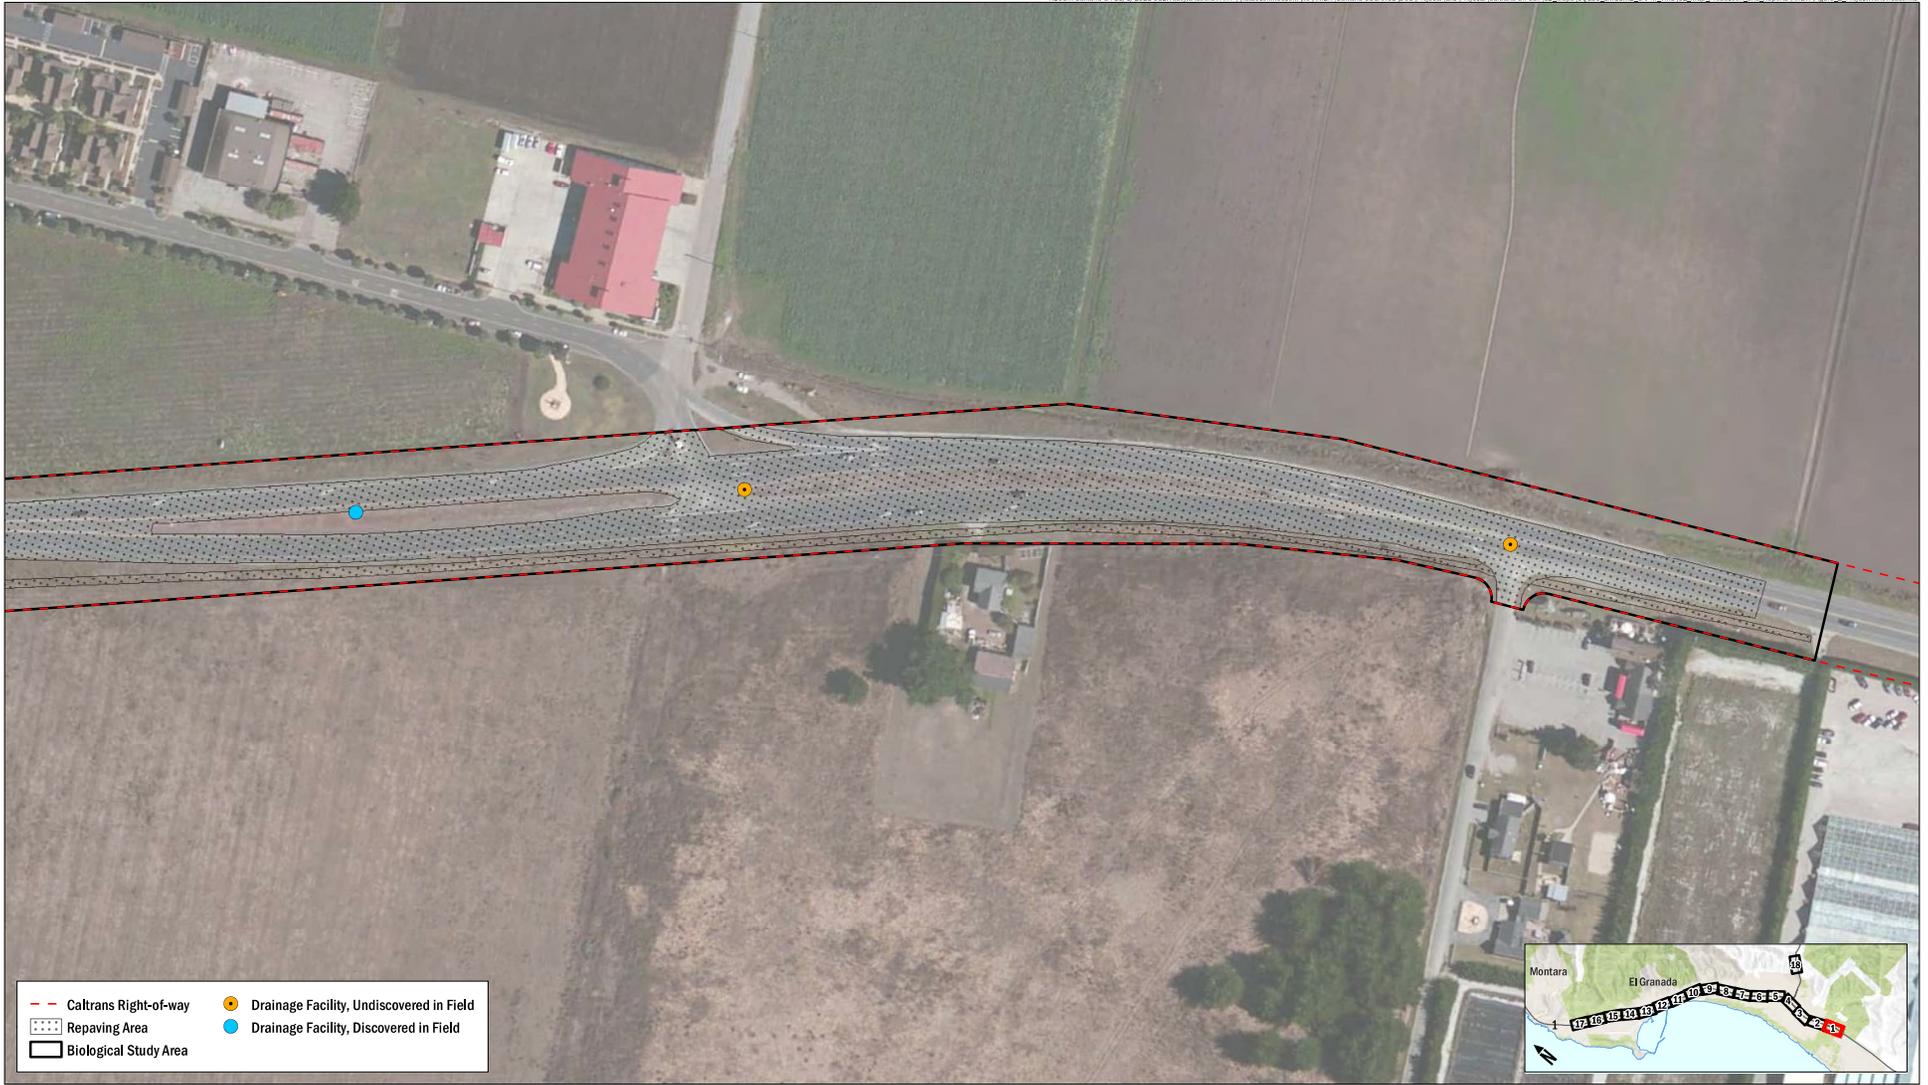
FIGURE 2
Project Work Areas in the
Biological Study Area
Page 1 of 18

Caltrans Right-of-way		Drainage Facility, Undiscovered in Field
	Repaving Area		Drainage Facility, Discovered in Field
	Biological Study Area

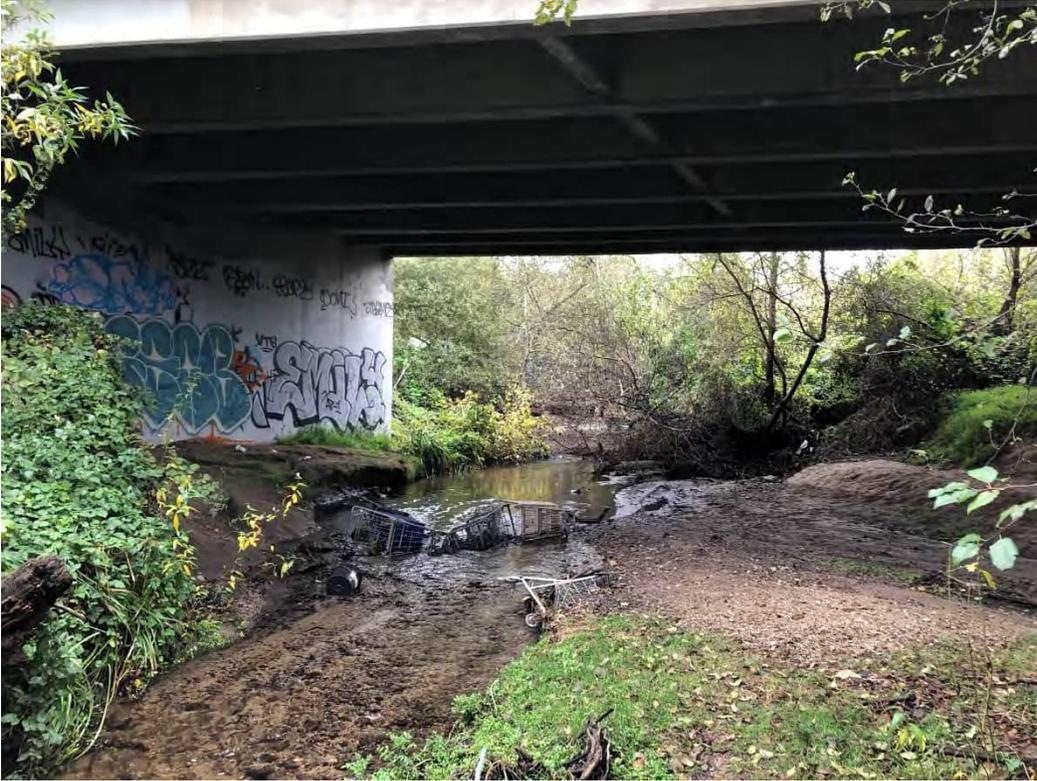
Photograph 3: Pilarcitos Creek (OWUS-1) under the SR 1 northbound bridge.

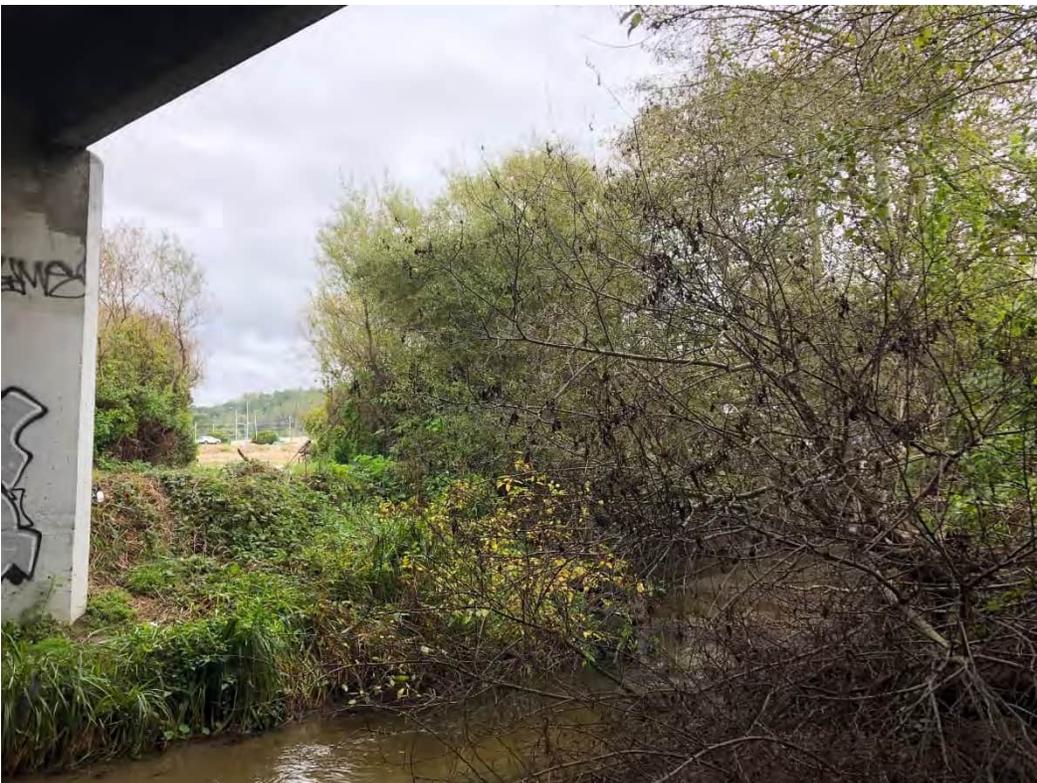
Photograph 4: Pilarcitos Creek (OWUS-1) upstream of the SR 1 northbound bridge.

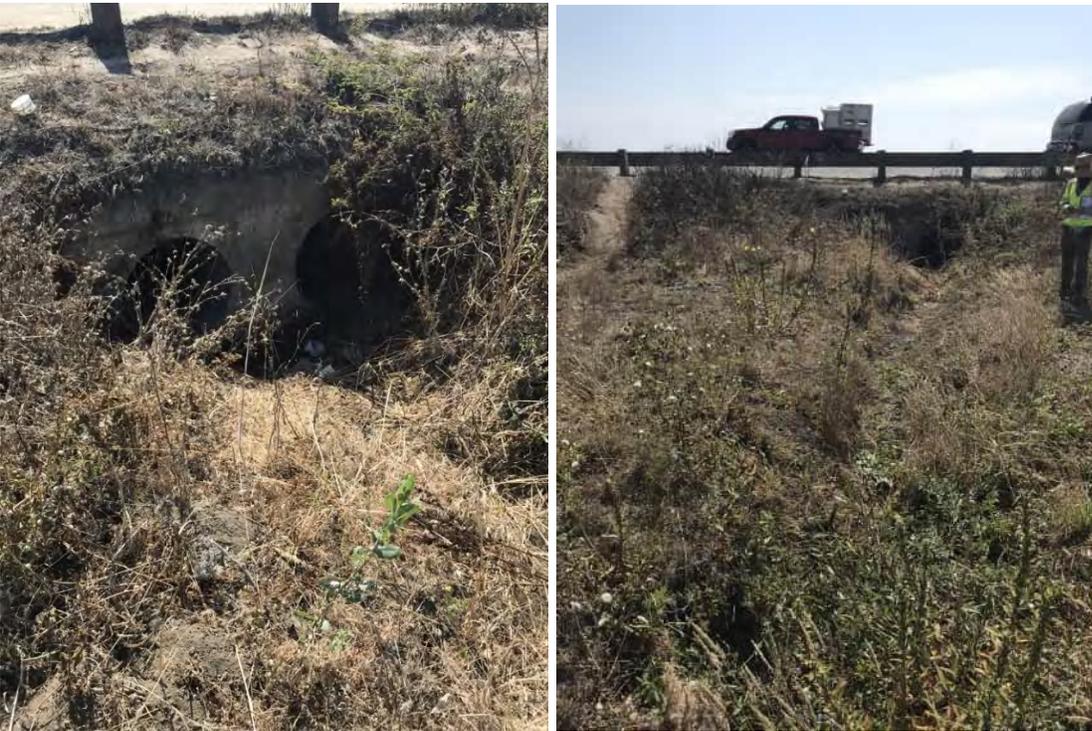
Ephemeral Creek (OWUS-8)

Photographs 28 and 29: Ephemeral creek (OWUS-8) leading to cross culvert (CWUS-6) under SR 1.

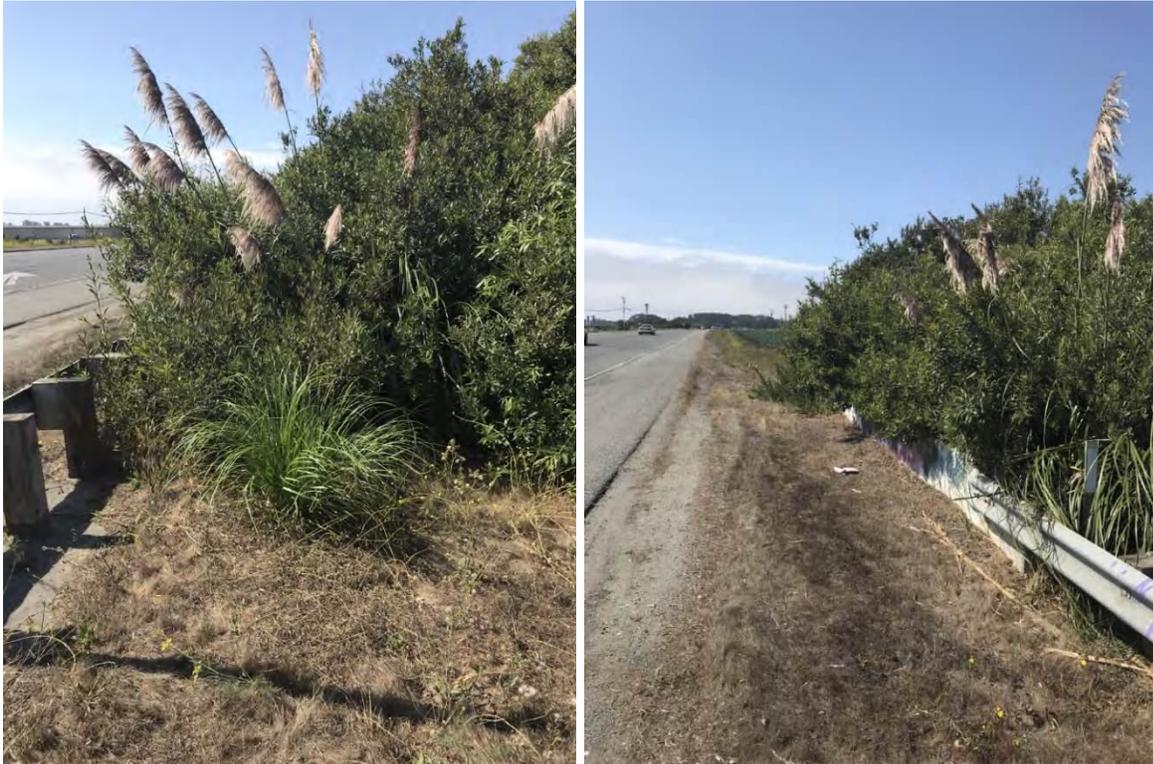
Denniston Creek (OWUS-9a, OWUS-9b)

Photographs 30 and 31: Willow riparian of Denniston Creek (OWUS-9a) east of SR 1.
