DRAFT MEMORANDUM

DATE: December 1, 2022
TO: Denice Hutten, City of Half Moon Bay
FROM: Benjamin Shick, PE
SUBJECT: Pilarcitos Avenue/Kehoe Watercourse Outfall Repair Project (CIP 1005),
Project Alternatives

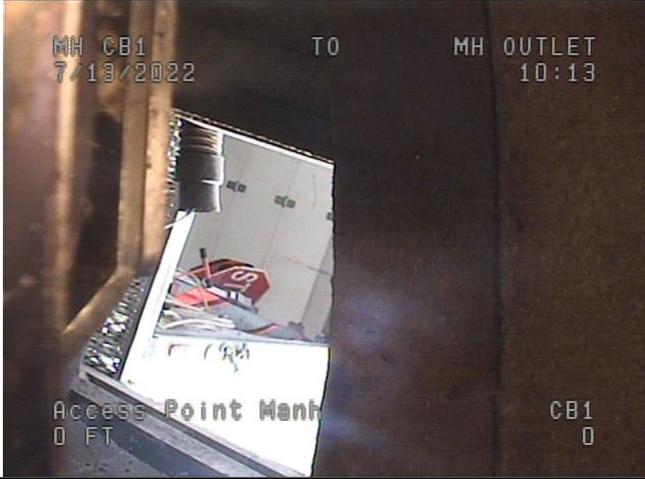
Distance	Fault Observation	Time	Picture
0.0	Access Point Manhole Severity: None Remarks: CB1	00:00:22

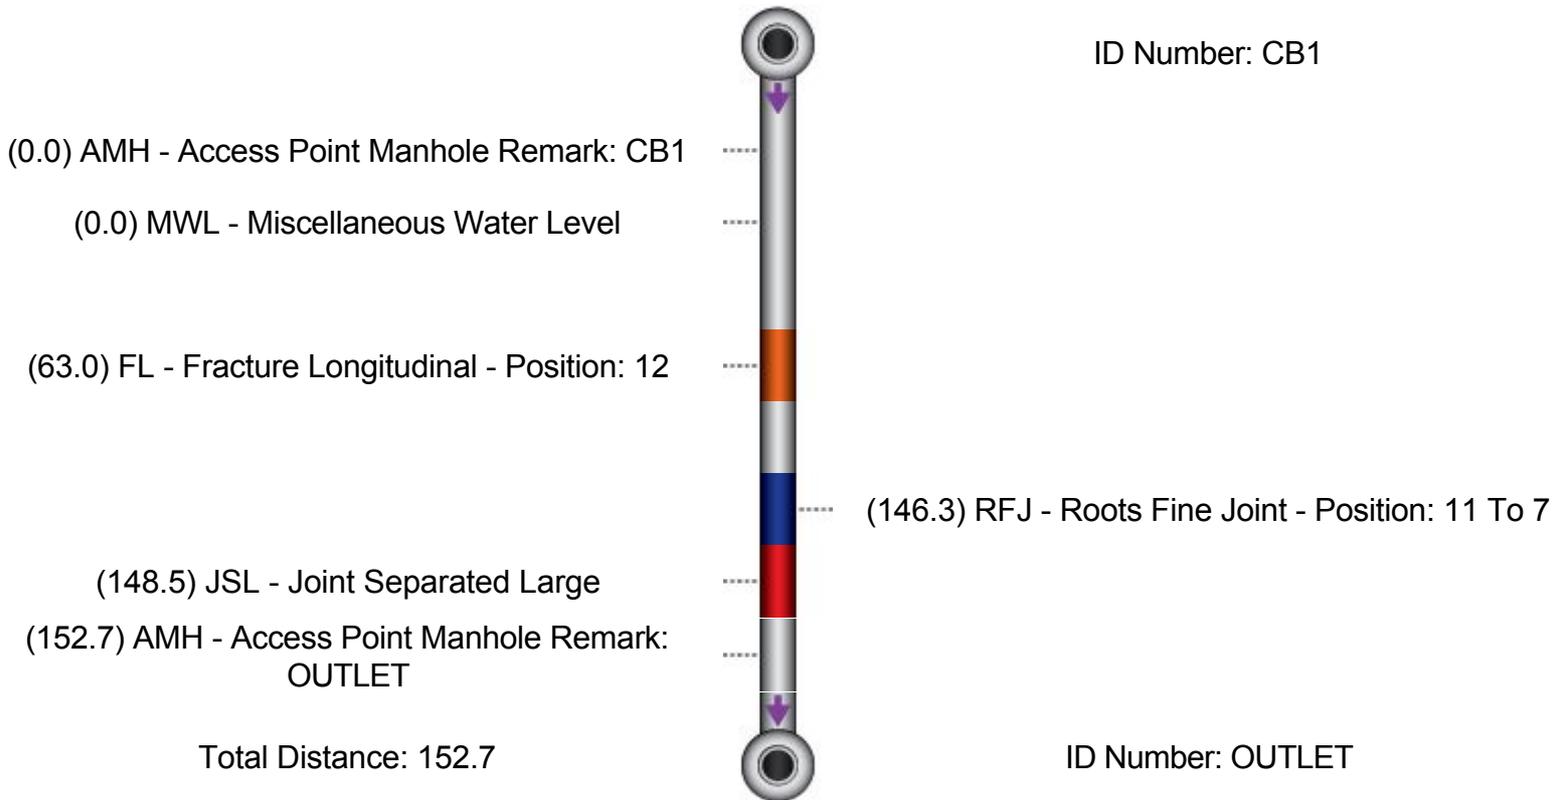
Nassco C.C.T.V. Defect Code Information

Grade	Structural	O&M	Overall
5	0	0	0
4	4	0	4
3	3	0	3
2	0	0	0
1	0	1	1
Overall	7	1	8
Number of Defects	2	1	3
Pipe Rating	4131	1100	4131
Pipe Ratings Index	3.5	1	2.7
